STATE OF CALIFORNIA
CALIFORNIA NATURAL RESOURCES AGENCY
DEPARTMENT OF WATER RESOURCES
DIVISION OF SAFETY OF DAMS

INSPECTION OF DAM AND RESERVOIR IN CERTIFIED STATUS

Name of Dam Phoenix Lake Dam No. 33-3 County Marin
 Type of Dam ERTH Type of Spillway Concrete weir and chute
 Water is 0.1 feet above the spillway crest and 15.1 feet below the dam crest.
 Weather Conditions Clear and mild
 Contacts Made Alex Anaya and Ronnie Chasteen during the inspection
 Reason for Inspection Periodic Evaluation

Inspected by J. Lowe
 Date of Inspection 7 April 2016
 Date of Report 8 April 2016

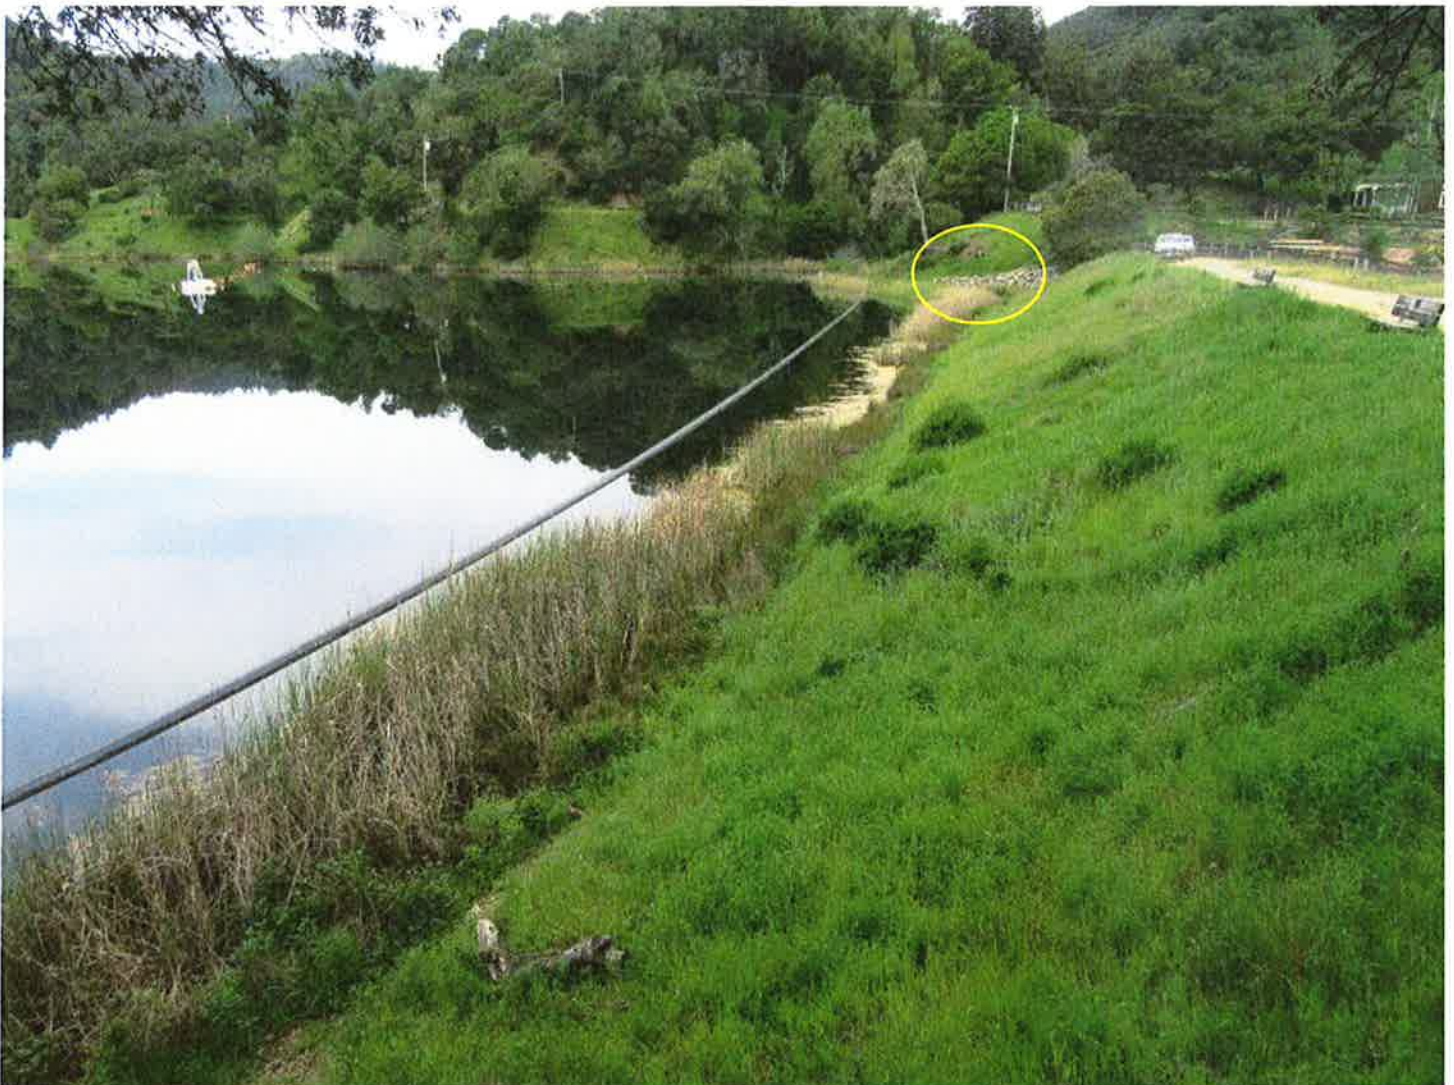
The upstream face as viewed from the right abutment. Tule and cattails along the upstream face waterline should be cleared before the next periodic inspection. The location of the spillway entrance is circled.

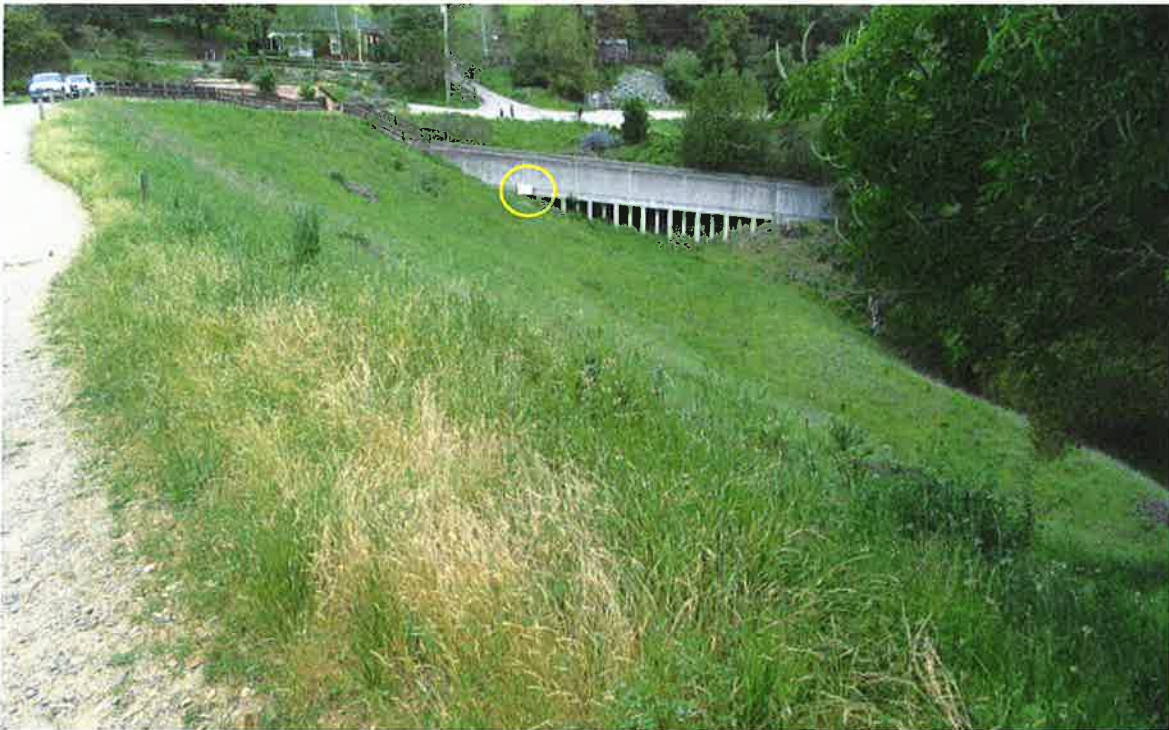
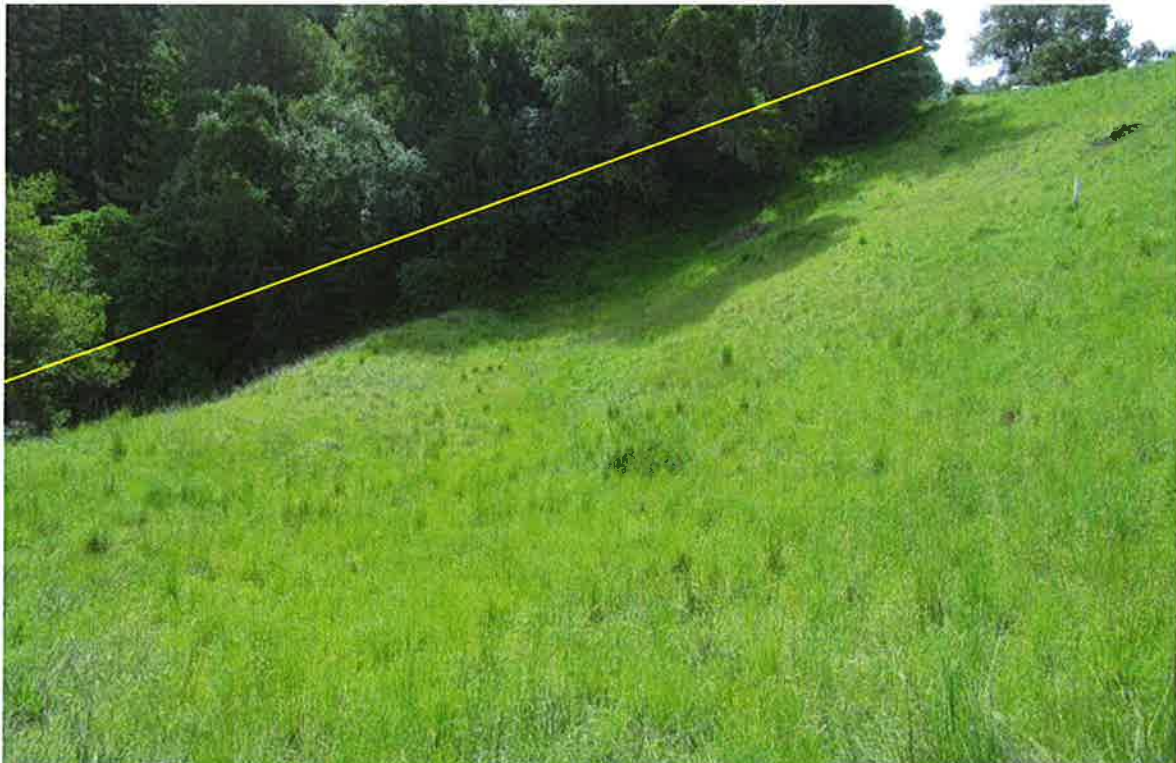
Spillway crack data covers the period between December 2005 and June 2015. Crack monitors indicate horizontal displacements are cyclic, with up to 5 mm displacement during the winter storm season, returning to essentially zero during the dry season. Vertical displacements, in contrast, are cumulative, and continue to increase over time. Total vertical settlement to date is on the order of 1.2 mm.

The downstream face looking towards the spillway adjacent to the left abutment, above, and towards the right abutment, below. The spillway crack monitoring instrumentation is contained within in the box circled in the photo above. Overhanging trees and bushes should be trimmed along the right downstream groin (below).

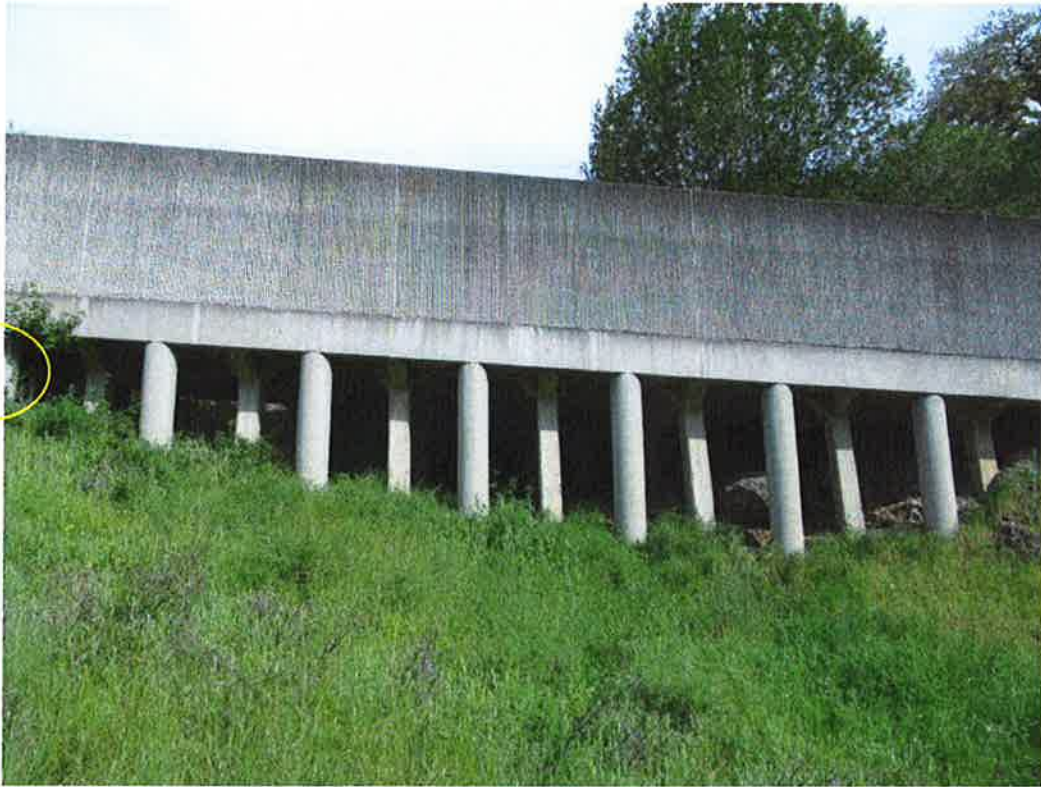
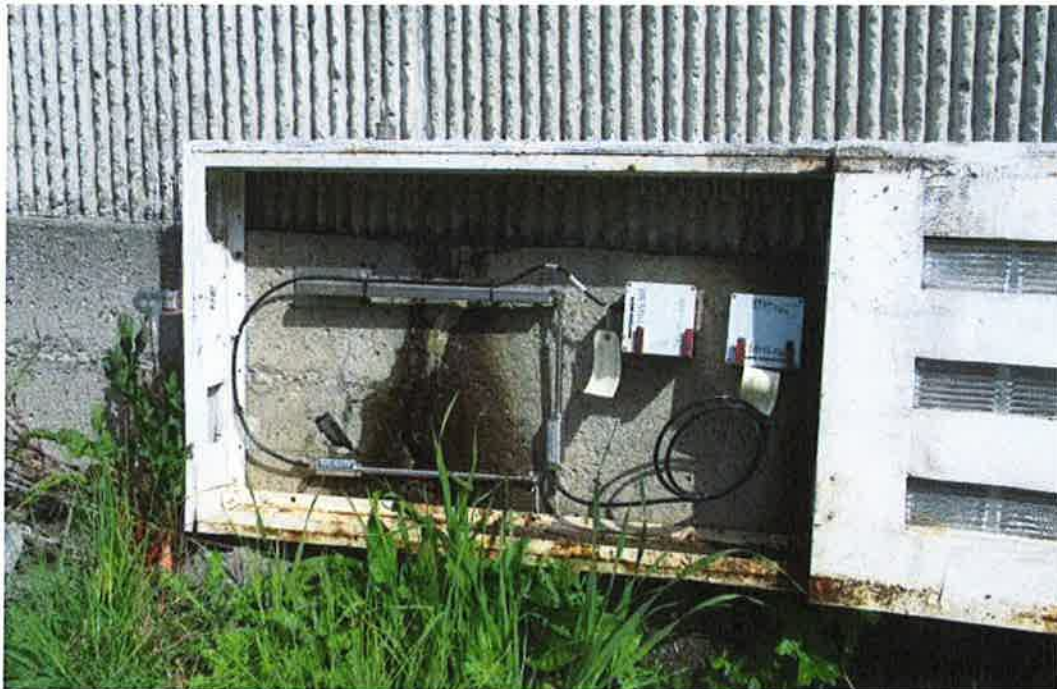
The raised portion of the spillway, above, and the extensometers monitoring movement along a crack through the spillway foundation, below. The location of the instrumentation is circled in the top photograph.
