INSPECTION OF DAM AND RESERVOIR IN CERTIFIED STATUS

Name of Dam Soulajule Dam No. 33-9 County Marin
 Type of Dam ERTH Type of Spillway Concrete weir and chute
 Water is 0.5 feet below the spillway crest and 12.5 feet below the dam crest.
 Weather Conditions Clear and mild
 Contacts Made Alex Anaya and Carl Sanders during the inspection
 Reason for Inspection Periodic Evaluation

Inspected by J. Lowe
 Date of Inspection 5 April 2016
 Date of Report 6 April 2016

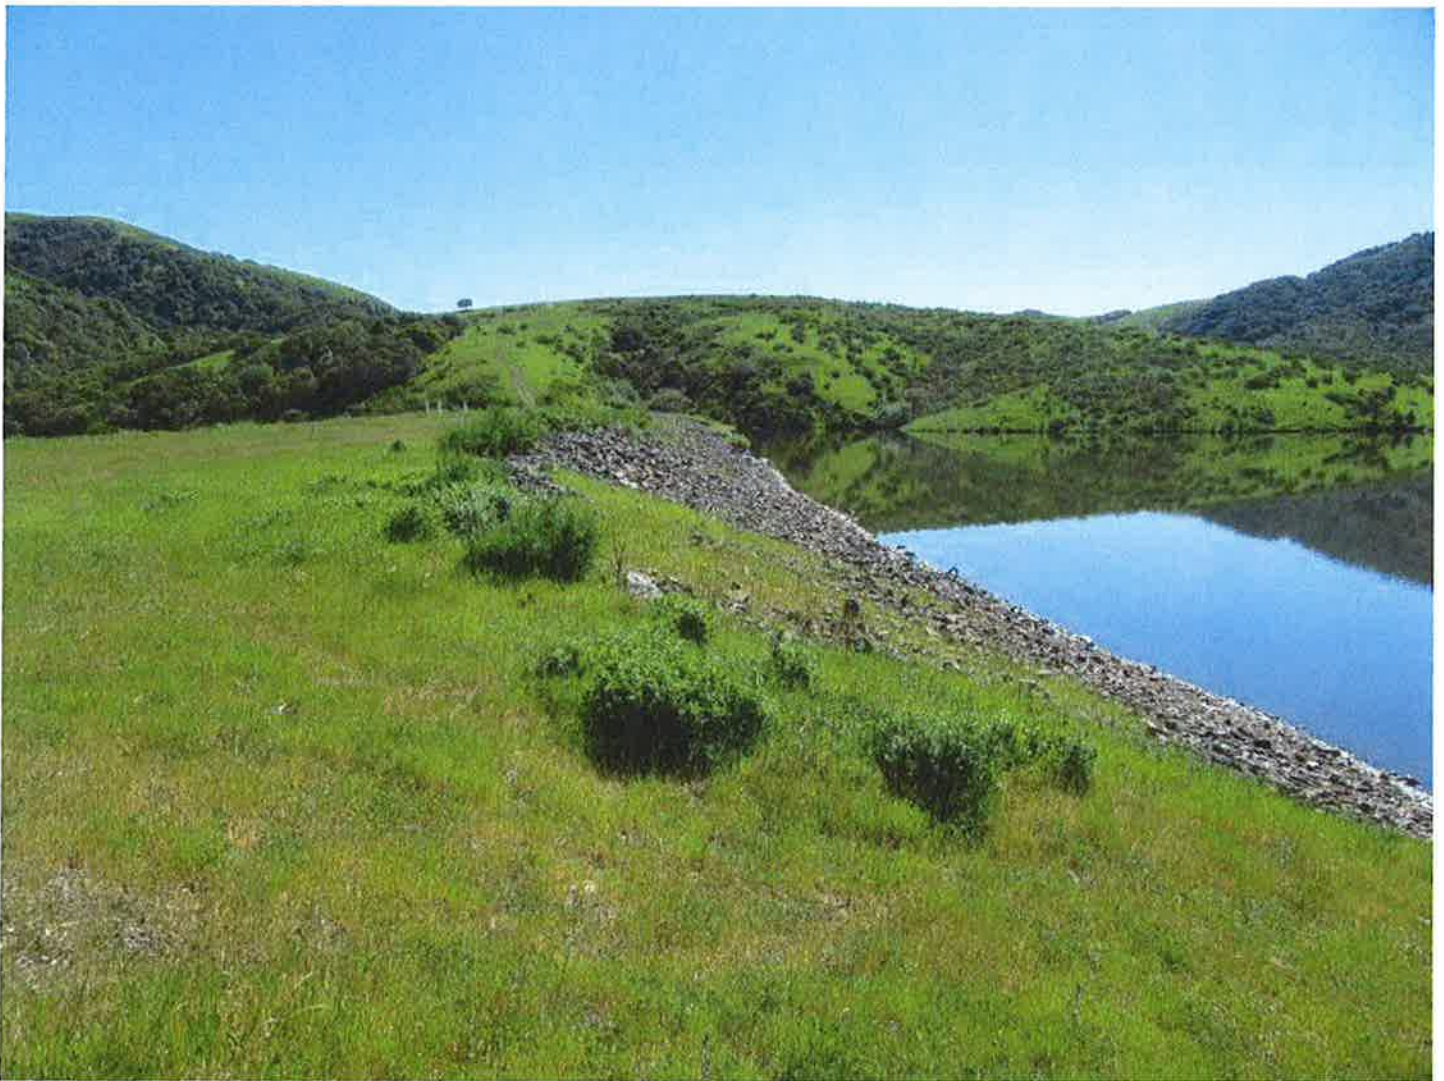
The crest and upstream face as viewed from the right spillway wall. The small bushes in the foreground have re-emerged after having been cut earlier in the year.

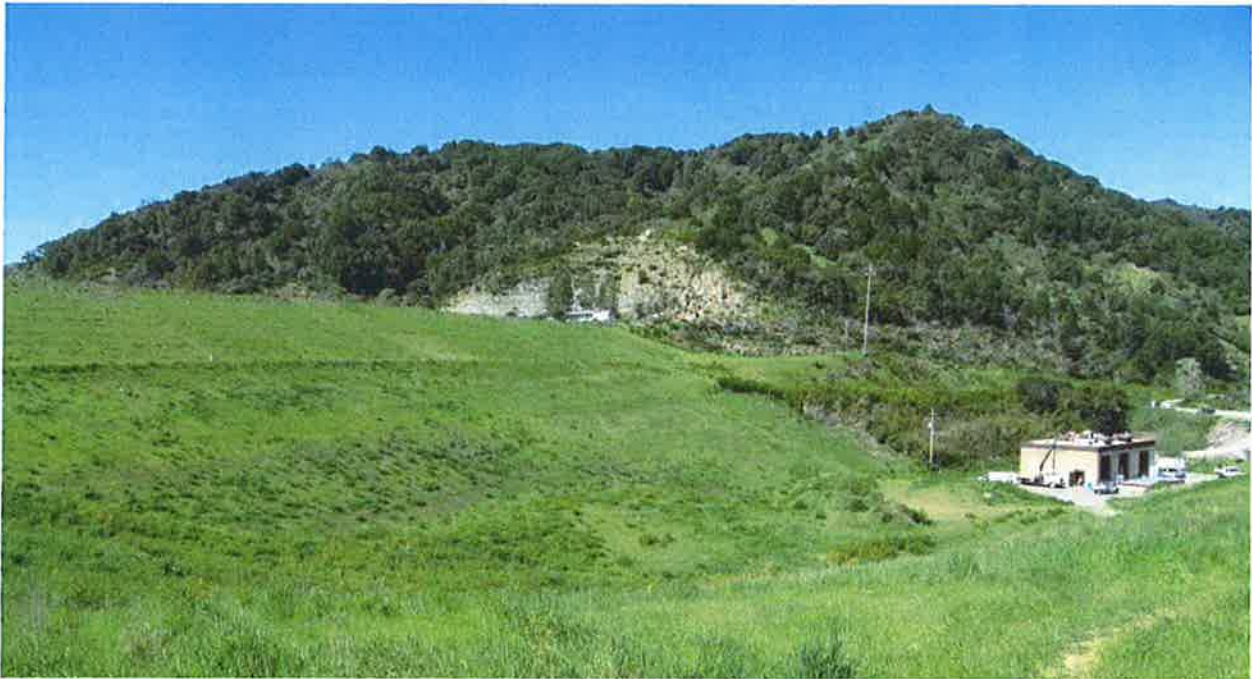
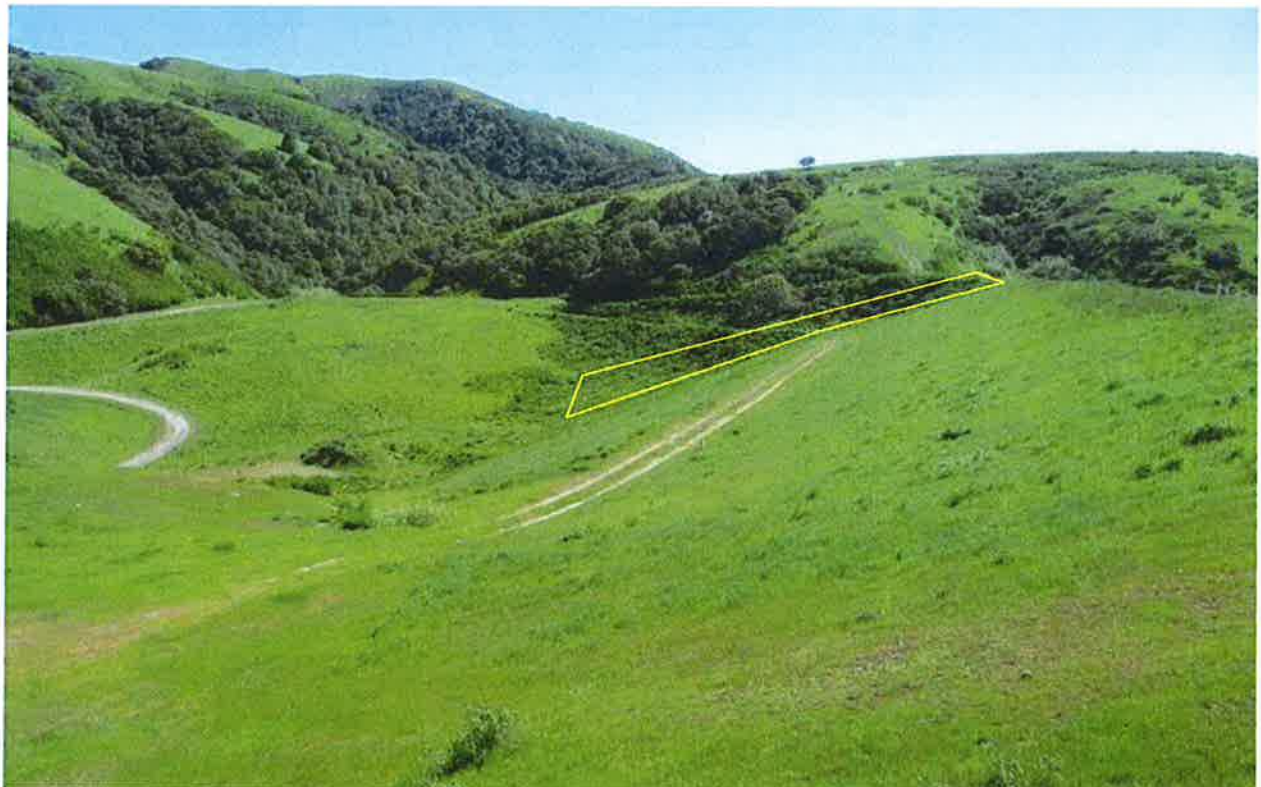
Vegetation control along the downstream face has improved significantly (above and below), and is now approaching excellent. The right downstream groin and left spillway wall could use a bit more work (outlined below and on the next page), but beyond that all is near perfect.

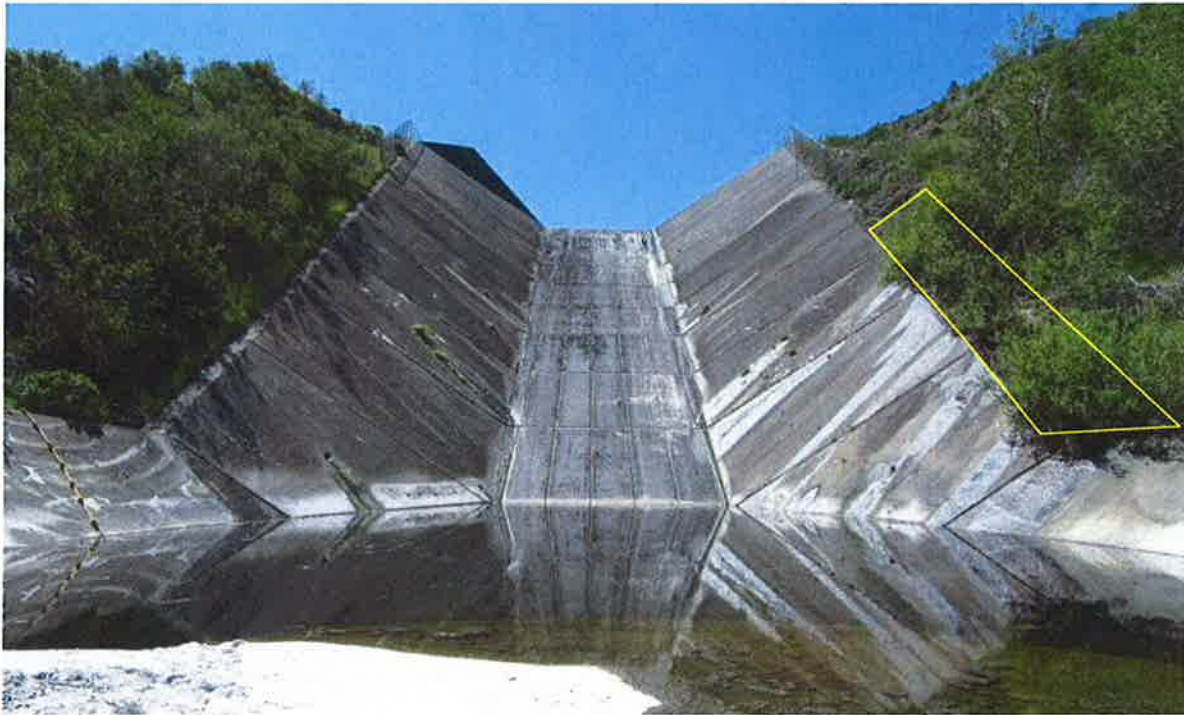
remains in good condition with no obvious signs of distress or deterioration. The concrete-slurry stabilized rock splash apron below the stilling basin is also in good condition, and pockets and holes near the base of the apron have been repaired as requested. Large bushes along the lower left spillway wall should probably be trimmed back a bit to prevent possible root damage.

The spillway and flip bucket looking in the upstream direction. Large bushes along the lower left spillway wall should probably be trimmed back a bit to prevent possible root damage.

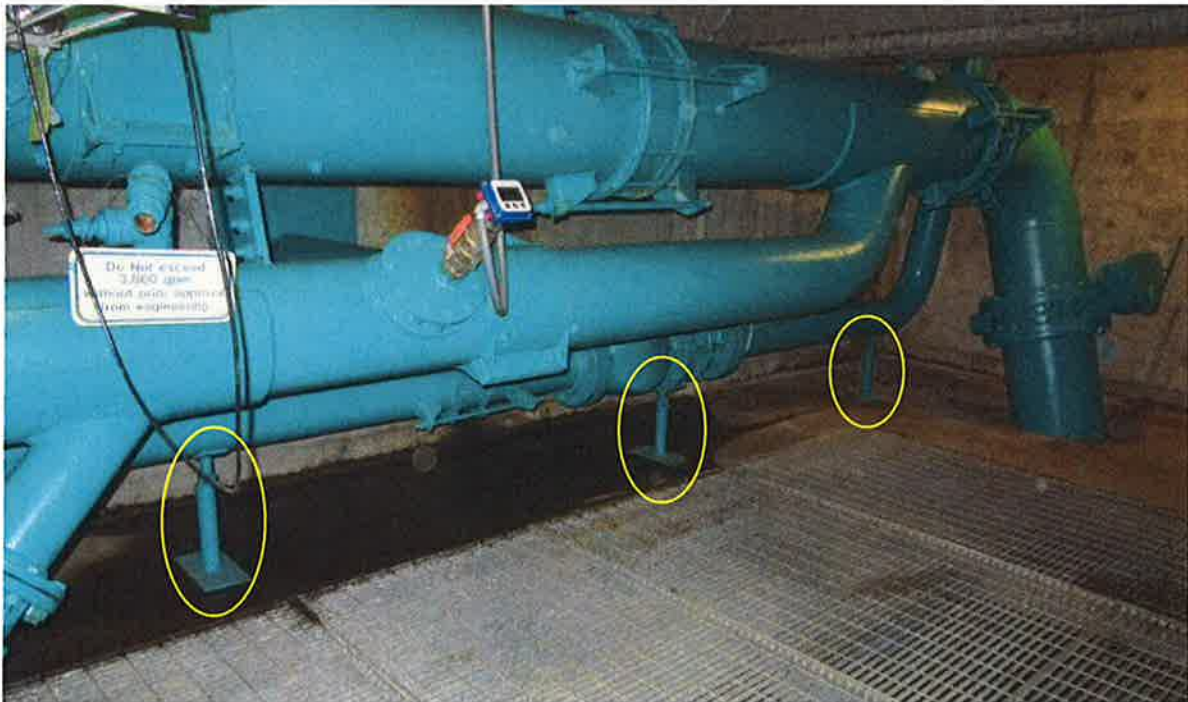
The severely corroded outlet bypass pipe supports and hardware within the downstream control valve vault have been replaced as directed. The severely corroded connection hardware for the 36-inch butterfly valve within the outlet vault was replaced the previous year.

The severely corroded outlet bypass pipe supports and hardware (circled) within the downstream control valve vault have been replaced as directed.
