INSPECTION OF DAM AND RESERVOIR IN CERTIFIED STATUS

Name of Dam Alpine Dam No. 33 County Marin
 Type of Dam GRAV Type of Spillway Eight siphons
 Water is 0.1 feet above the spillway crest and 7.9 feet below the dam crest.
 Weather Conditions Clear and mild
 Contacts Made Alex Anaya and Ronnie Chasteen during the inspection
 Reason for Inspection Periodic evaluation, including that of the dam internal galleries and outlet tower

Name of Dam Alpine Dam No. 33

Date of Inspection 12 April 2016

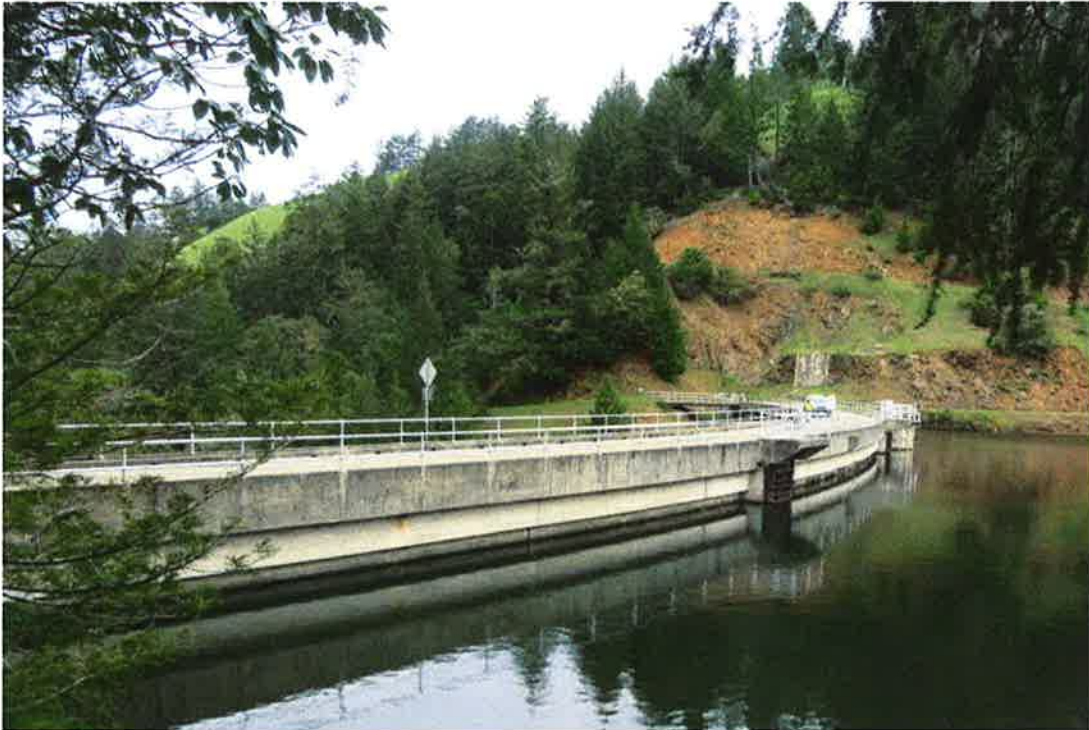
The upstream face as viewed from the left abutment. The reservoir water surface elevation is 0.1 feet above the spillway crest.

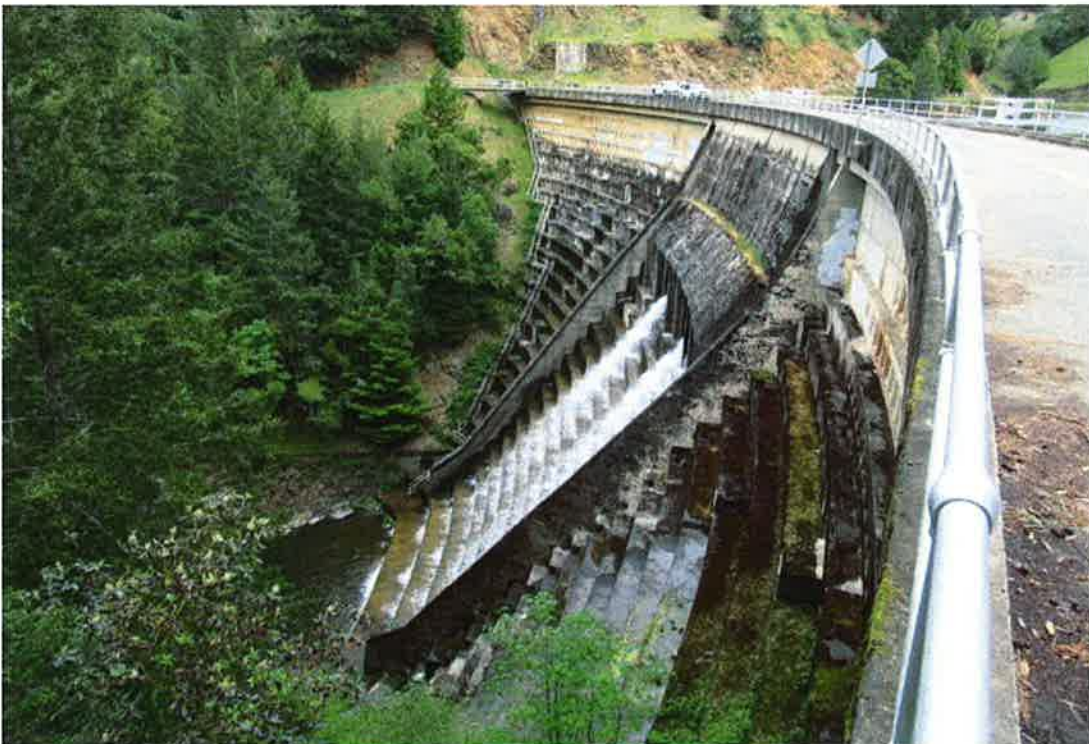
The downstream face as viewed from the left abutment.

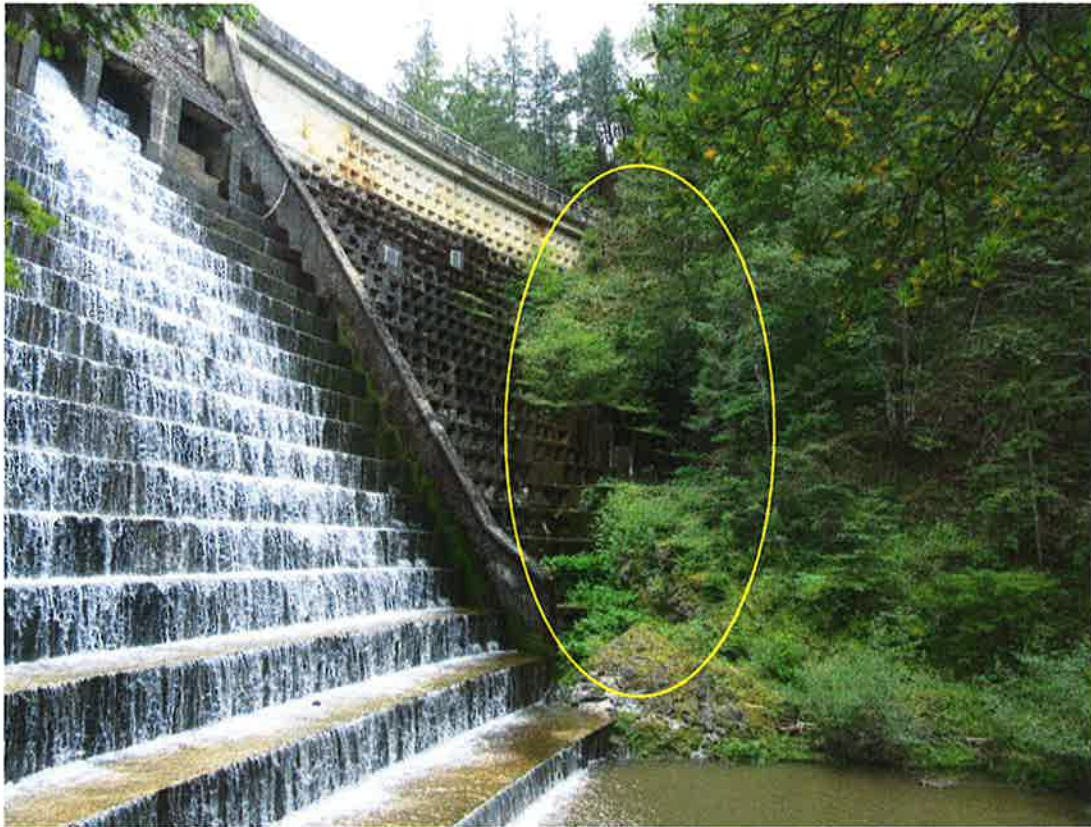
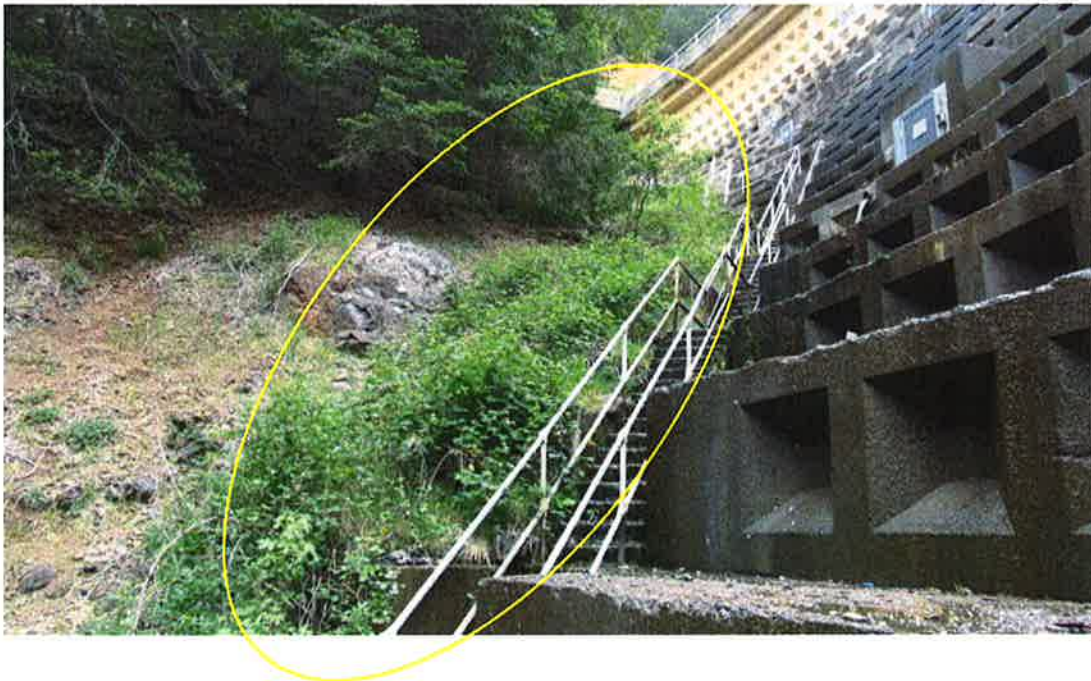
Vegetation control is generally satisfactory, but woody and tall non-woody vegetation that has been accumulating along both downstream groins should be removed before the next annual inspection.

Vegetation control is generally satisfactory, but woody and tall non-woody vegetation that has been accumulating along both downstream groins (circled) should be removed before the next annual inspection. The left groin is shown in the photograph above, the right groin in the photograph below.

I asked Mr. Anaya to have vegetation cleared from within 25-feet of the right and left downstream groins.
