INSPECTION OF DAM AND RESERVOIR IN CERTIFIED STATUS

Name of Dam Bon Tempe Dam No. 33-6 County Marin
 Type of Dam ERTH Type of Spillway Concrete weir and chute
 Water is 0.2 feet below the spillway crest and 6.2 feet below the dam crest.
 Weather Conditions Clear and mild
 Contacts Made Alex Anaya and Ronnie Chasteen during the inspection
 Reason for Inspection Periodic Evaluation

Inspected by J. Lowe
 Date of Inspection 7 April 2016
 Date of Report 8 April 2016

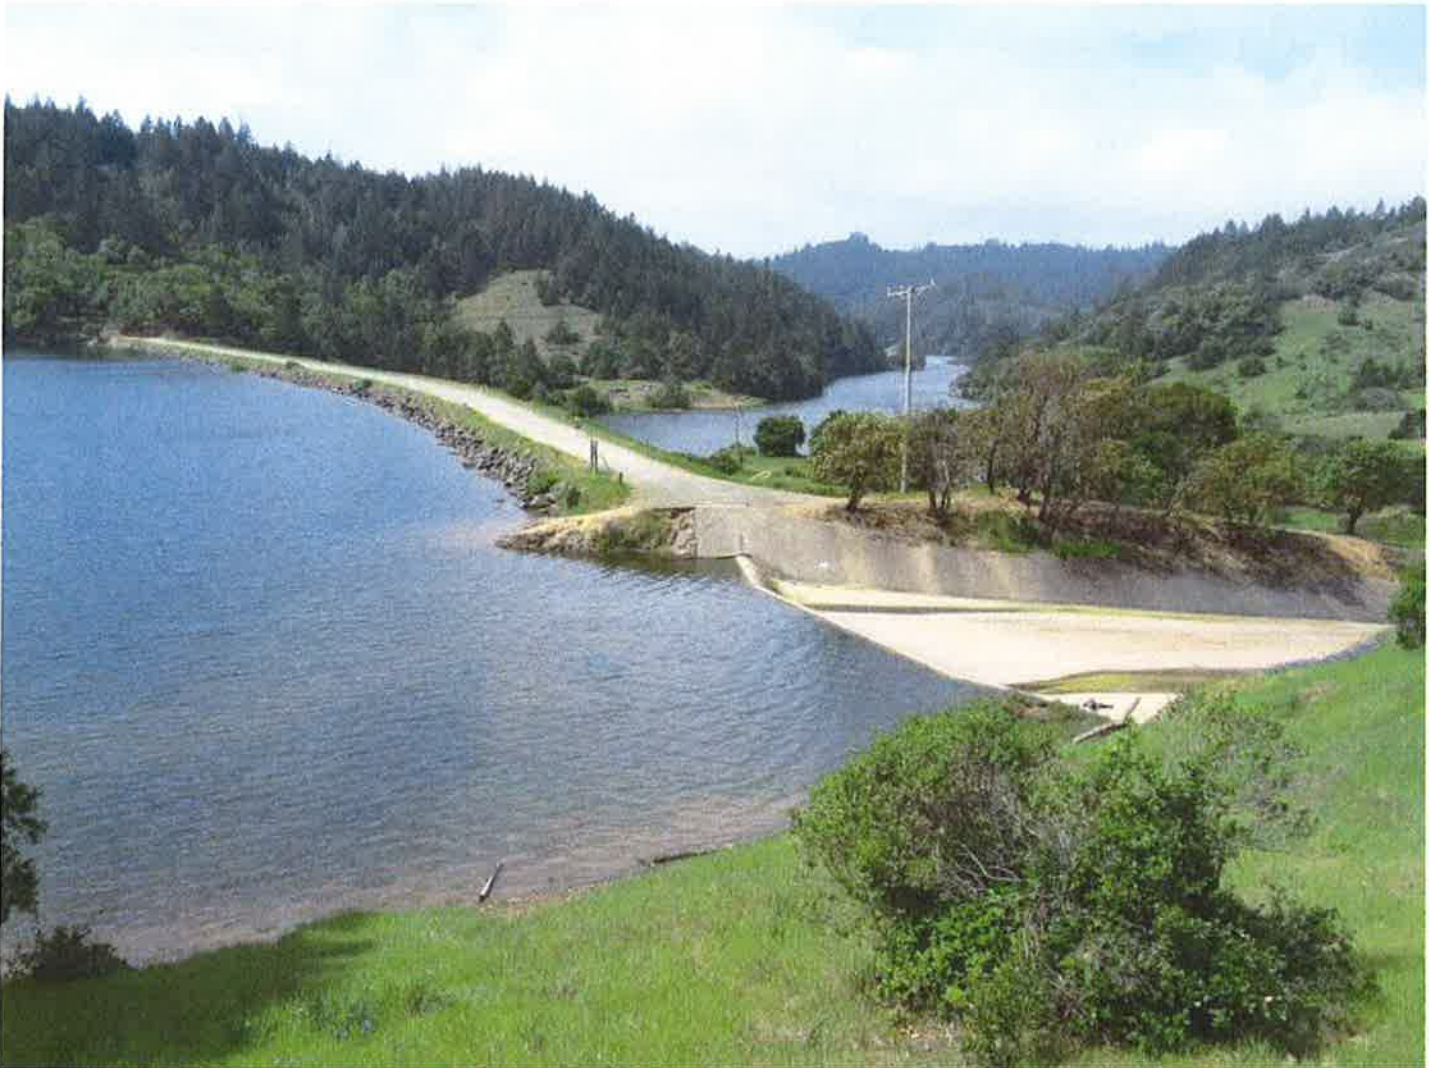
As discussed in the April 25, 2013 inspection report, the upstream face is armored with large riprap that remains in generally satisfactory condition, but that is showing signs of local deterioration. I've asked Mr. Anaya to repair damaged areas of riprap as soon as is reasonably practical.

The spillway entrance, crest, and upstream face as viewed from the right abutment. As discussed in the April 25, 2013 inspection report, localized areas of the upstream face rock riprap is showing signs of local deterioration. I've asked Mr. Anaya to repair damaged areas of riprap as soon as is reasonably practical.

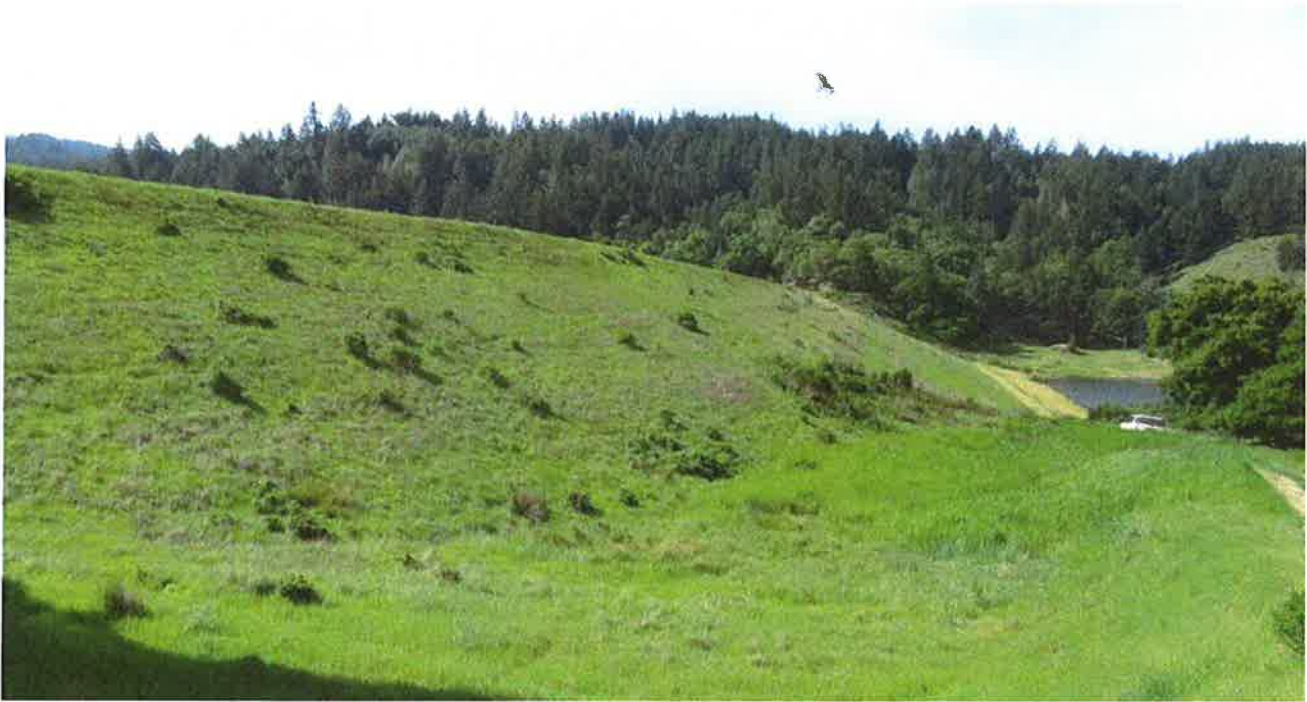
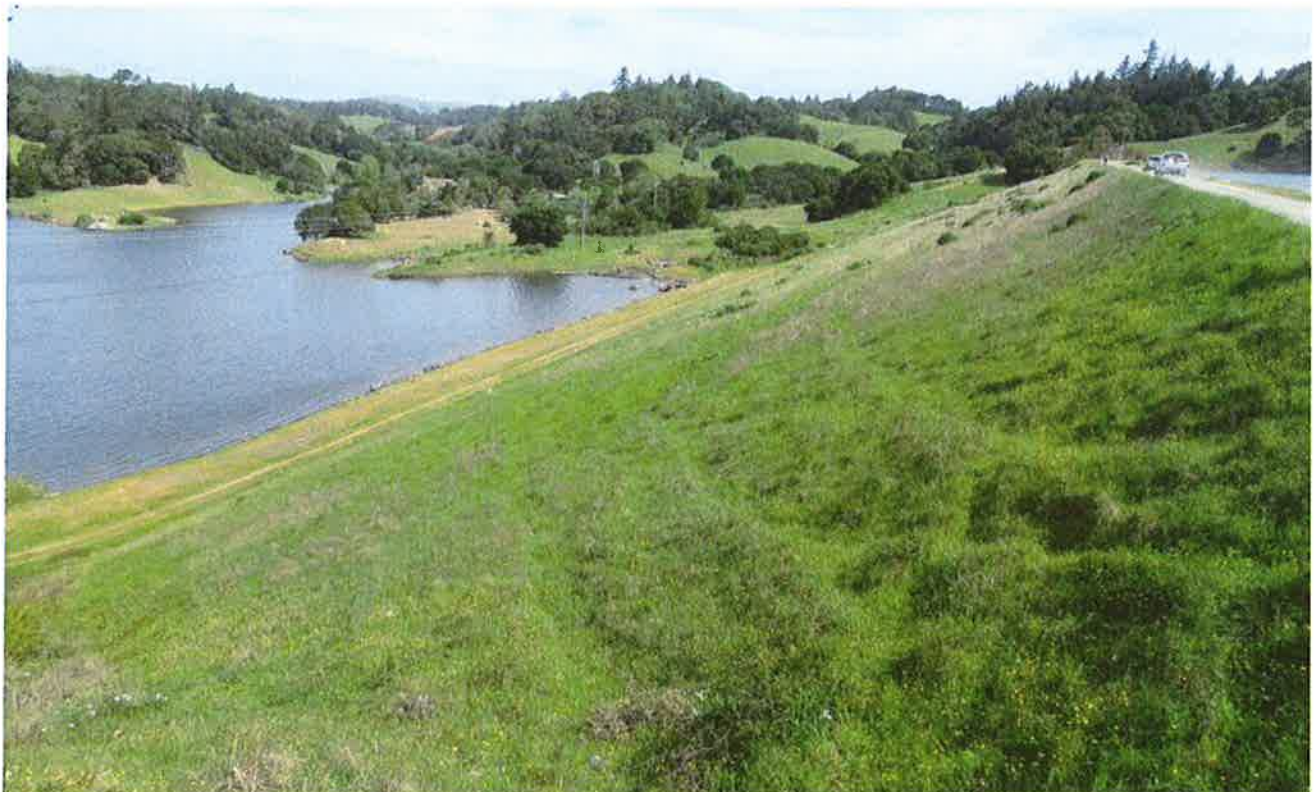
The downstream face as viewed from the right abutment, above, and the left abutment, below. Vegetation control remains generally quite good.

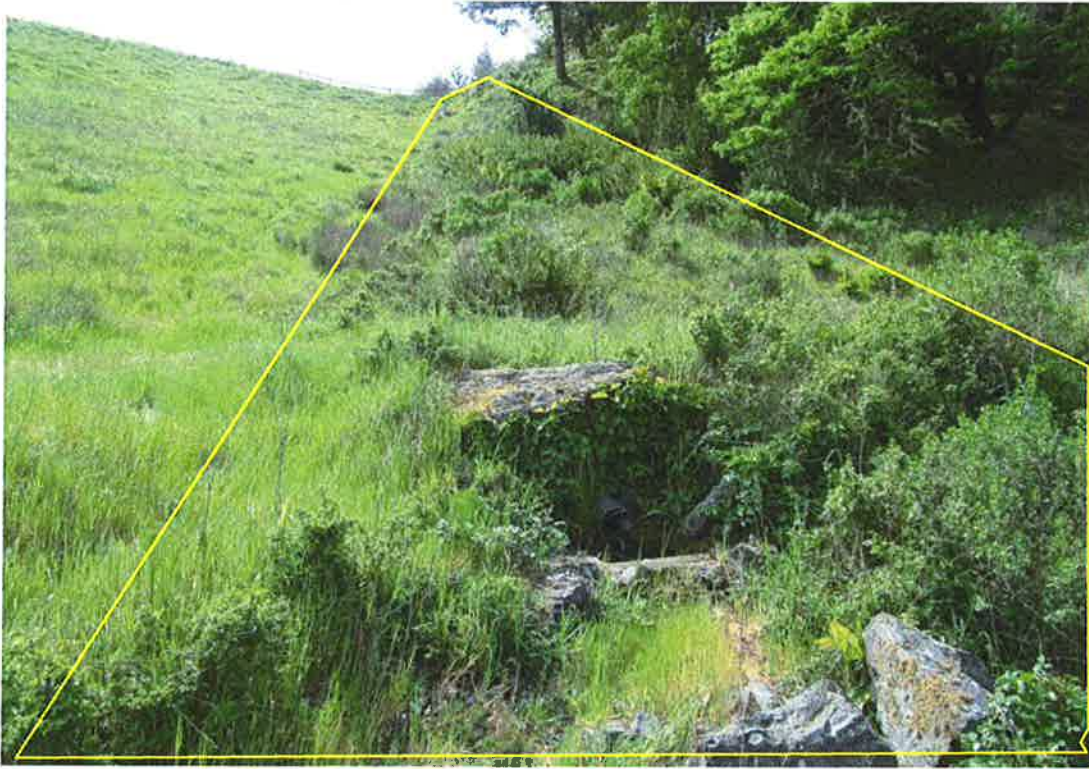
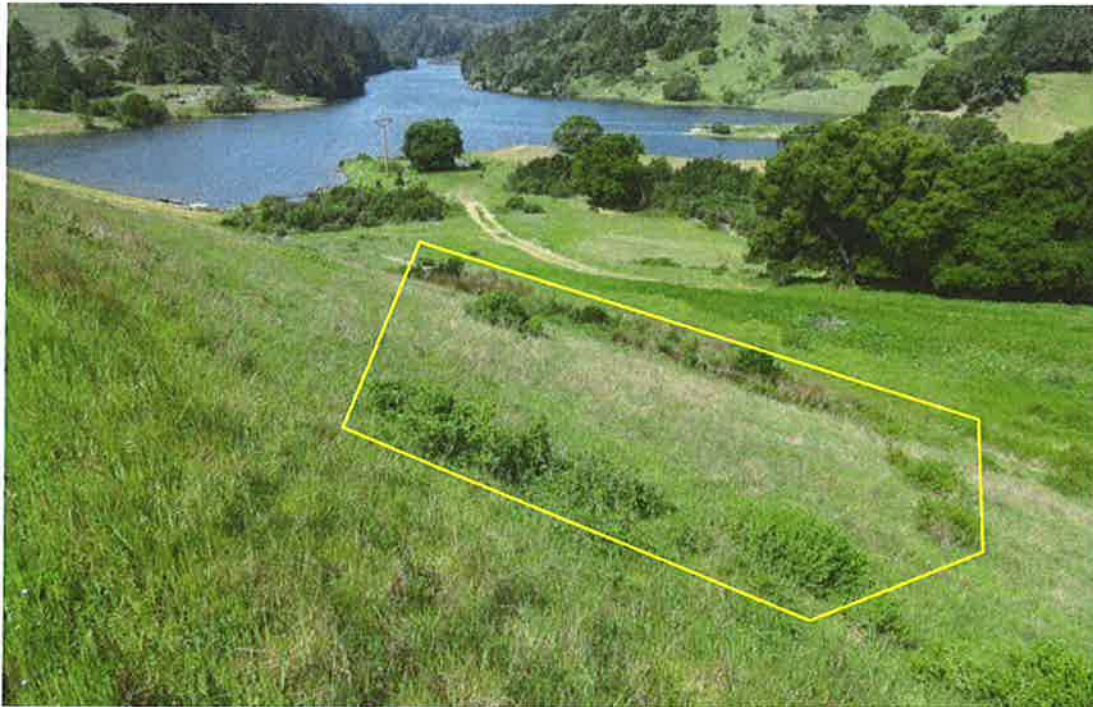
Vegetation control remains generally quite good, but limited areas of tall and dense vegetation within both downstream groins need to be cleared to improve the effectiveness of monitoring for seepage and other defects within these important locations.

Limited areas of tall and dense vegetation within both downstream groins needs to be cleared to improve the effectiveness of monitoring for seepage and other defects within these important locations (above and below).

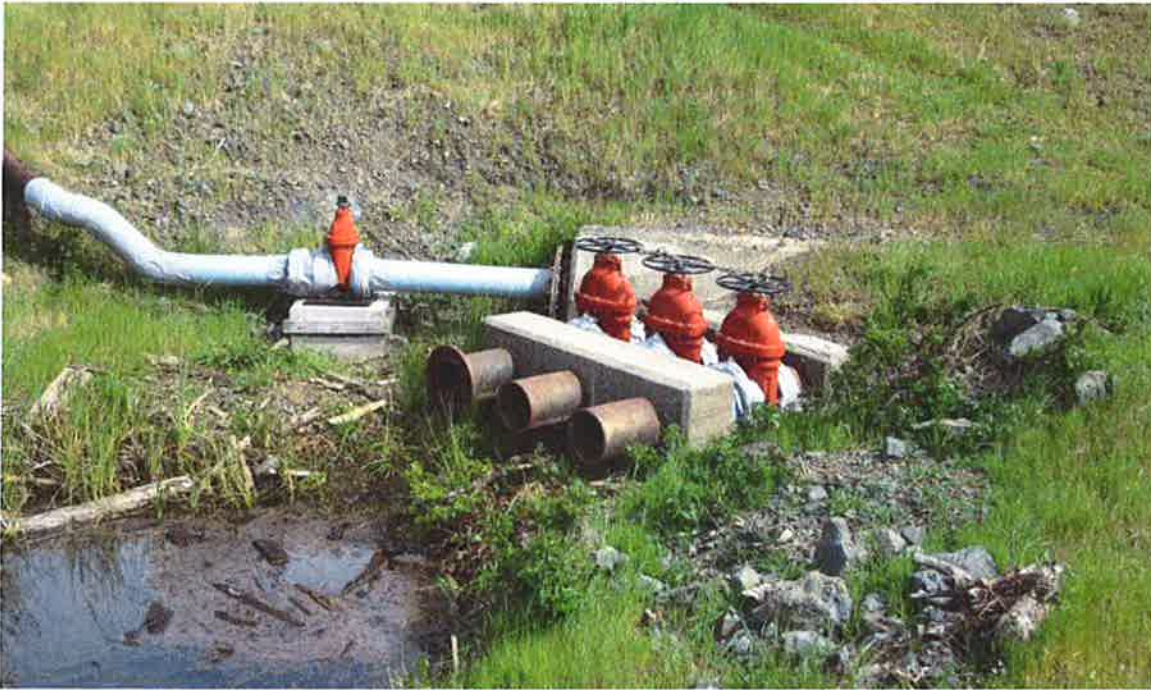
Since the March 2015 inspection, the original three downstream control gate valves were replaced with new butterfly valves (Kennedy, AWWA 250), which were partially cycled and are in good working order.

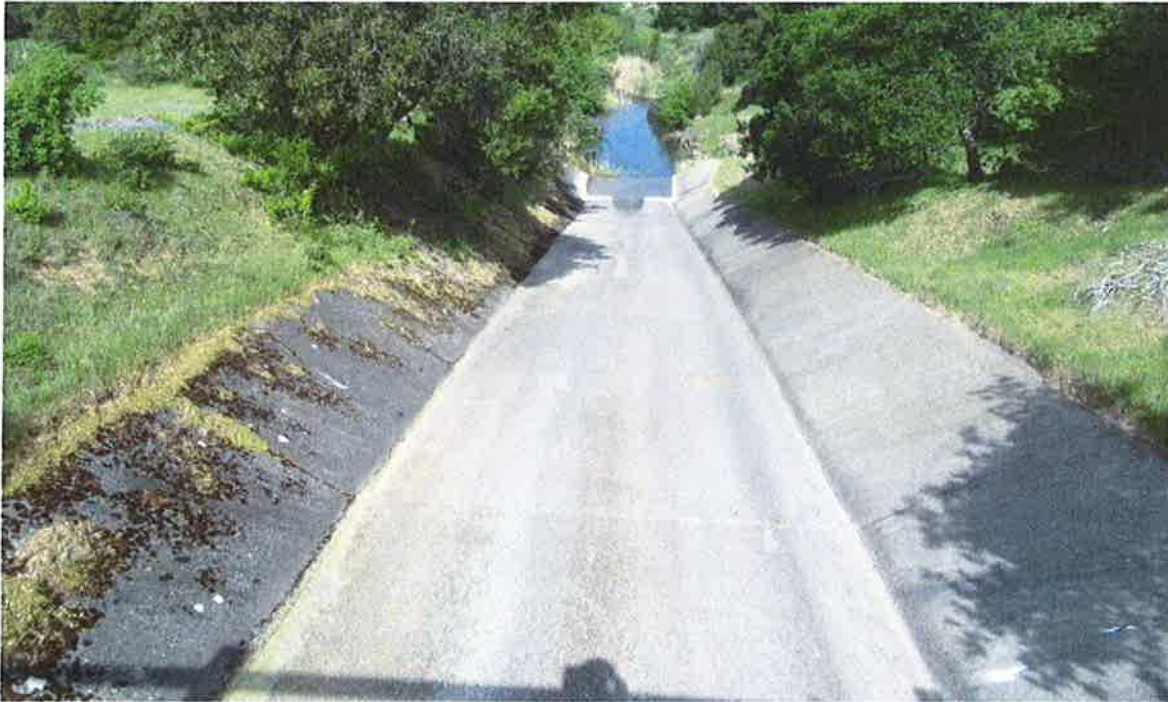
The concrete spillway channel looking towards the plunge pool. The concrete spillway walls and invert remain in satisfactory condition and are free of significant cracks or spalls.
