STATE OF CALIFORNIA
CALIFORNIA NATURAL RESOURCES AGENCY
DEPARTMENT OF WATER RESOURCES
DIVISION OF SAFETY OF DAMS

INSPECTION OF DAM AND RESERVOIR IN CERTIFIED STATUS

Name of Dam Peters Dam No. 33-7 County Marin
 Type of Dam ERTH Type of Spillway Concrete weir and chute
 Water is 0.5 feet below the spillway crest and 15.5 feet below the dam crest.
 Weather Conditions Clear and mild
 Contacts Made Alex Anaya and Ronnie Chasteen during the inspection
 Reason for Inspection Periodic Evaluation

Inspected by J. Lowe
 Date of Inspection 5 April 2016
 Date of Report 6 April 2016

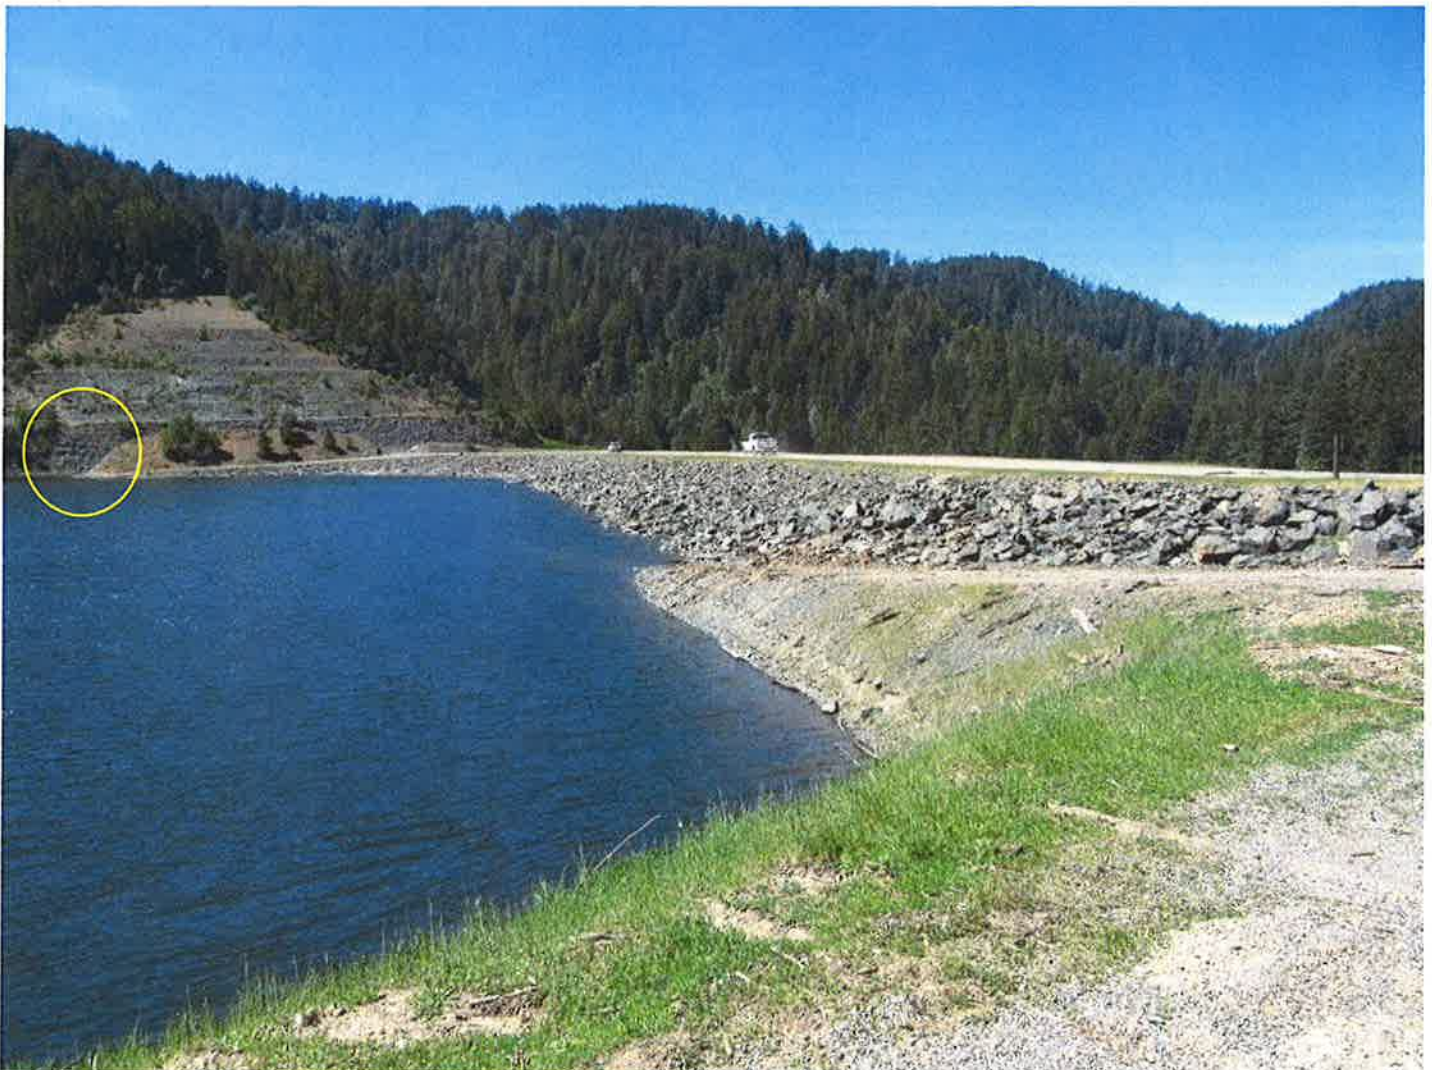
The upstream face as viewed from the right abutment. The large boulder rock riprap upstream face protection remains in good condition. The spillway entrance through the left abutment is circled.

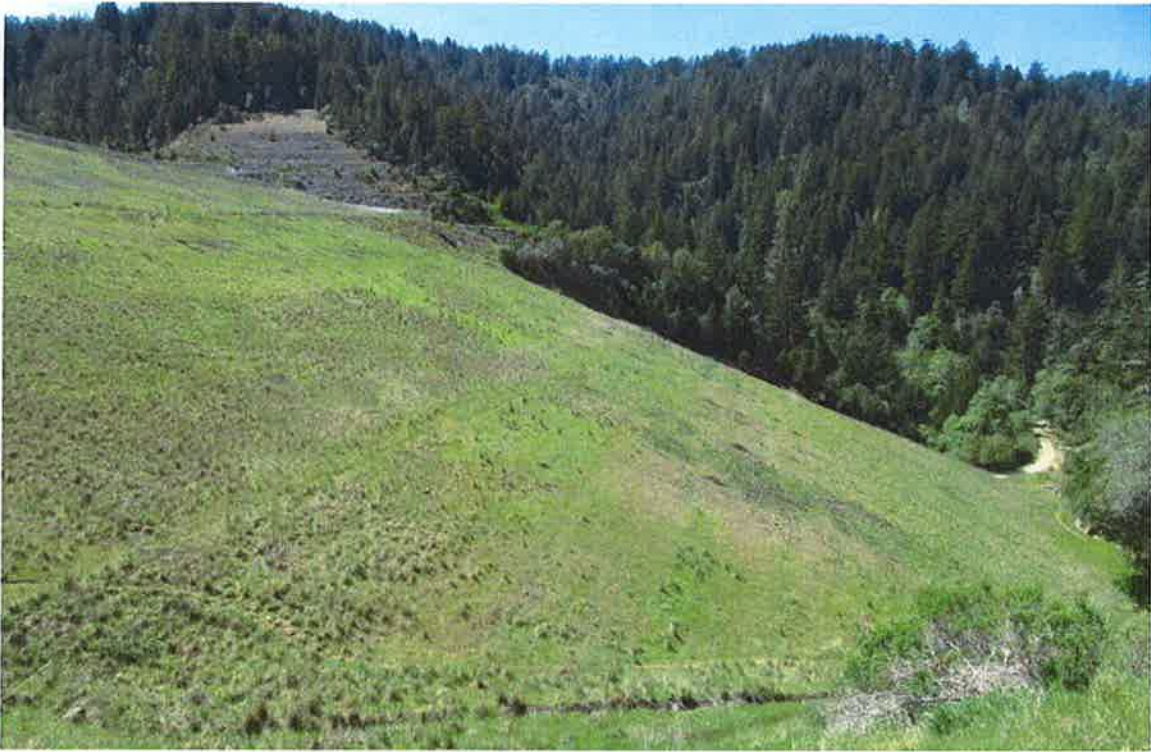
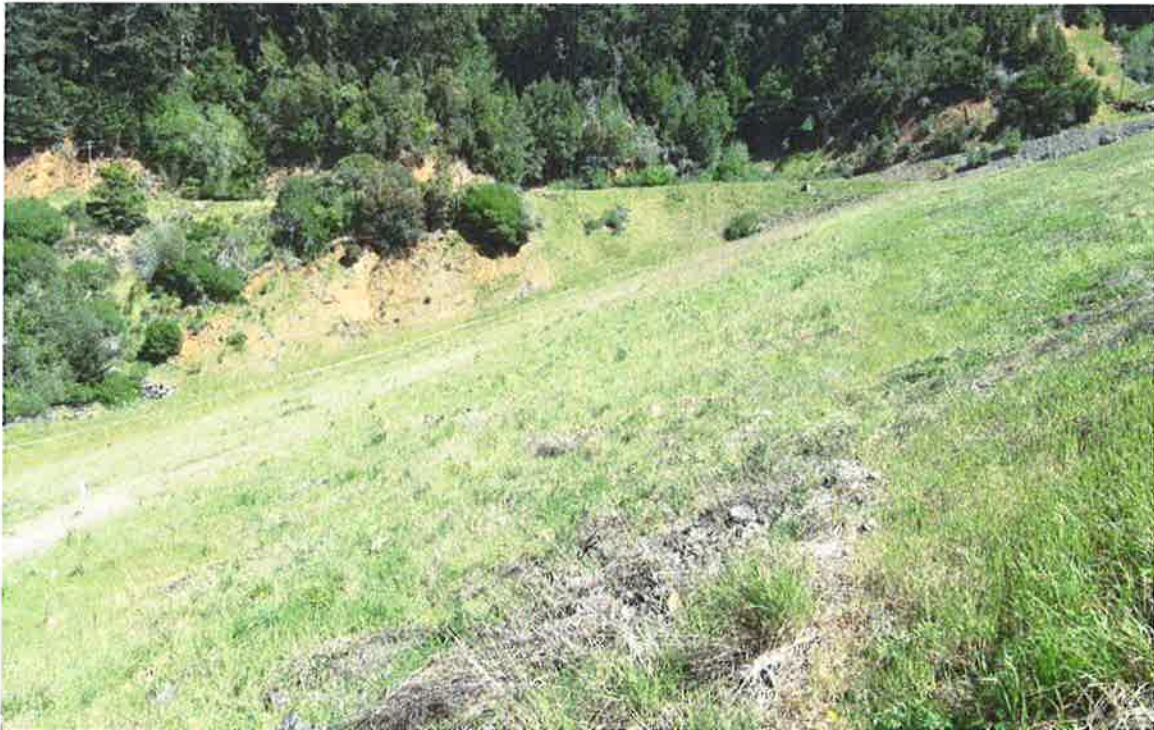
- Vegetation control along the downstream face has improved significantly, and is now excellent. Tall and dense bushes and emerging trees throughout the embankment and downstream groins have been cleared to open these important areas to improved monitoring for seepage and other defects. I called Mr. Carl Sanders to thank him for the excellent work he and his crew performed in correcting all vegetation control deficiencies.
- Small willow trees and woody bushes that had taken root within construction joints along the upper level outlet outfall chute have been removed to prevent damage to the concrete chute invert and sidewalls.
- On January 26, 2016, the outlet control was run under full head for the first time in over fifteen years. Mr. Anaya's outlet valve operation plan and documentation of the full head outlet operation is attached to this report.

The downstream face as viewed from the right abutment, above, and from the left abutment, below. As is evident from the photographs, vegetation control is now excellent.
