**INSPECTION OF DAM AND RESERVOIR IN CERTIFIED STATUS**

Name of Dam Lagunitas Dam No. 33-2 County Marin  
 Type of Dam ERTH Type of Spillway Concrete weir with steel and timber flume  
 Water is 0.1 feet below the spillway crest and 7.6 feet below the dam crest.  
 Weather Conditions Clear and mild  
 Contacts Made Alex Anaya and Ronnie Chasteen during the inspection  
 Reason for Inspection Periodic Evaluation

Inspected by J. Lowe  
 Date of Inspection 7 April 2016  
 Date of Report 11 April 2016

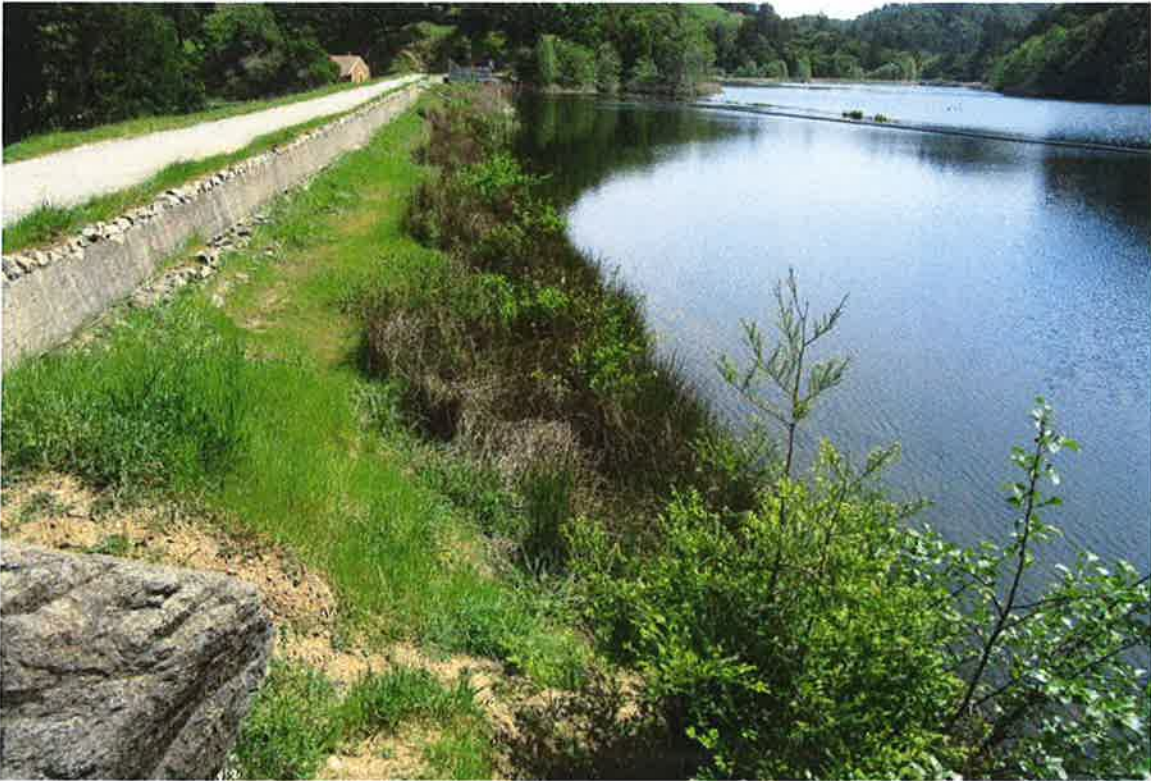
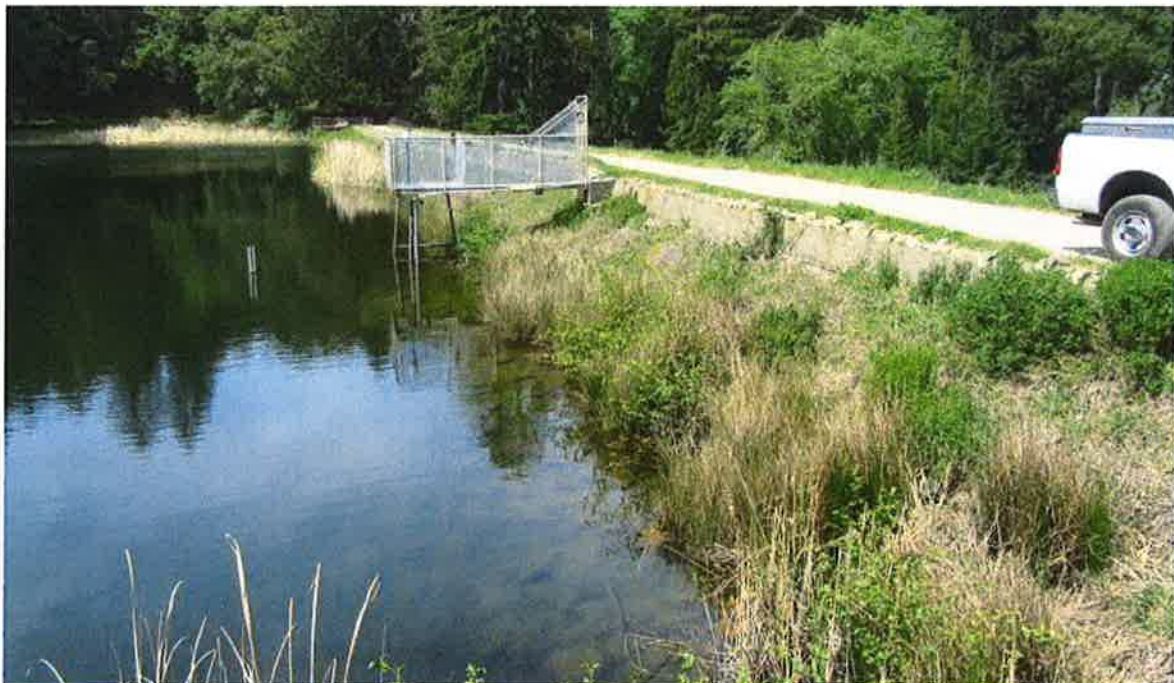
The upstream face as viewed from the left abutment, above, and as viewed from the right abutment, below. Vegetation control along the upstream face needs improvement, and numerous small trees, bushes, and other woody vegetation that have accumulated along the waterline and upstream groins require removal.

Vegetation control along the upstream face needs improvement, and numerous small trees, bushes, and other woody vegetation that have accumulated along the waterline and upstream groins require removal.

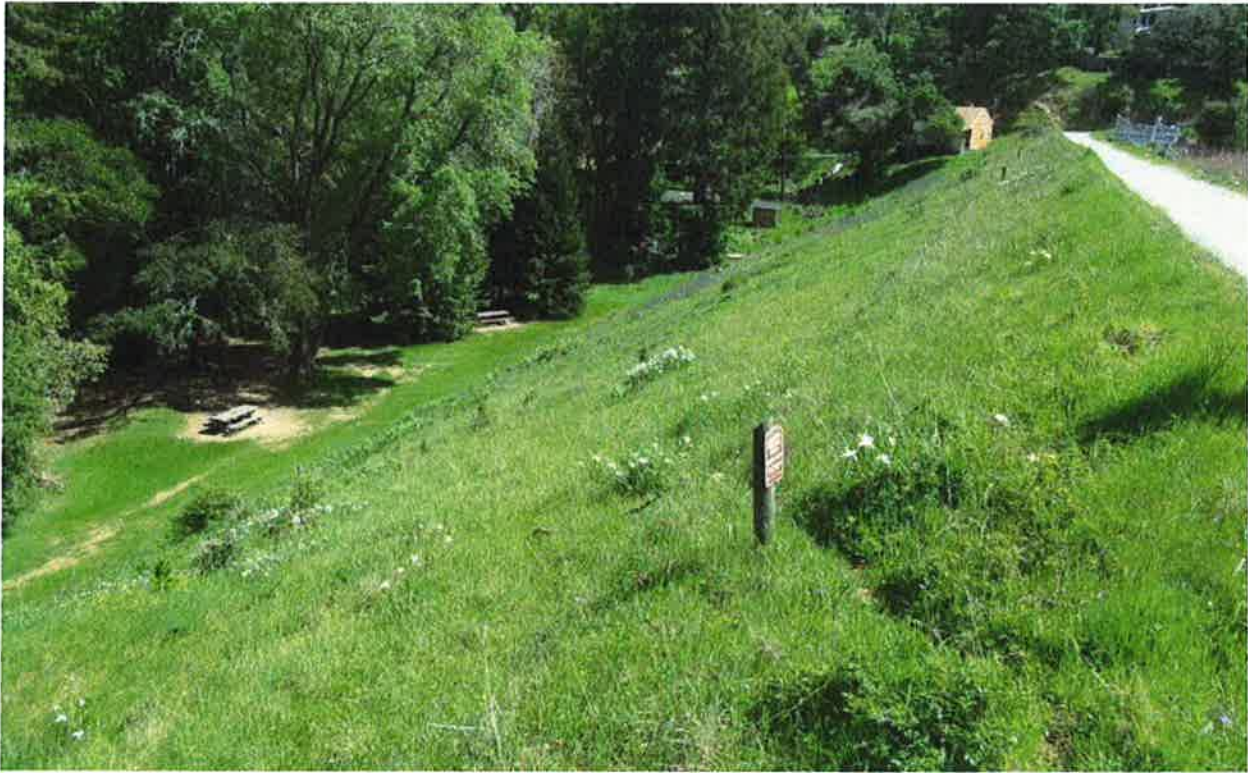
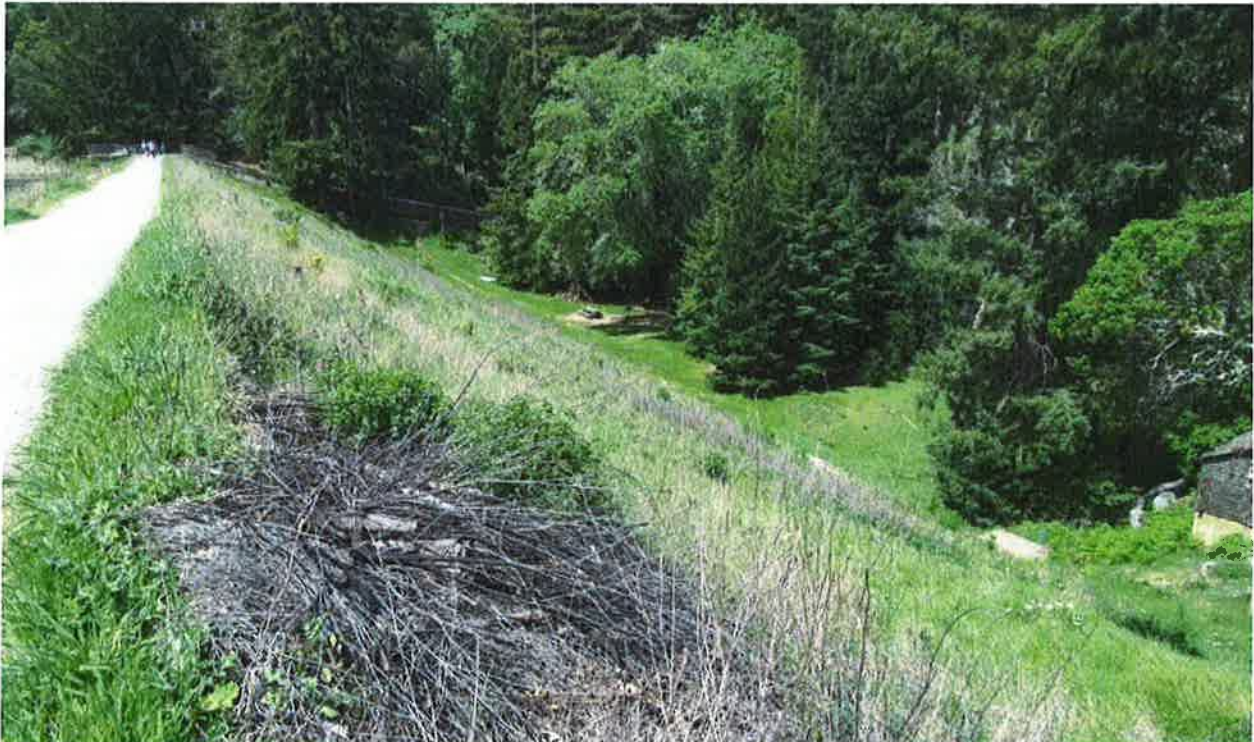
The downstream face as viewed from the left abutment, above, and as viewed from the right abutment, below. Vegetation control along the downstream face is satisfactory, and access for inspection and monitoring is good.

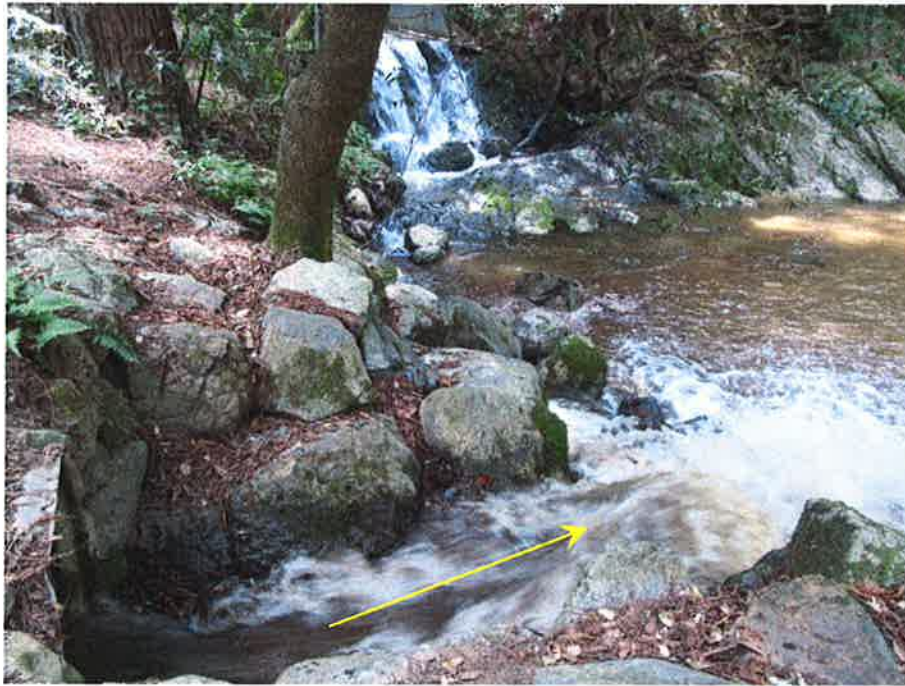
The 16-inch upstream control and the 10-inch downstream control were fully cycled during the first full-head test of this outlet in at least 15 years. The 12-inch upstream control was partially cycled. Other than a lack of feedback from the single hydraulic pressure gauge monitoring the upstream control actuator, all outlet control valves and hydraulic actuators appear to function well.

Flow from the full head outlet test of the 16-inch upstream control and 10-inch downstream control is visible in the lower half of the photograph. Flow from the spillway outfall can be seen in the top center of the photograph.

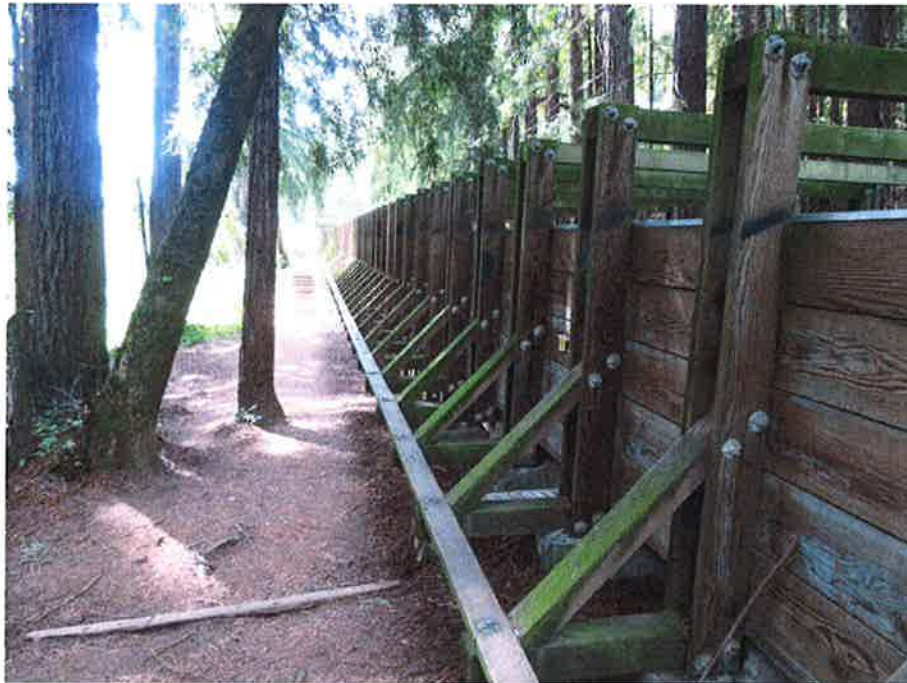
The right side of the wood timber spillway flume looking in the upstream direction. Pressure treated timbers supporting the flume appear to be in good condition, as does the stainless steel flume sheathing, the under flume supports, and flume foundation connections.
