STATE OF CALIFORNIA  
CALIFORNIA NATURAL RESOURCES AGENCY  
DEPARTMENT OF WATER RESOURCES  
DIVISION OF SAFETY OF DAMS

**INSPECTION OF DAM AND RESERVOIR IN CERTIFIED STATUS**

Name of Dam Seeger (Nicasio) Dam No. 33-8 County Marin  
 Type of Dam ERTH Type of Spillway Concrete side channel ogee  
 Water is 0.1 feet above the spillway crest and 15 feet below the dam crest.  
 Weather Conditions Clear and mild  
 Contacts Made Alex Anaya, Carl Sanders, and Ronnie Chasteen during the inspection  
 Reason for Inspection Periodic Evaluation

Inspected by J. Lowe *6 Apr 2016*  
 Date of Inspection 5 April 2016  
 Date of Report 6 April 2016 *D K/11/16*

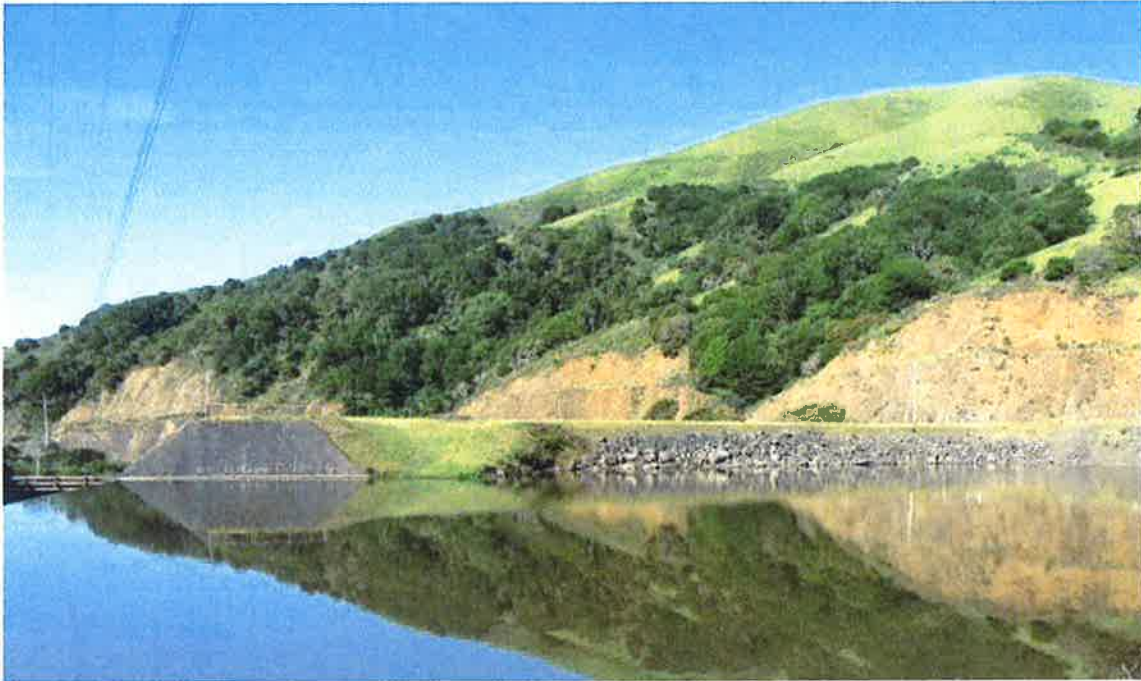
The upstream face as viewed from the upstream end of the spillway channel. The large boulder riprap face protection remains in good condition.

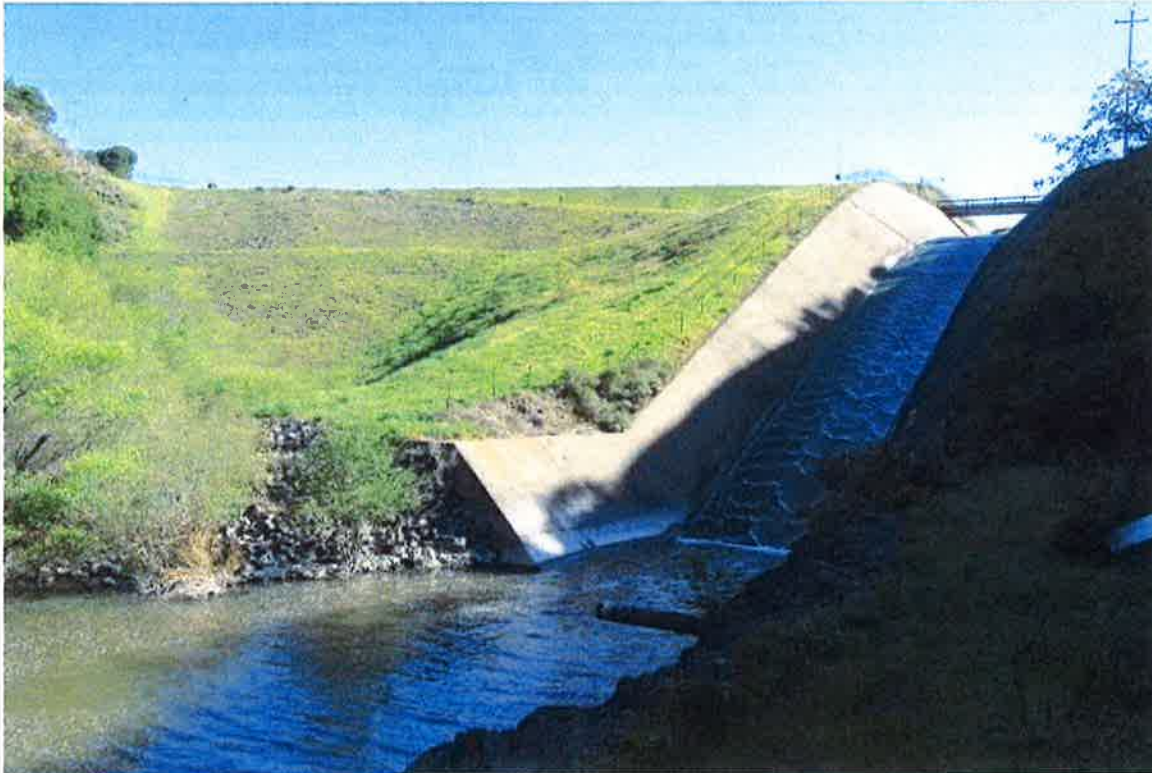
The downstream face, spillway outflow channel, and stilling basin. The outlet discharges into the stilling basin just upstream of the drain pipe visible in the bottom center of the photograph.

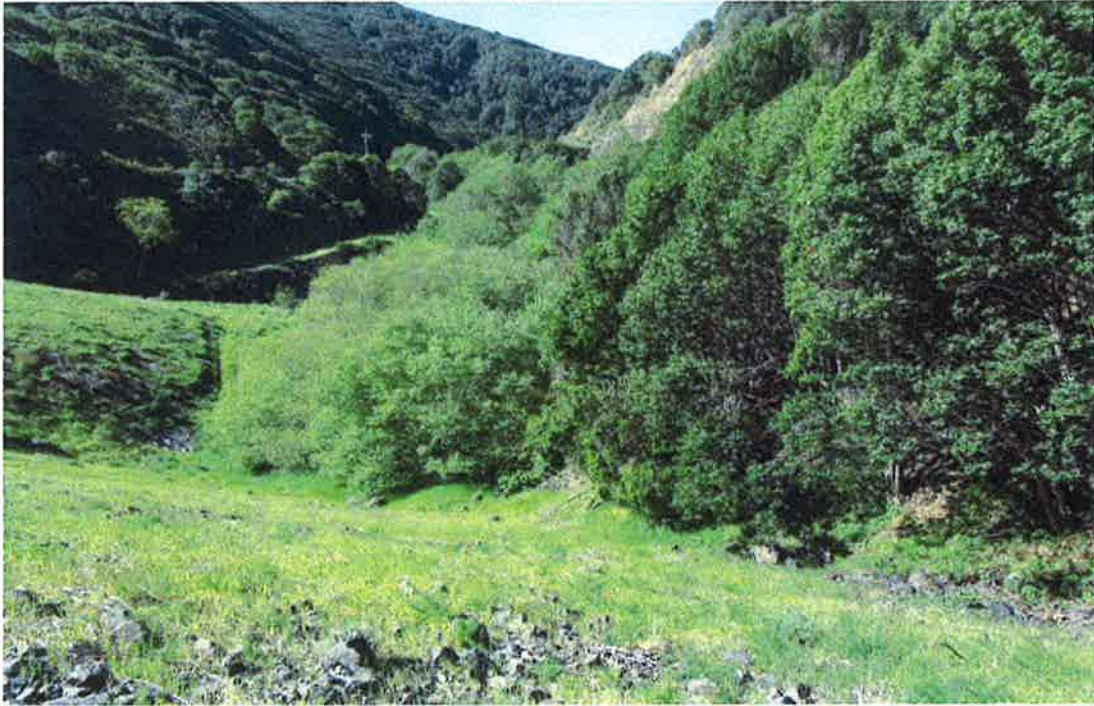
Vegetation control remains quite good, and continues to improve, but some additional clearing of the downstream toe and lower right downstream groin is desirable to improve access for monitoring by MMWD staff.

A closer look at the lower right downstream face and downstream toe. Overhanging vegetation indicated by the yellow line should be removed to improve access for monitoring by MMWD staff.

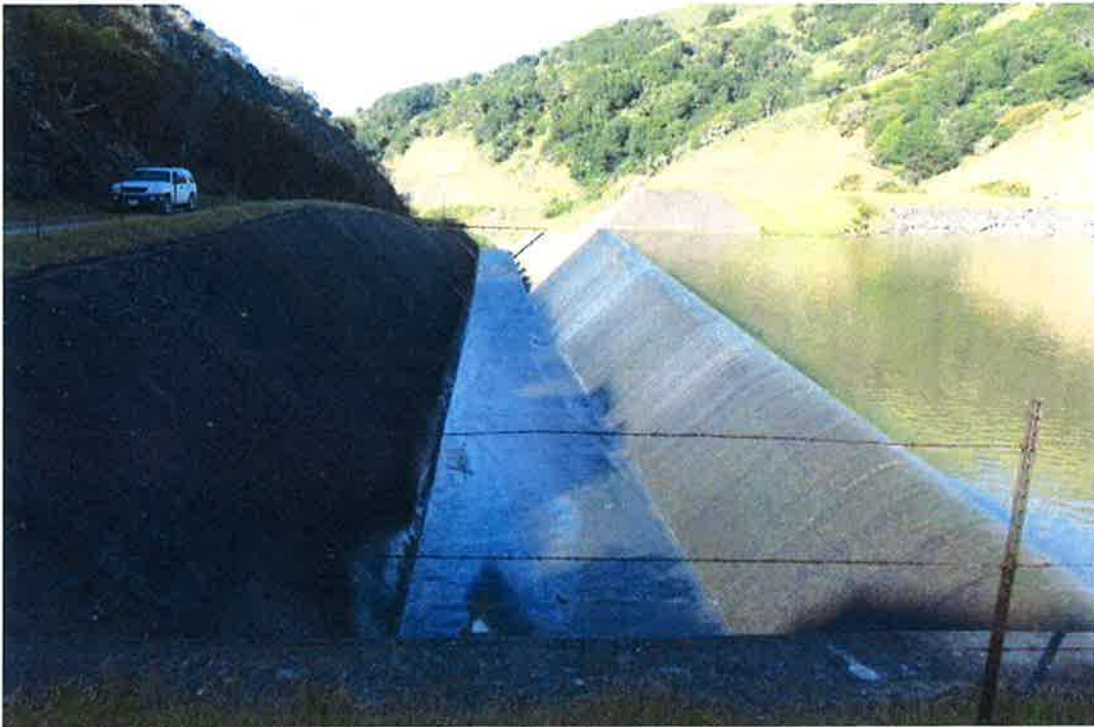
<u>Spillway</u>	<p>The approach, control section, and exit channel were open and clear. The spillway concrete structure remains in satisfactory condition, and is free of significant cracks or spalls indicative of excessive stress or deterioration.</p>

The spillway channel looking in the downstream direction. The spillway concrete structure remains in satisfactory condition, and is free of significant cracks or spalls indicative of excessive stress or deterioration.
