STATE OF CALIFORNIA
CALIFORNIA NATURAL RESOURCES AGENCY
DEPARTMENT OF WATER RESOURCES
DIVISION OF SAFETY OF DAMS

INSPECTION OF DAM AND RESERVOIR IN CERTIFIED STATUS

Name of Dam Alpine Dam No. 33 County Marin
 Type of Dam GRAV Type of Spillway Eight siphons
 Water is 1 feet above the spillway crest and 7.0 feet below the dam crest.
 Weather Conditions Moderate to heavy rain
 Contacts Made Lucy Croy, Trinity Leonard, and Ronnie Chasteen during the inspection
 Reason for Inspection Periodic evaluation

Inspected by J. Lowe
 Date of Inspection 8 February 2017
 Date of Report 21 February 2017

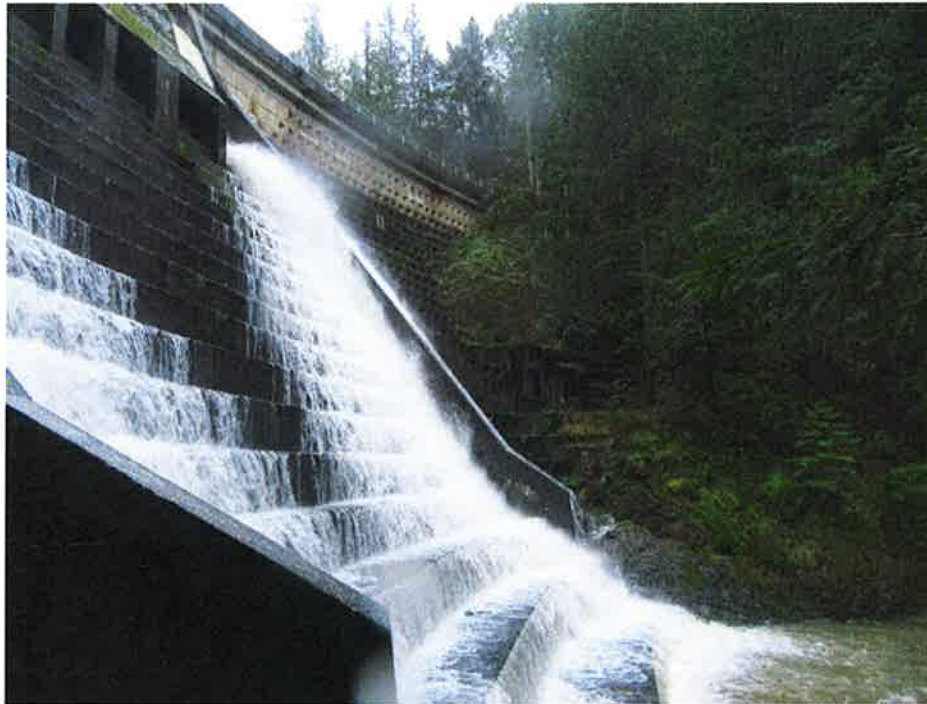
Approximately 1.0 of water was flowing through the two spillway gates; the spillway siphon was not flowing.

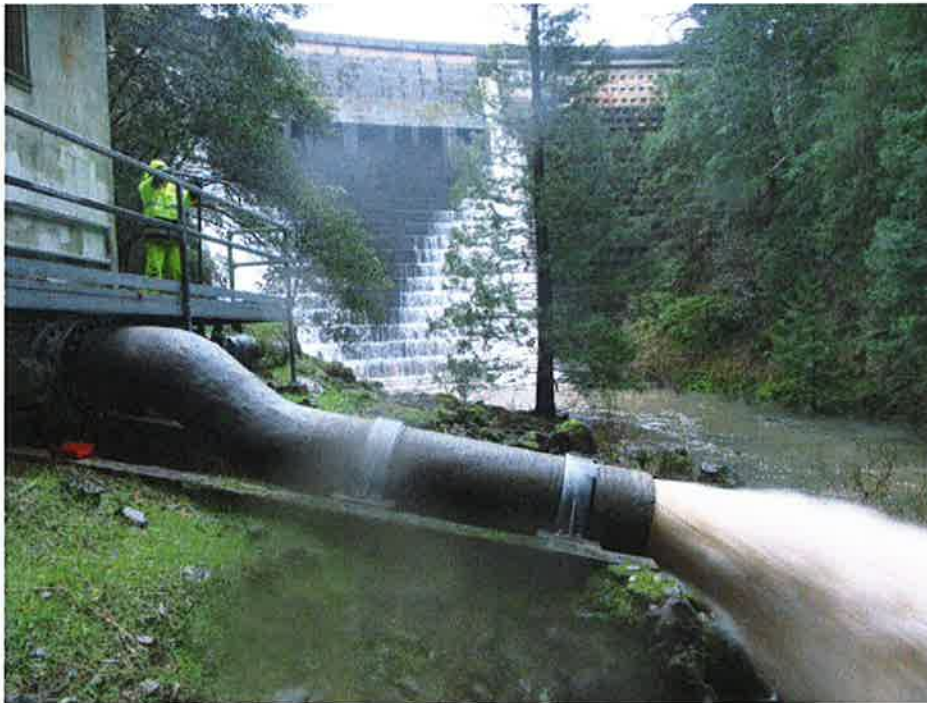
The three 24" butterfly controls at the outlet conduit Tee were fully cycled and found to be in good operating condition; none of the upstream controls were cycled during this inspection. Those upstream and downstream outlet controls accessible from outside of the outlet tower (exterior valves) were partially cycled during the 12 April 2016 inspection. All upstream and downstream controls that remain operable, including those within the outlet tower, were fully cycled during either the February 26, 2015, or April 30, 2015 inspections.

The three 24" butterfly controls at the outlet conduit Tee outfall were fully cycled and found to be in good operating condition. The plunge pool below the Tee outfall is susceptible to erosion and should be armored with concrete stabilized large-boulder riprap.

The plunge pool below the outlet conduit Tee outfall is susceptible to erosion and should be armored with concrete stabilized large-boulder riprap.
