INSPECTION OF DAM AND RESERVOIR IN CERTIFIED STATUS

Name of Dam Bon Tempe Dam No. 33-6 County Marin
 Type of Dam ERTH Type of Spillway Concrete weir and chute
 Water is 0.4 feet above the spillway crest and 5.6 feet below the dam crest.

Name of Dam Bon Tempe Dam No. 33-6

Date of Inspection 8 February 2017

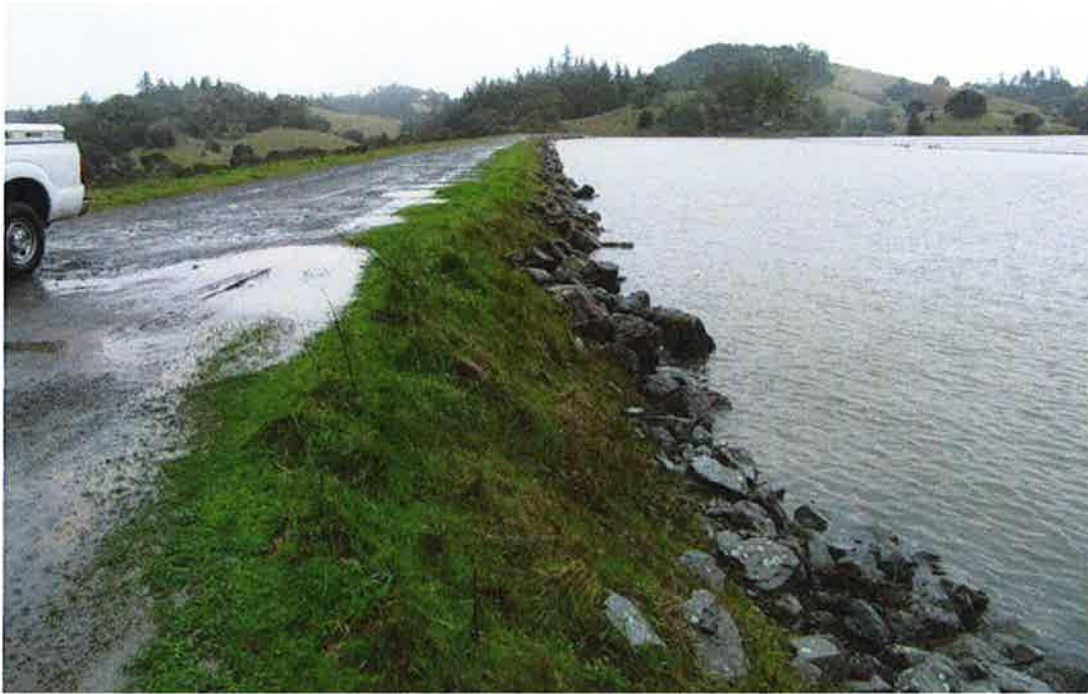
As discussed in the April 25, 2013 inspection report, the upstream face (above) is armored with large riprap that remains in generally satisfactory condition, but that shows signs of local deterioration.

As discussed in the April 25, 2013 inspection report, the upstream face is armored with large riprap that remains in generally satisfactory condition, but that shows signs of local deterioration. I've asked Ms. Croy to repair damaged areas of riprap as soon as is reasonably practical.

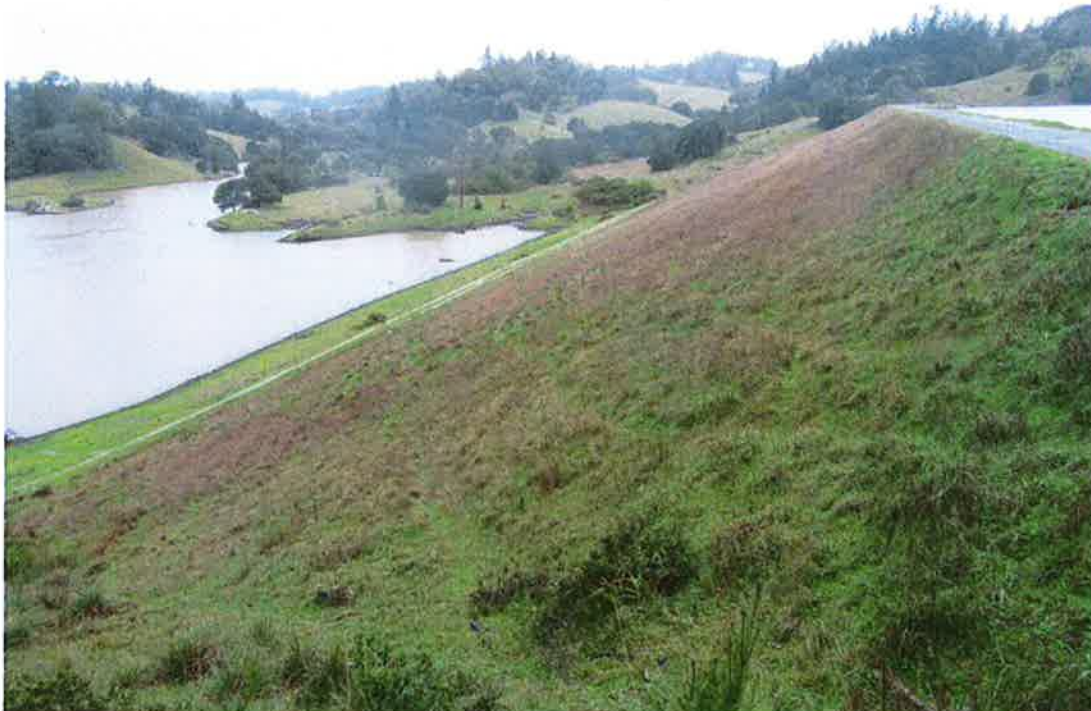
Vegetation control along the downstream face continues to improve, and is now quite good.

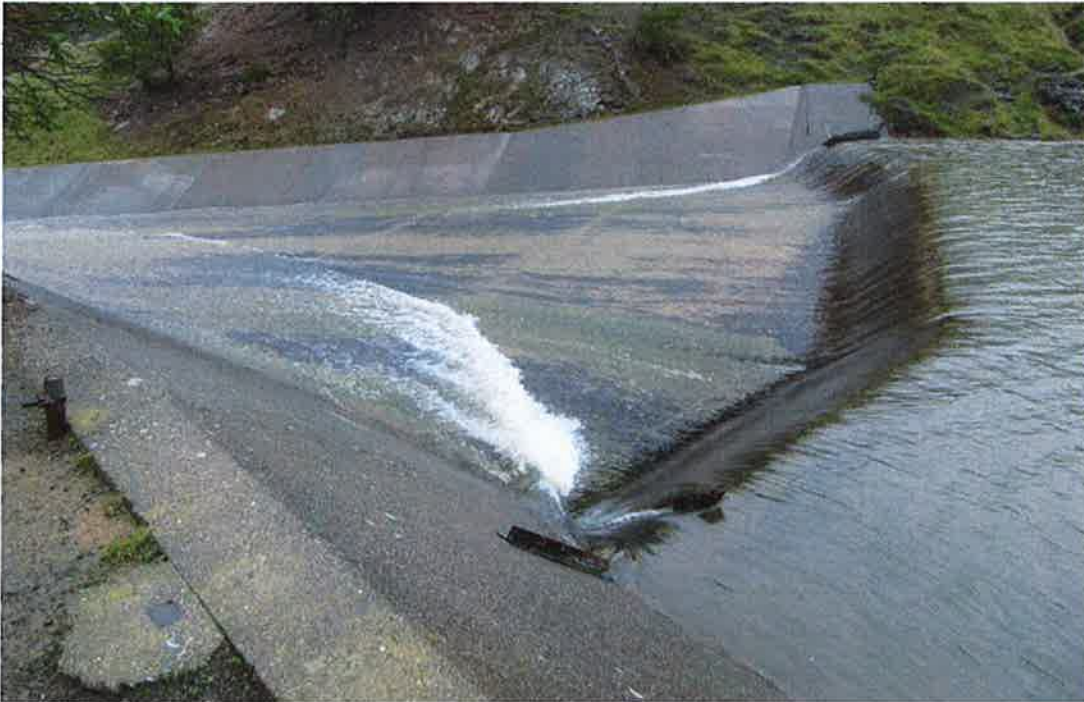
Approximately 0.4' of water was flowing through the spillway control section. Flow within the channel is free of excessive turbulence and gives no evidence of significant flaws within the invert.

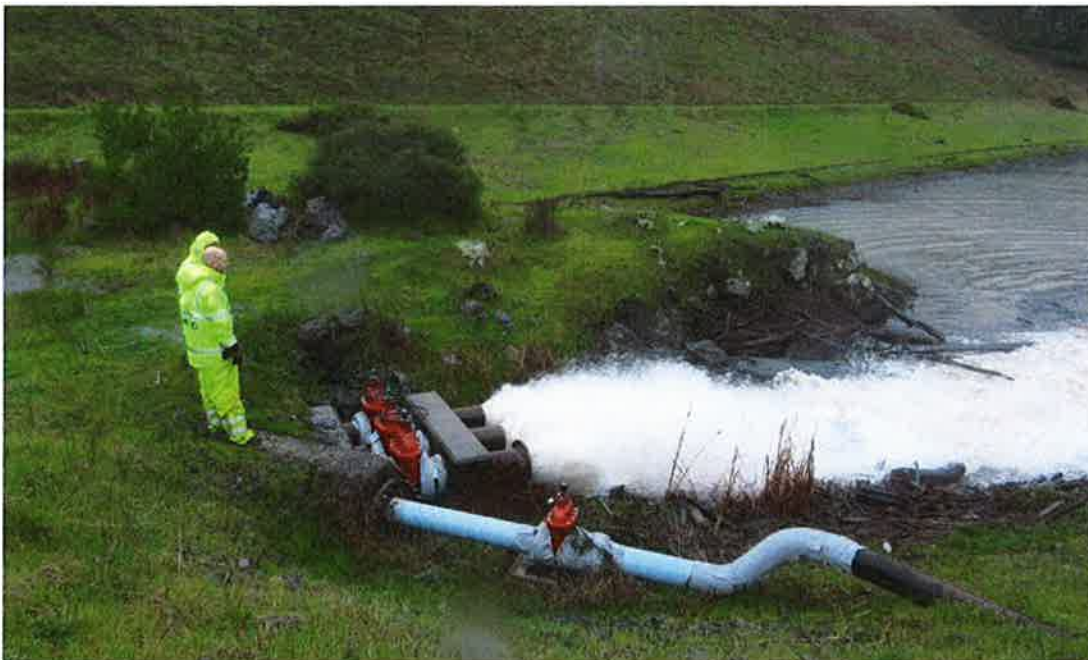
All upstream and downstream controls were fully cycled and found to be in good operating condition. The three recently replaced downstream control gate valves are shown below.
