STATE OF CALIFORNIA  
CALIFORNIA NATURAL RESOURCES AGENCY  
DEPARTMENT OF WATER RESOURCES  
DIVISION OF SAFETY OF DAMS

**INSPECTION OF DAM AND RESERVOIR IN CERTIFIED STATUS**

Name of Dam Peters Dam No. 33-7 County Marin  
 Type of Dam ERTH Type of Spillway Concrete weir and chute  
 Water is 2.9 feet above the spillway crest and 11.9 feet below the dam crest.

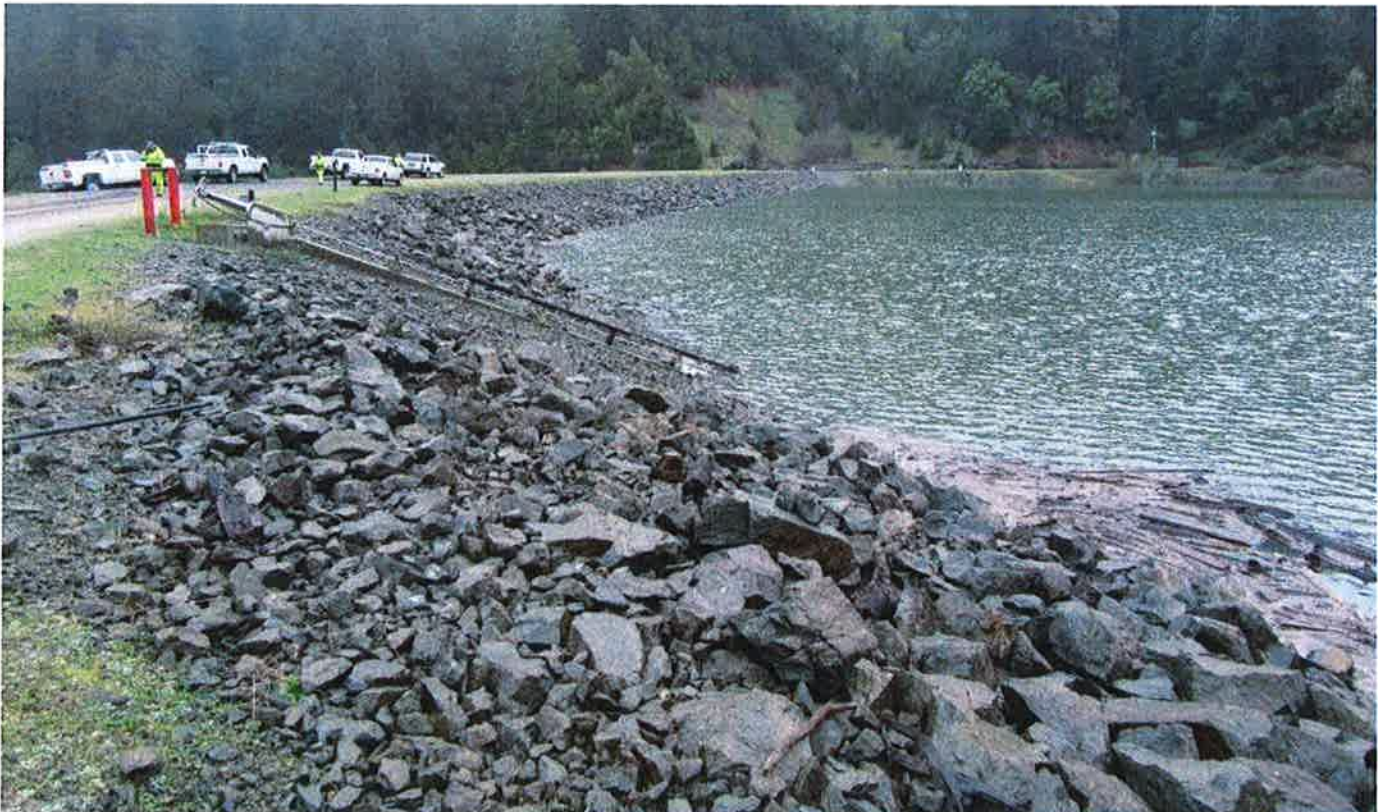
The upstream face as viewed from the left abutment. The large boulder rock riprap upstream face protection remains in good condition.

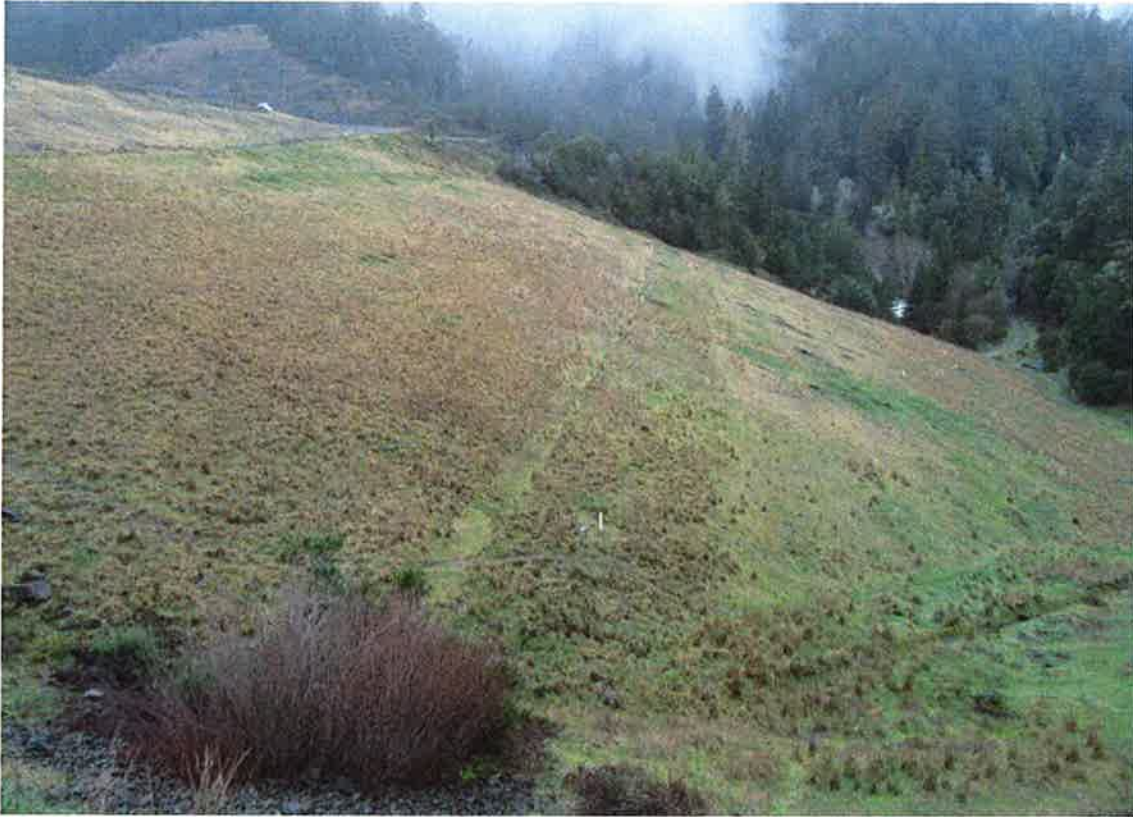
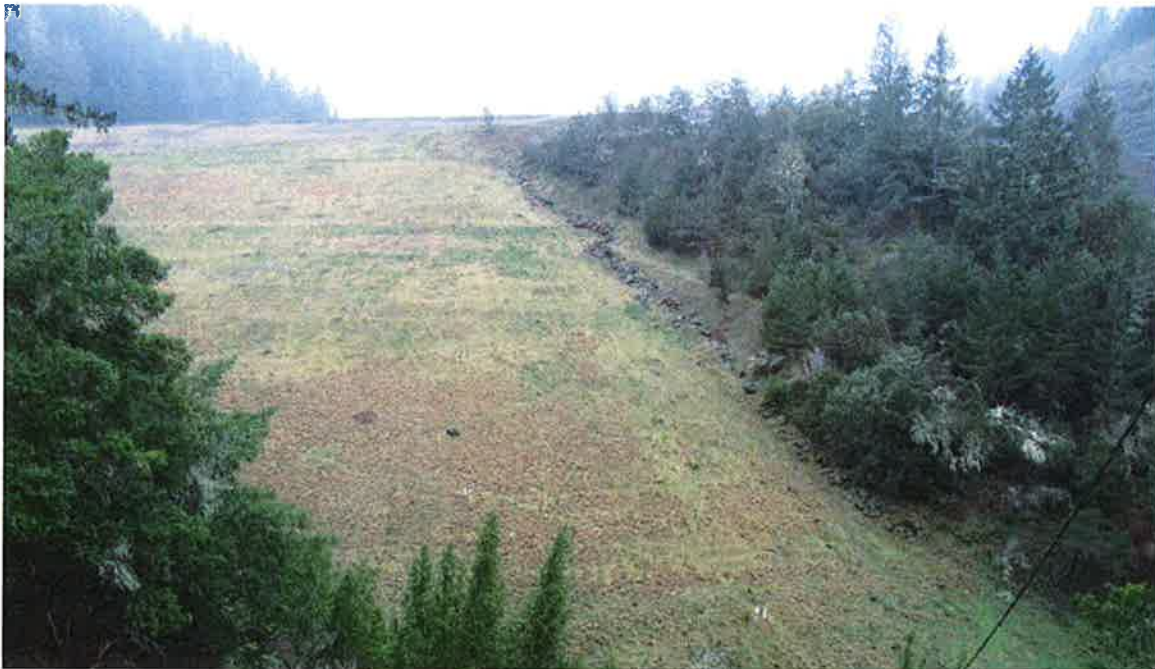
Looking across the downstream face of the embankment towards the left groin, above, and another look at the left groin and downstream toe, below. As evident by the photographs, vegetation control is excellent.

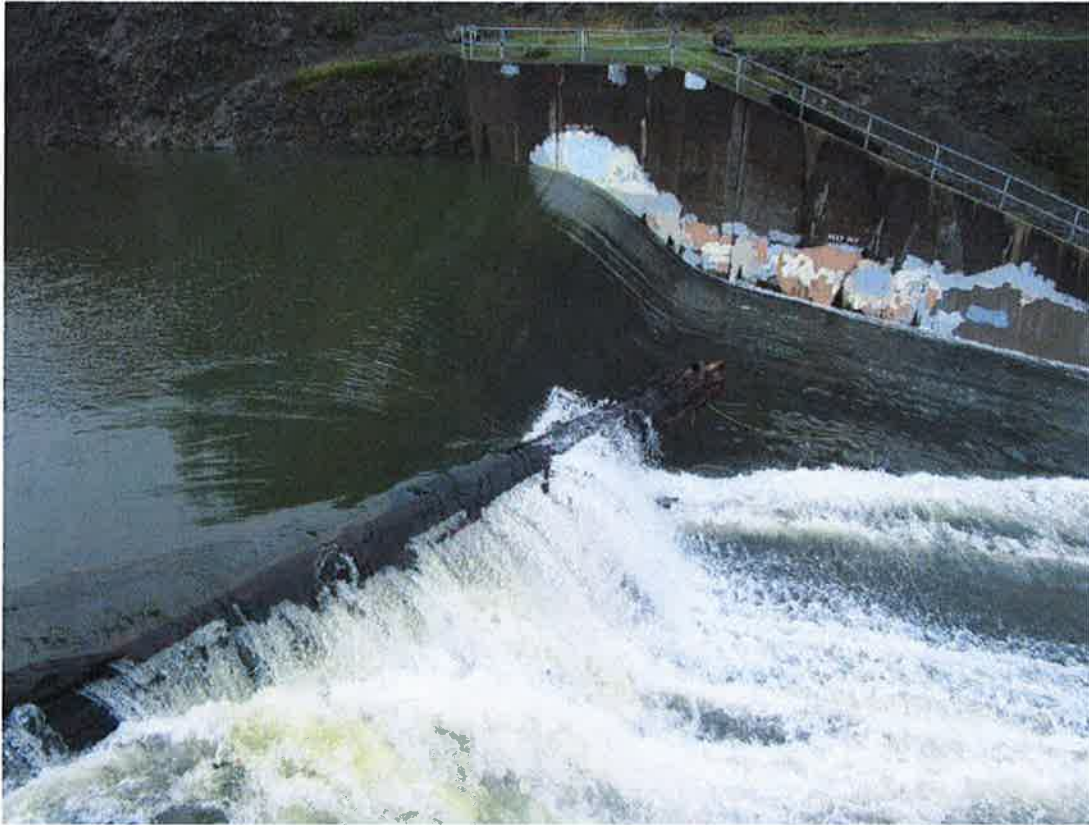
A large redwood log that has drifted into and was caught on the right side of the concrete spillway control weir requires removal.

A large redwood log that has drifted into and was caught on the right side of the concrete spillway control weir requires removal, above. The photograph below shows flow within the concrete spillway channel entering the unlined spillway exit channel.
