INSPECTION OF DAM AND RESERVOIR IN CERTIFIED STATUS

Name of Dam Lagunitas Dam No. 33-2 County Marin
 Type of Dam ERTH Type of Spillway Concrete weir with steel and timber flume
 Water is 0.4 feet above the spillway crest and 7.1 feet below the dam crest.

Inspected by J. Lowe
 Date of Inspection 8 February 2017
 Date of Report 13 February 2017

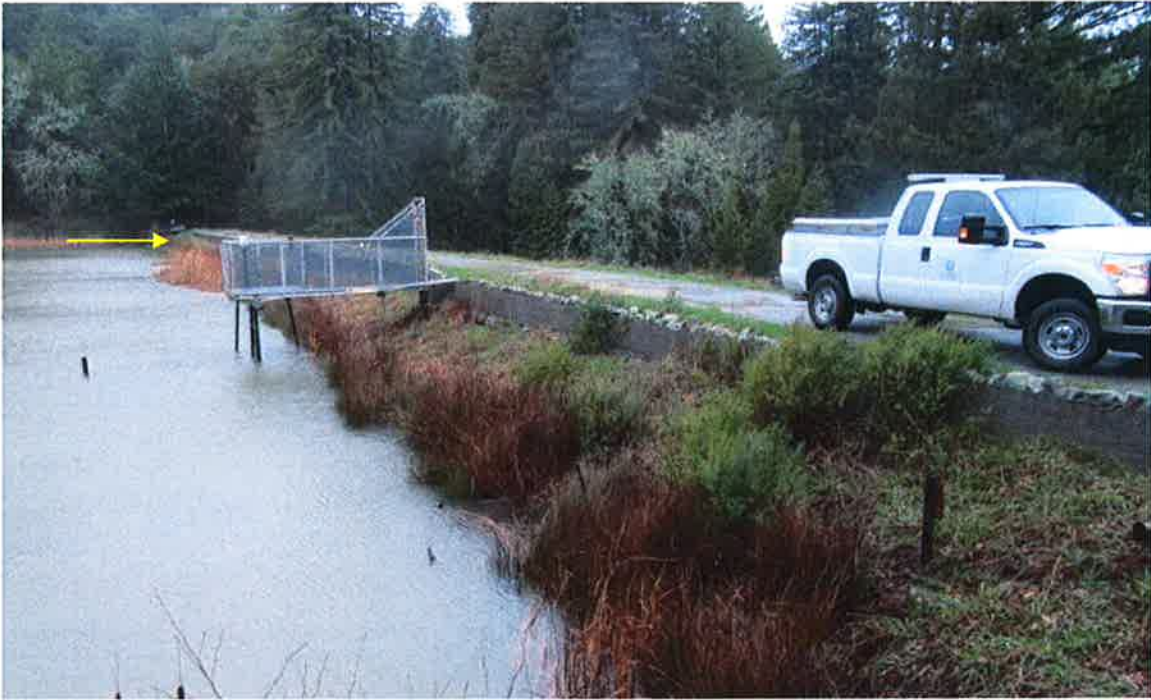
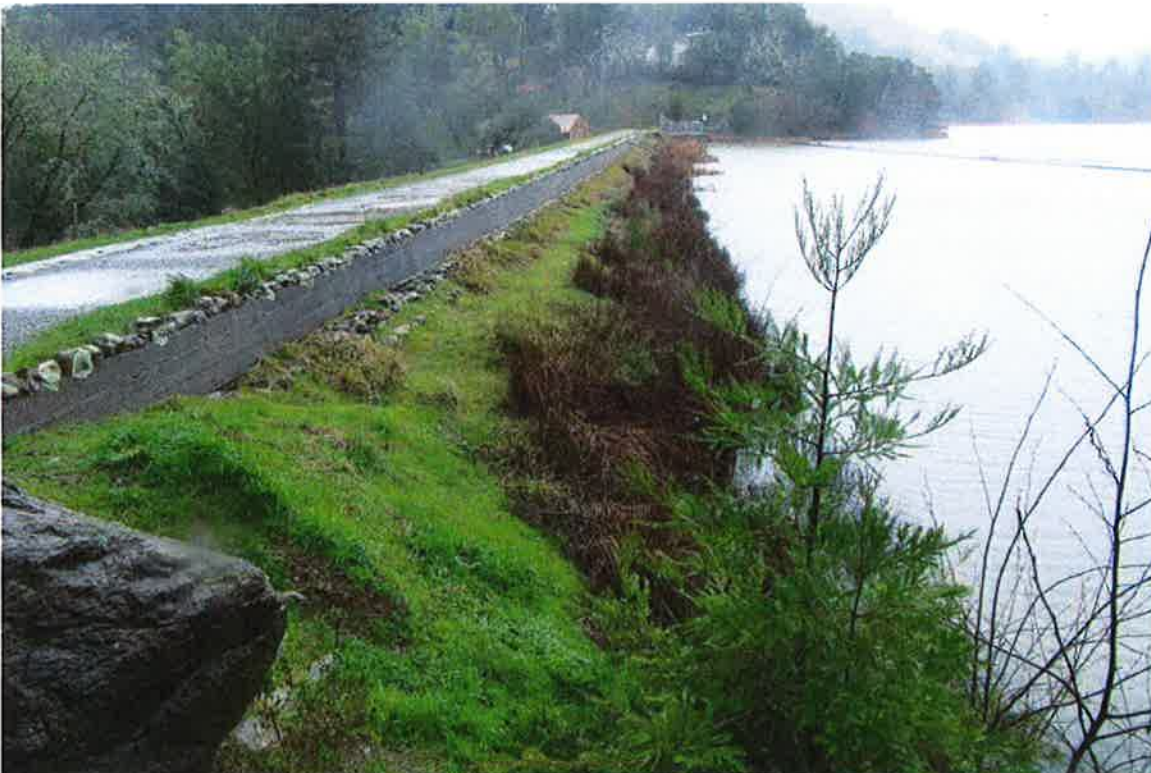
Vegetation control along the upstream face needs improvement, and numerous small trees, bushes, and other woody vegetation that have accumulated along the waterline and upstream groins require removal.

The upstream face looking towards the spillway (indicated), above, and looking away from the spillway, below. Vegetation control along the upstream face needs improvement, and numerous small trees, bushes, and other woody vegetation that have accumulated along the waterline and upstream groins require removal.

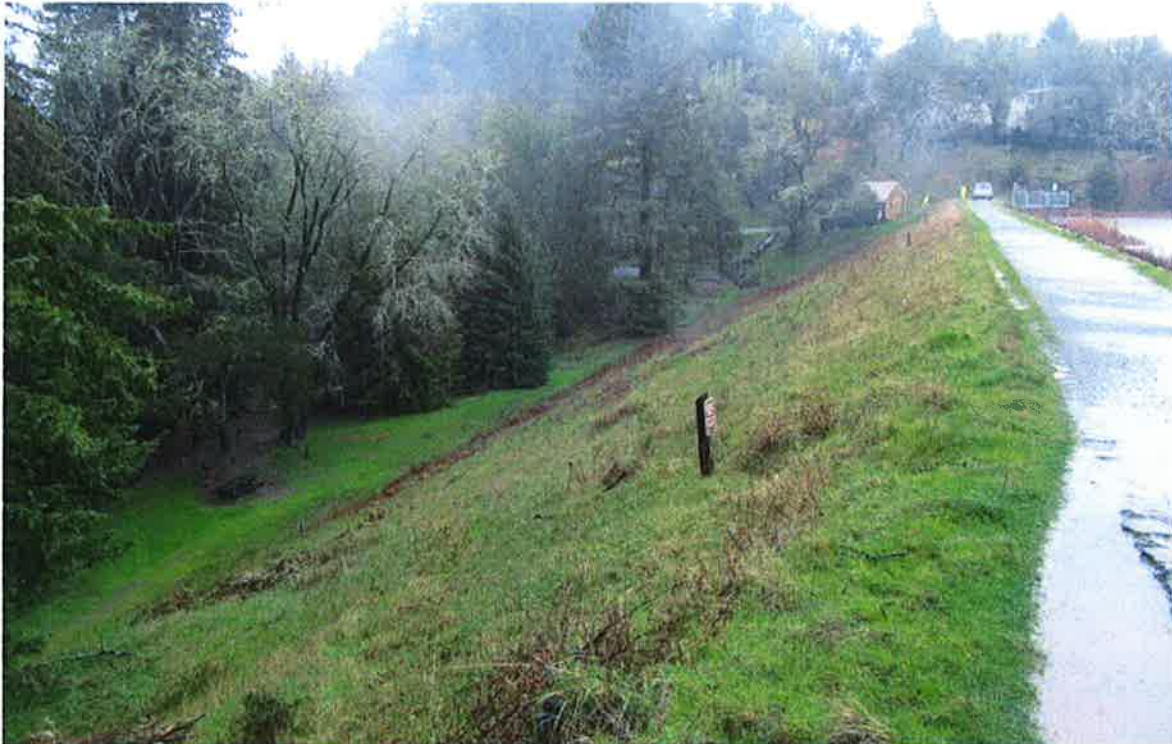
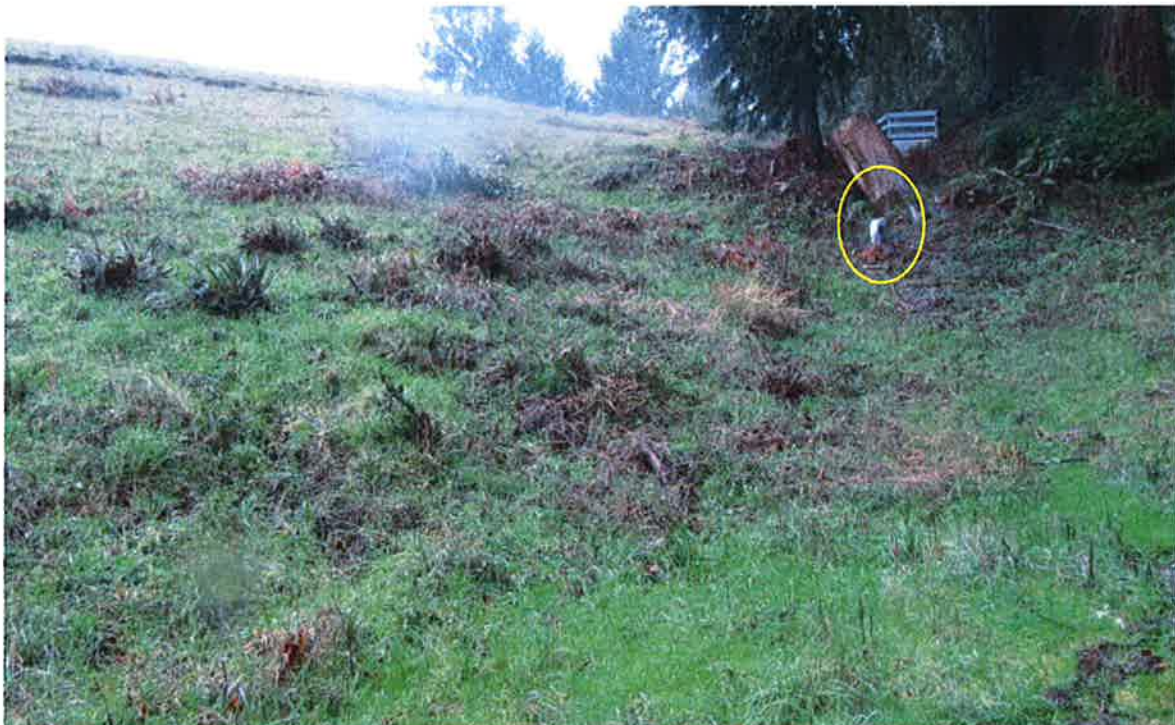
Historical seepage from two sources along the left abutment, identified as the "Upper" and "Lower" leaks, is monitored from the lower left groin. Clear seepage through the Upper and Lower left abutment leaks were estimated at 6 gpm, and 3 gpm, respectively; seepage flows are within historical limits.

View towards the right downstream groin, above, and towards the left downstream groin, below. Note the location of the seepage collection pipe near the upper left groin (circled).

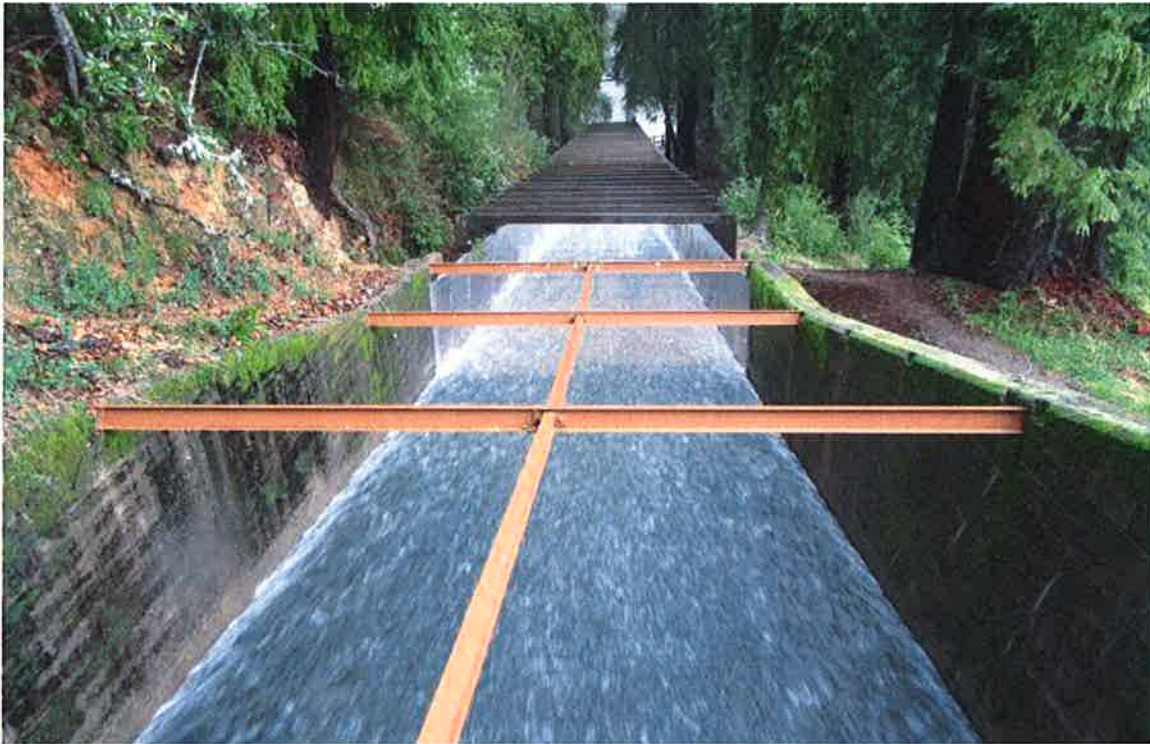
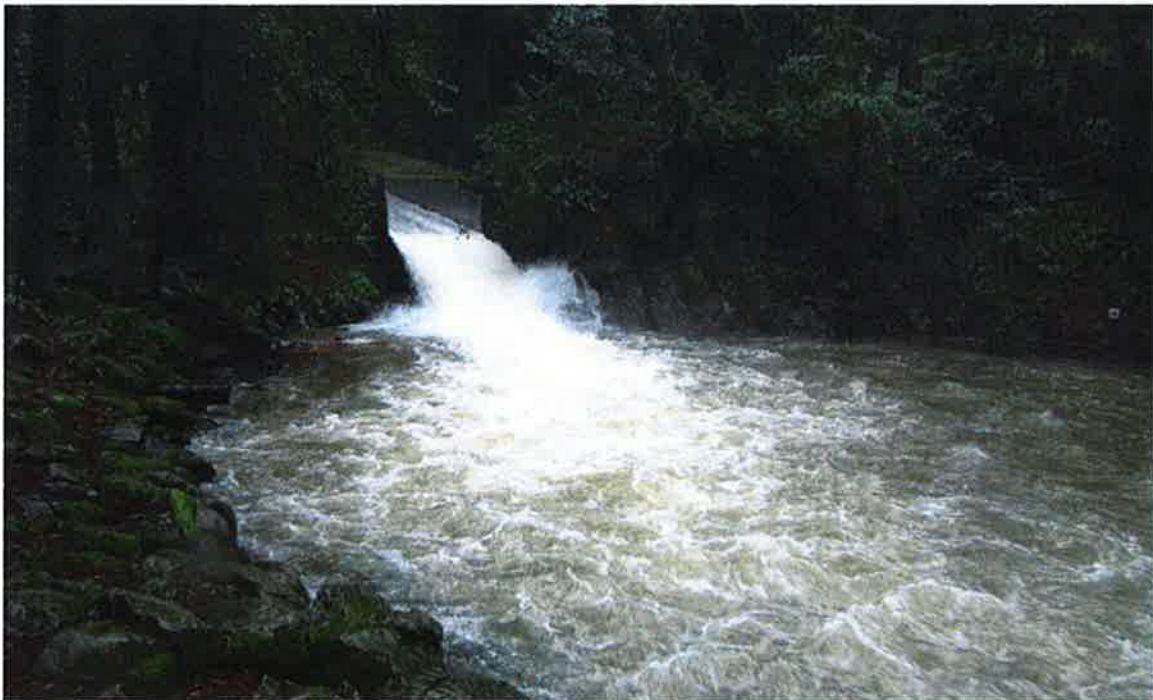
Approximately 0.4' of water was flowing through the spillway control section. Flow within the timber-supported steel-sheathed flume appeared normal (above). The bottom photograph shows spillway flow exiting the flume into the unlined plunge pool.
