STATE OF CALIFORNIA  
CALIFORNIA NATURAL RESOURCES AGENCY  
DEPARTMENT OF WATER RESOURCES  
DIVISION OF SAFETY OF DAMS

**INSPECTION OF DAM AND RESERVOIR IN CERTIFIED STATUS**

Name of Dam Seeger (Nicasio) Dam No. 33-8 County Marin  
 Type of Dam ERTH Type of Spillway Concrete side channel ogee  
 Water is 1.3 feet above the spillway crest and 13.7 feet below the dam crest.  
 Weather Conditions Overcast with light rain  
 Contacts Made Lucy Croy, Trinity Leonard, Carl Sanders and Ronnie Chasteen during the inspection  
 Reason for Inspection Periodic Evaluation

Inspected by J. Lowe *10 Feb 2017*  
 Date of Inspection 7 February 2017  
 Date of Report 10 February 2017 *2/21/17*

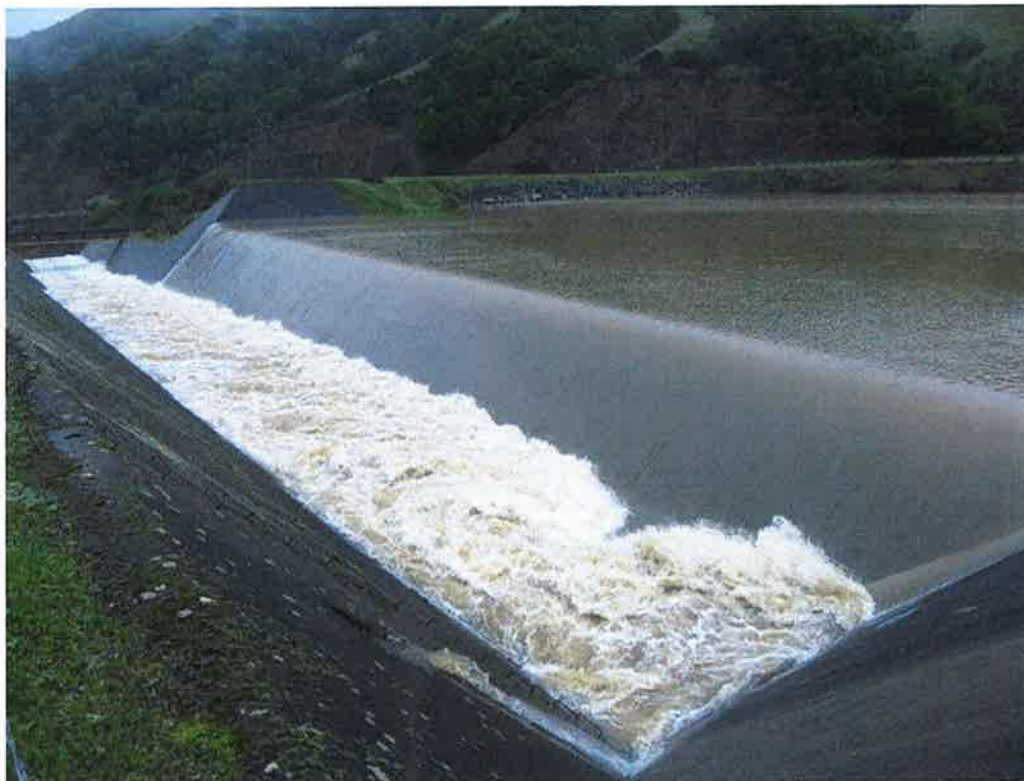
The upstream face and the spillway control weir as viewed from the outlet tower access road. Flow over the weir is approximately 1.3' deep.

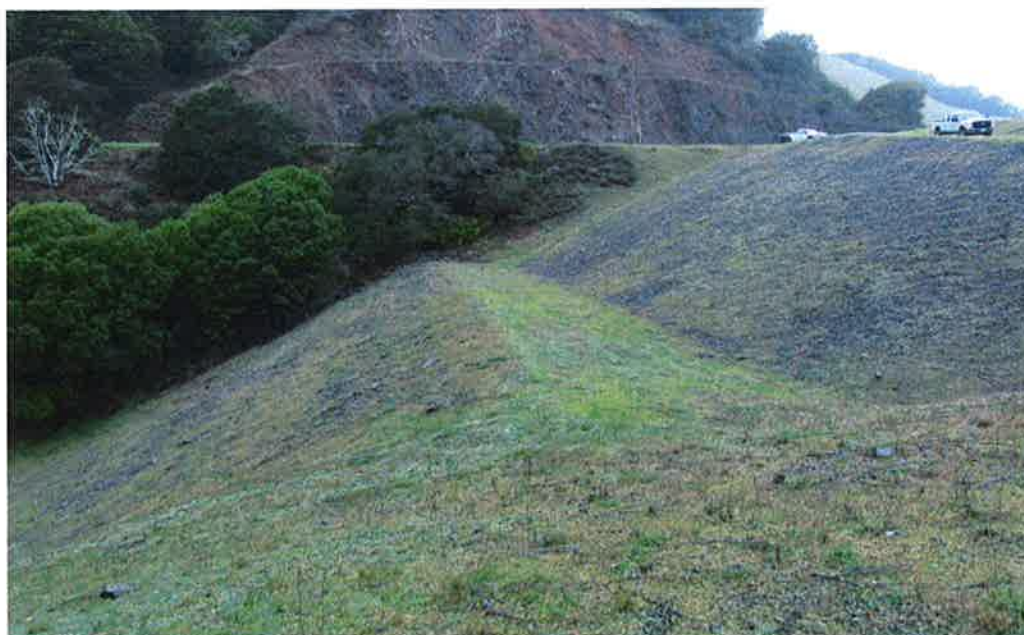
Vegetation control continues to improve and is now excellent. As requested, additional clearing of the downstream toe and lower right downstream groin has been performed to improve access for monitoring by MMWD staff.

The downstream face as viewed from the access road to the base of the dam. Vegetation control is excellent and access for inspection and monitoring for seepage and other defects is unimpeded.

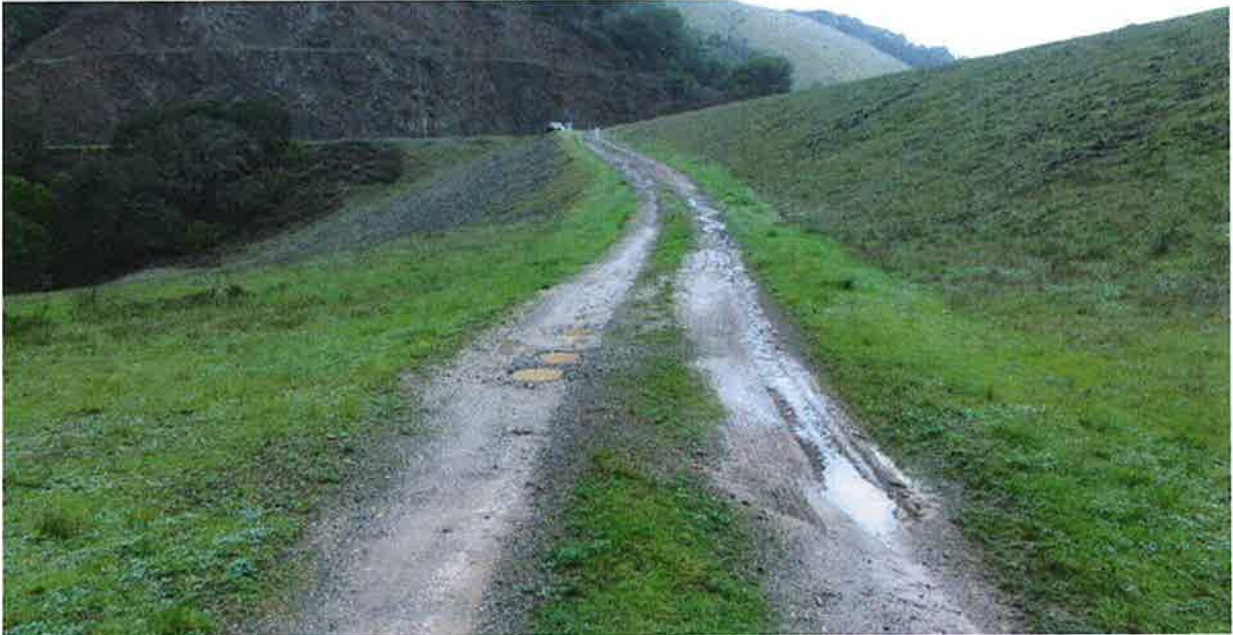
I repeated my request that ruts within the lower access road across the downstream face of the dam be filled and graded to prevent rainfall from ponding on the downstream face.

I repeated my request that ruts within the lower access road across the downstream face of the dam be filled and graded to prevent rainfall from ponding on the downstream face.

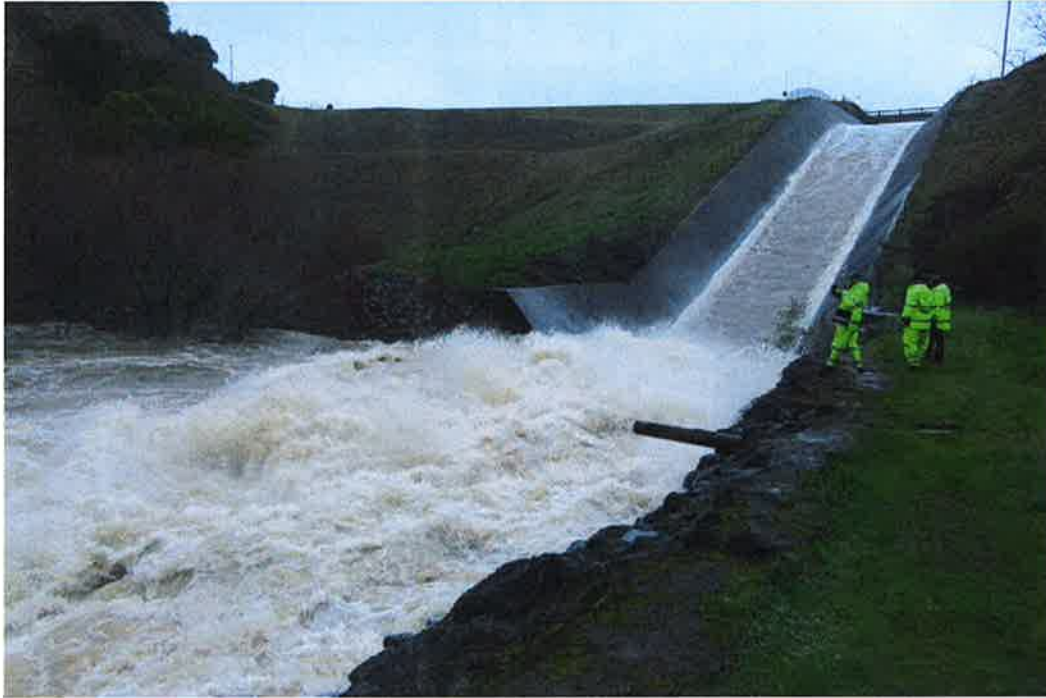
Spillway flow leaving the concrete spillway channel and entering the unlined exit channel, above. The bottom photograph shows the recently repaired downstream most outlet control valve. A recently installed and very well constructed guardrail installed to protect workers operating the downstream outlet control valves.

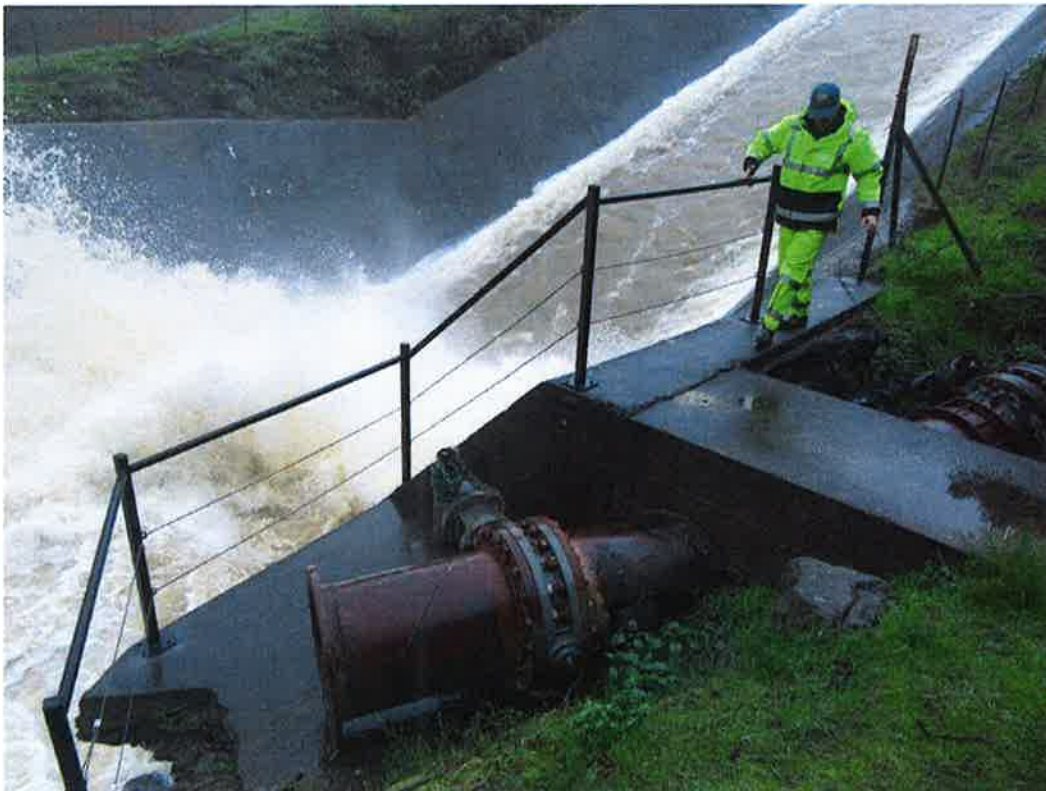
The downstream most 24-inch outlet control valve has been repaired, was fully cycled during this inspection, and is now fully functional.
