**INSPECTION OF DAM AND RESERVOIR IN CERTIFIED STATUS**

Name of Dam Phoenix Lake Dam No. 33-3 County Marin  
 Type of Dam ERTH Type of Spillway Concrete weir and chute  
 Water is 1.6 feet above the spillway crest and 13.6 feet below the dam crest.

Inspected by J. Lowe  
 Date of Inspection 8 February 2017  
 Date of Report 13 February 2017

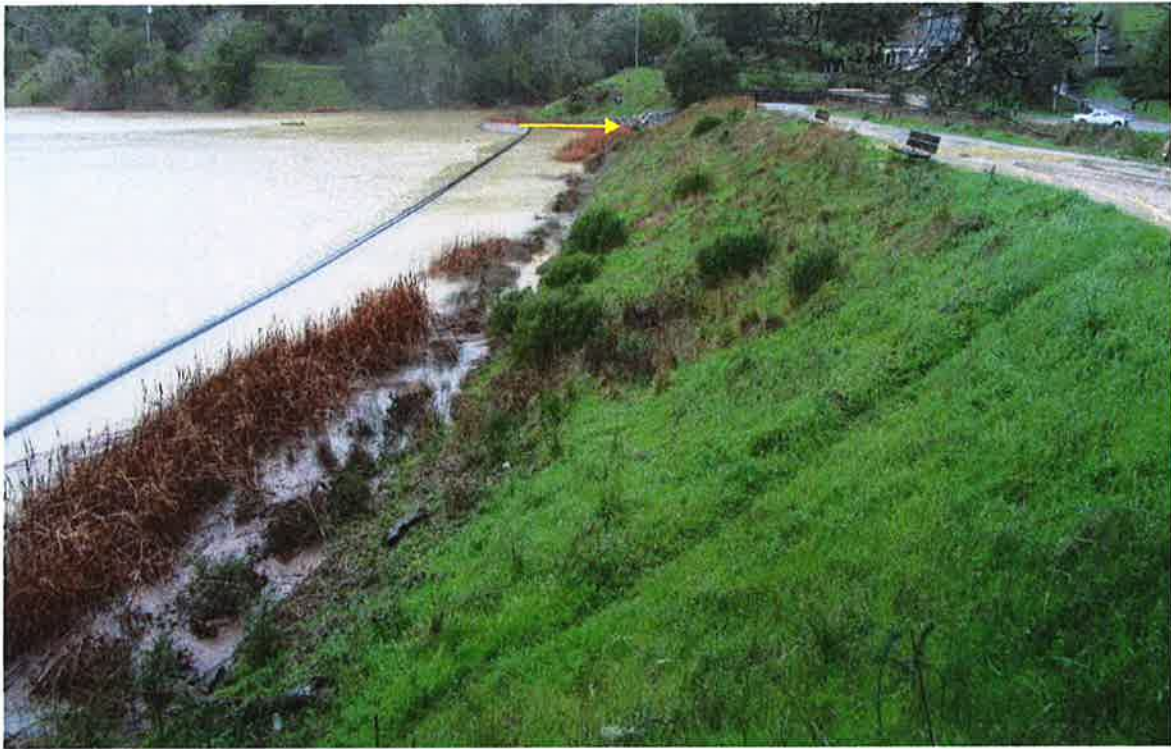
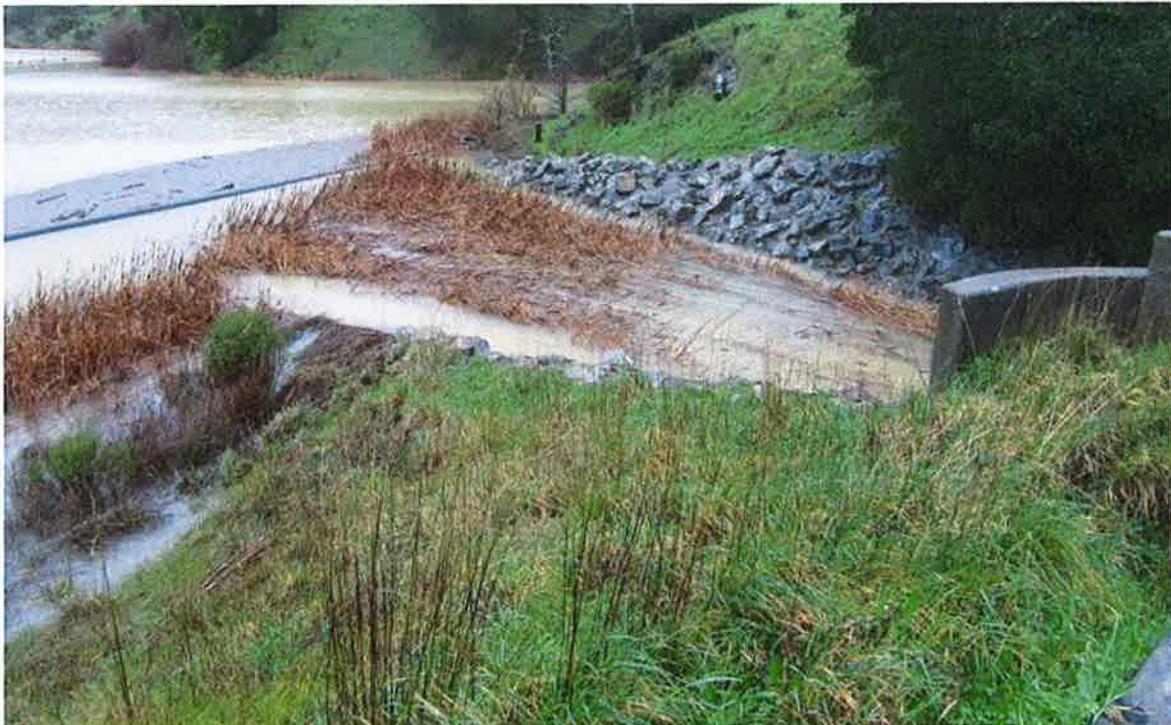
The upstream face looking towards the spillway entrance (indicated), above. A closer look at the spillway entrance, and the polyethylene log boom protecting the entrance, is shown below.

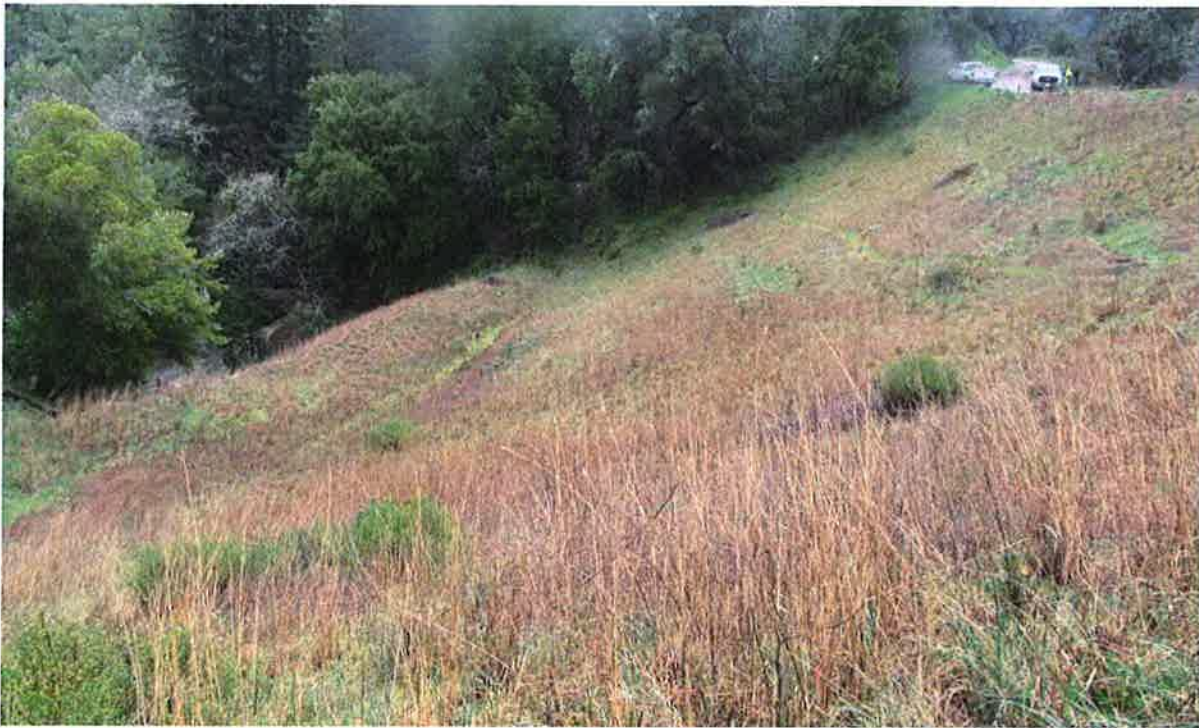
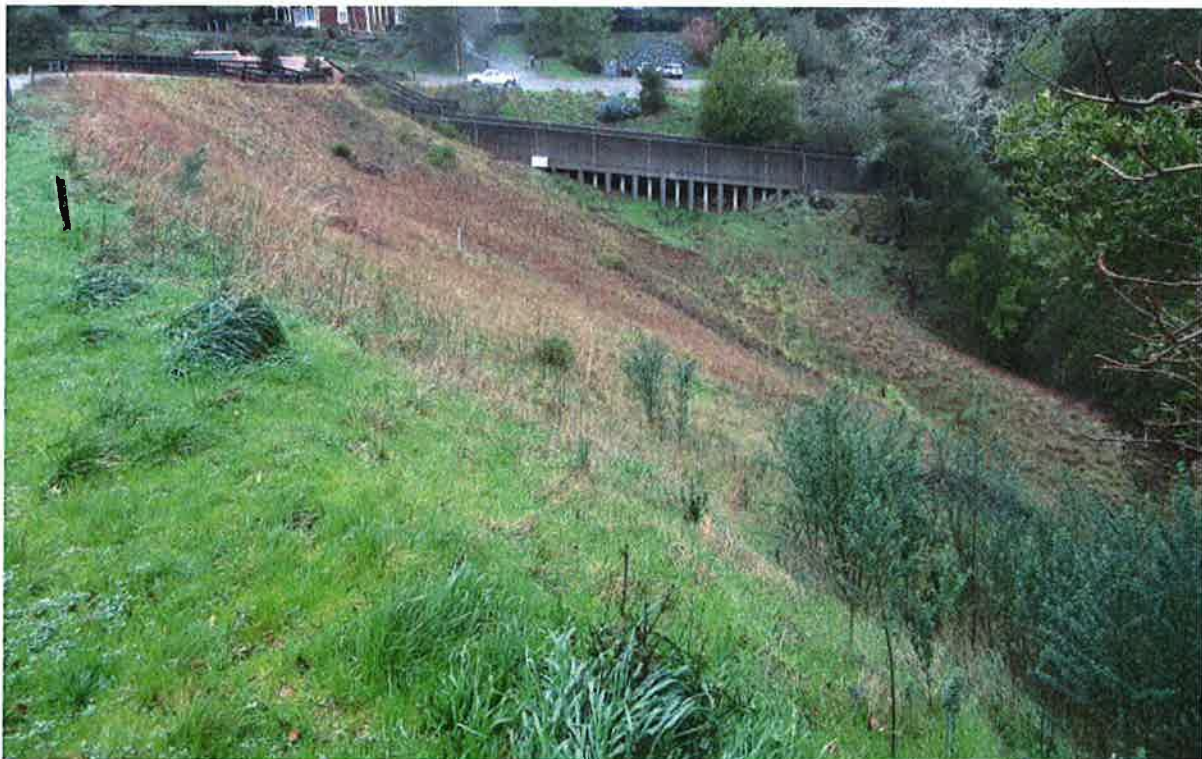
<u>Dam</u>	<p>The visible portion of the upstream face, crest, downstream face, and abutments are in generally satisfactory condition, with no indication of deep seated distress or instability. Several deep erosion gullies occupy the lower portions of both downstream groins, and repairs are required to fill the gullies to minimize or prevent future damage to the embankment. I reminded Mr. Sanders and Ms. Croy of the need to develop and implement a plan to address the erosion as soon as is practical.</p> <p>Vegetation control is generally satisfactory, but emerging bushes along the upstream face and scattered across the downstream face should be removed later in the season. Tule and cattails along the waterline should also be cleared, and overhanging trees and bushes should be trimmed along the right downstream groin.</p> <p>Similar to recent past inspections rodent control remains satisfactory and few to no indications of rodent activity were observed.</p>

View towards the right downstream groin, above, and towards the left downstream groin and spillway, below. Emerging bushes scattered throughout the downstream face should be removed later in the season.

As discussed within the 25 April 2013 inspection report, several deep erosion gullies occupy the lower portions of both downstream groins, and repairs are required to fill the gullies to minimize or prevent future damage to the embankment. I reminded Mr. Sanders and Ms. Croy of the need to develop and implement a plan to address the erosion as soon as is practical.

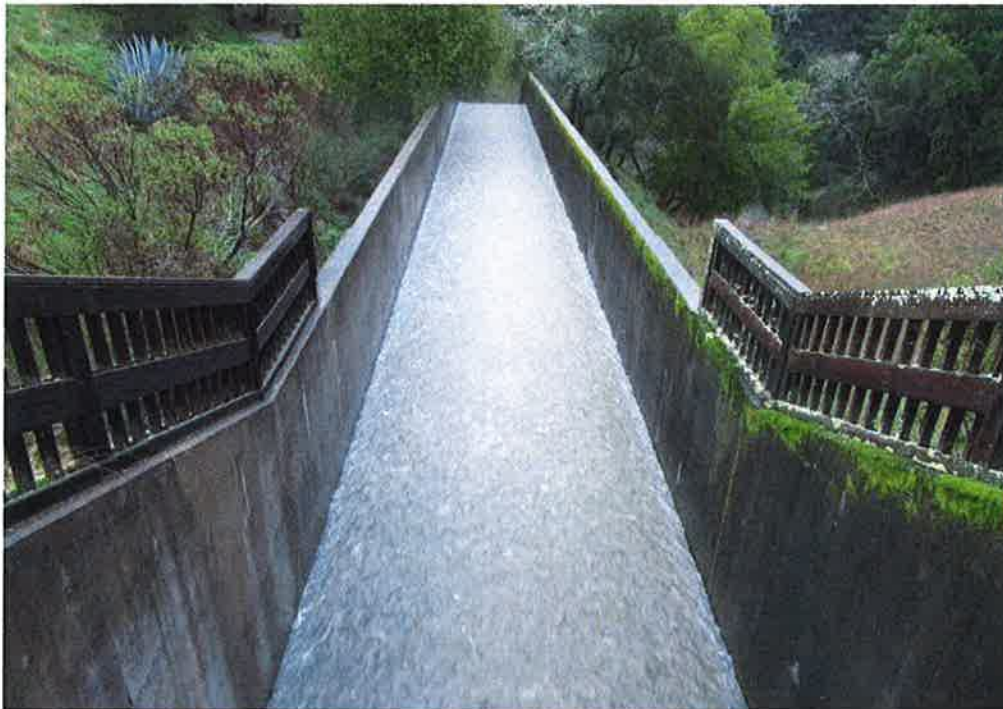
Flow through the concrete spillway channel appears normal, above.

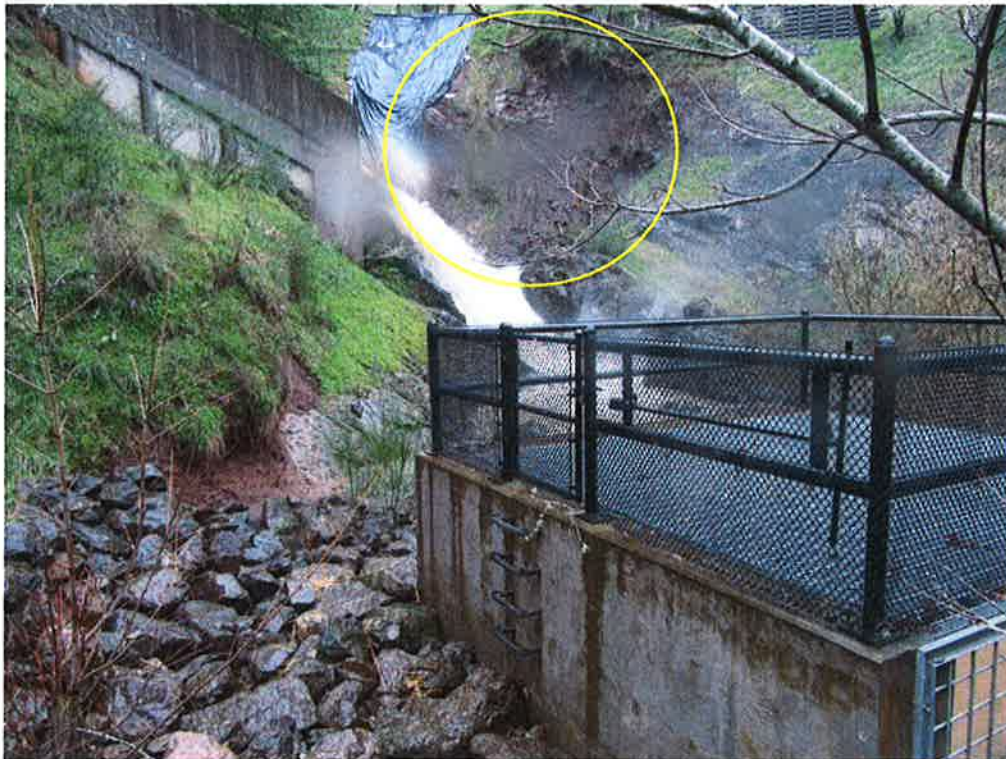
A small rock fall has occurred within the lower left abutment just below the concrete spillway channel outfall (circled); the rock fall did no damage to the lower spillway channel.
