INSPECTION OF DAM AND RESERVOIR IN CERTIFIED STATUS

Name of Dam Soulajule Dam No. 33-9 County Marin
 Type of Dam ERTH Type of Spillway Concrete weir and chute
 Water is 1.3 feet above the spillway crest and 10.7 feet below the dam crest.
 Weather Conditions Overcast with light rain
 Contacts Made Lucy Croy, Trinity Leonard, and Carl Sanders during the inspection
 Reason for Inspection Periodic Evaluation

Inspected by J. Lowe
 Date of Inspection 7 February 2017
 Date of Report 10 February 2017

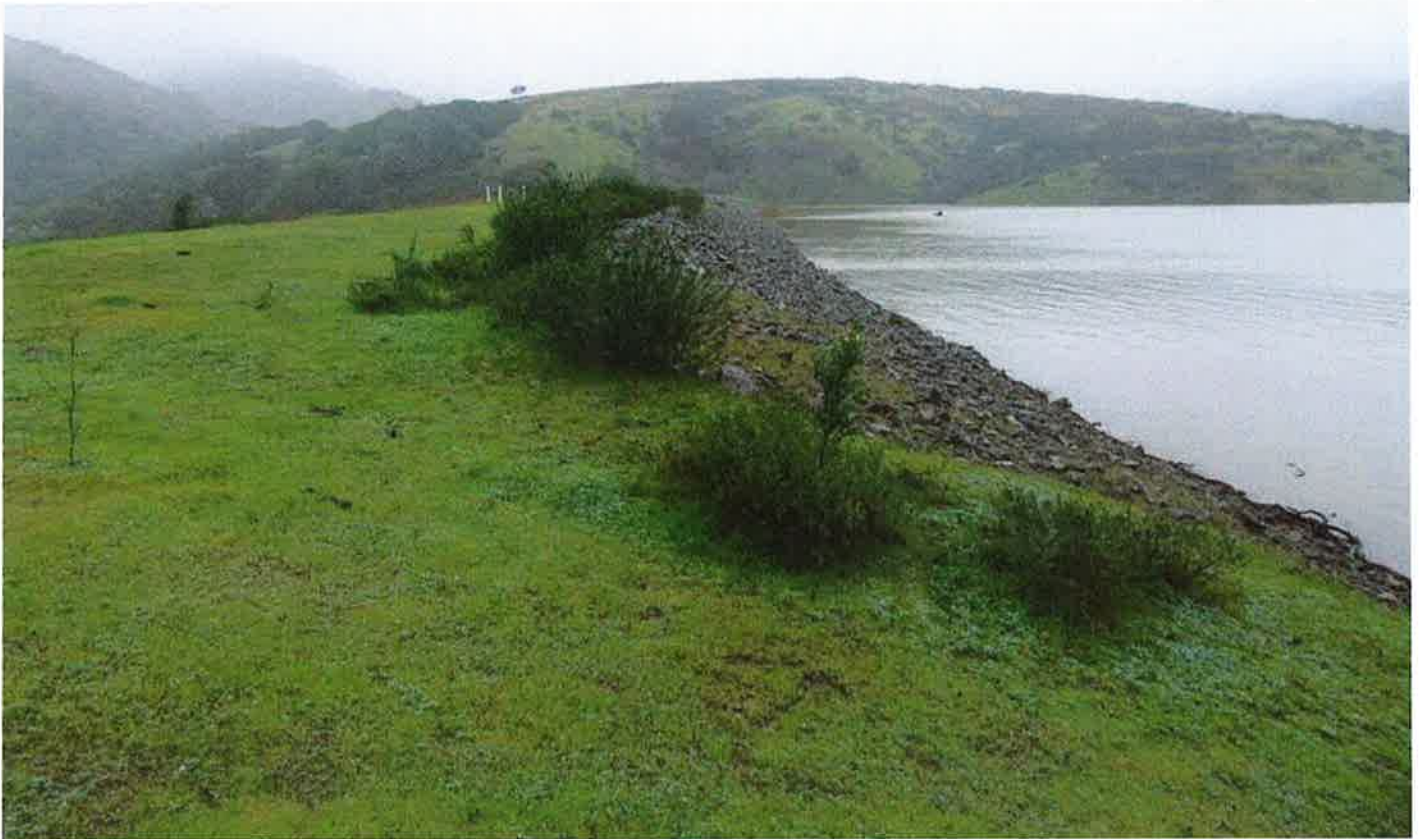
The upstream face of the embankment as viewed from the spillway entrance.

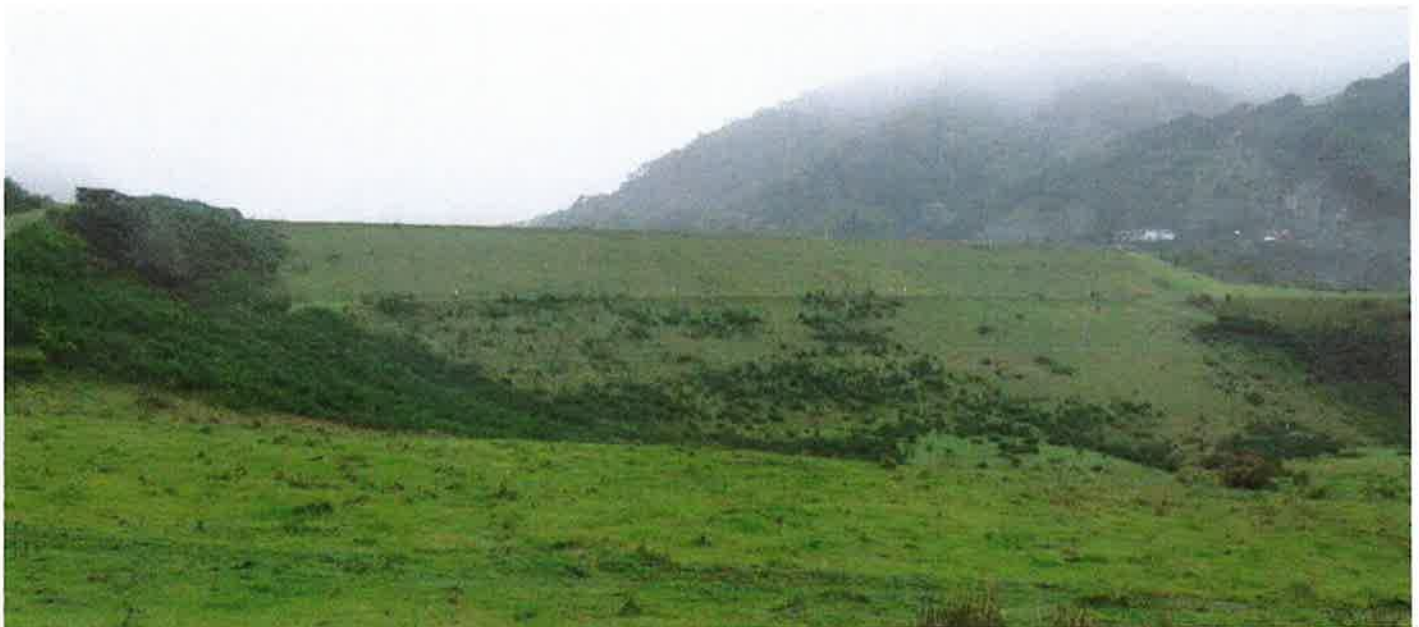
The downstream face of the embankment as viewed from the alternative access road.

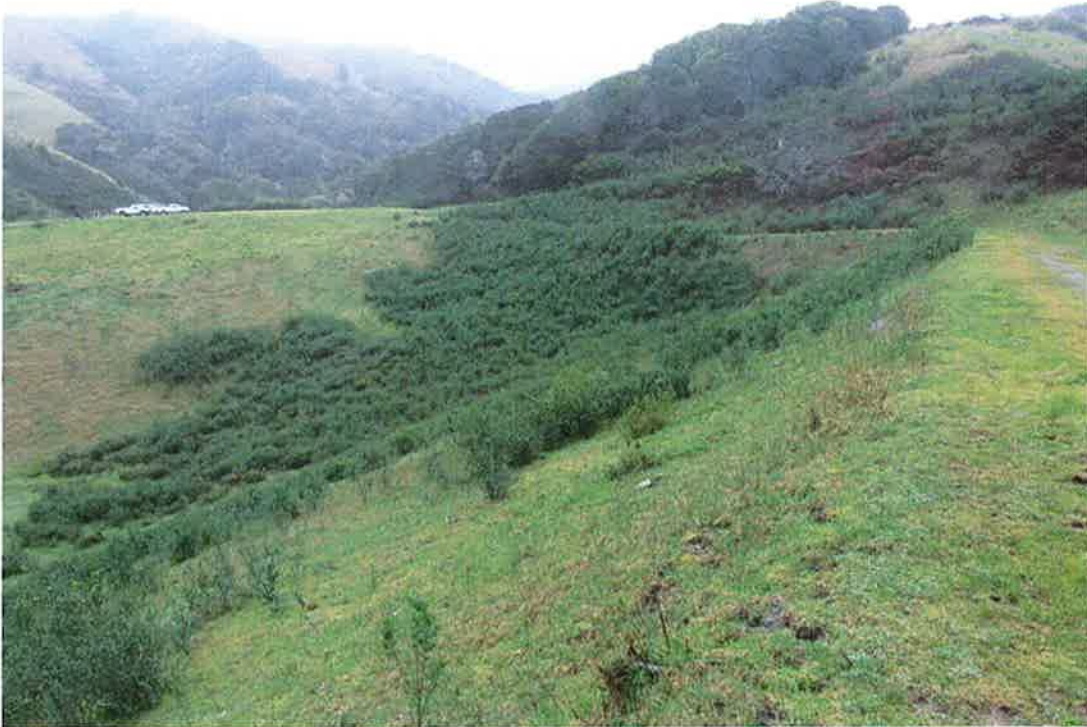
A closer look at the right downstream groin and abutment. Scotch broom and other woody growth throughout the embankment, and within 15' of the groins, should be removed.

Overall care and maintenance of the dam and appurtenances remains quite good, though consistent annual vegetation control is required to prevent emerging vegetation from reducing the effectiveness of inspection and monitoring for seepage and other defects.

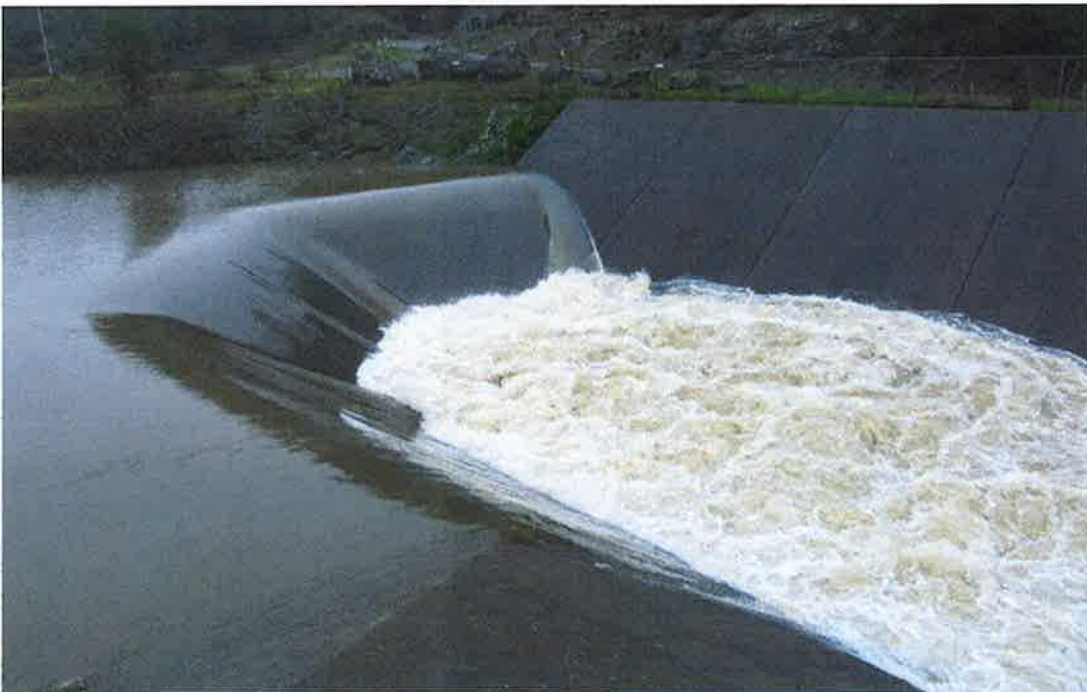
1.3' flow over the spillway entrance weir.

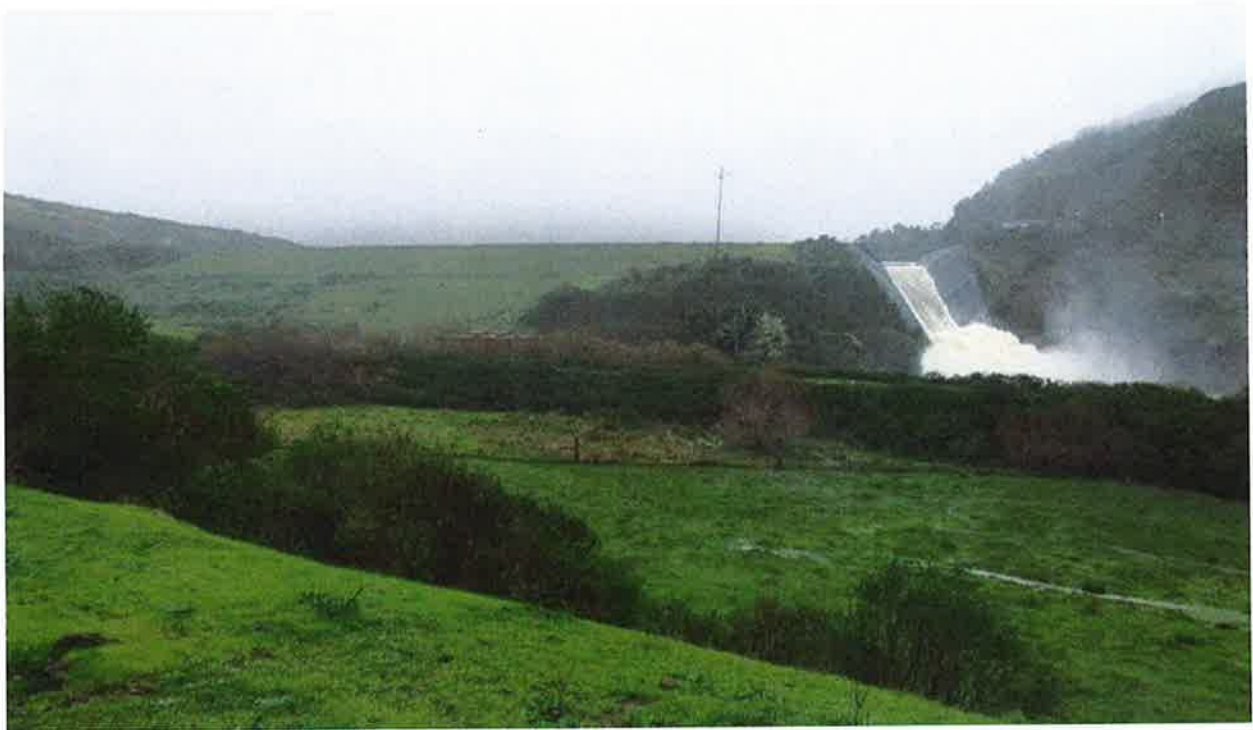
<u>Other</u>	<p>Primary access to the dam is limited when the spillway is flowing. The alternative access road is only partially armored, and may not be suitable for all equipment or in all weather. All-weather access for any and all equipment required to safely operate the dam and reservoir is a dam safety requirement. Existing access should be improved, or alternative all-weather access should be provided if not already in place.</p>

The downstream face as viewed from the alternative access road. The alternative access road is only partially armored, and may not be suitable for all equipment or in all weather.

Primary access to the dam is limited when the spillway is flowing. All-weather access for any and all equipment required to safely operate the dam and reservoir is a dam safety requirement. Existing access should be improved, or alternative all-weather access should be provided if not already in place.

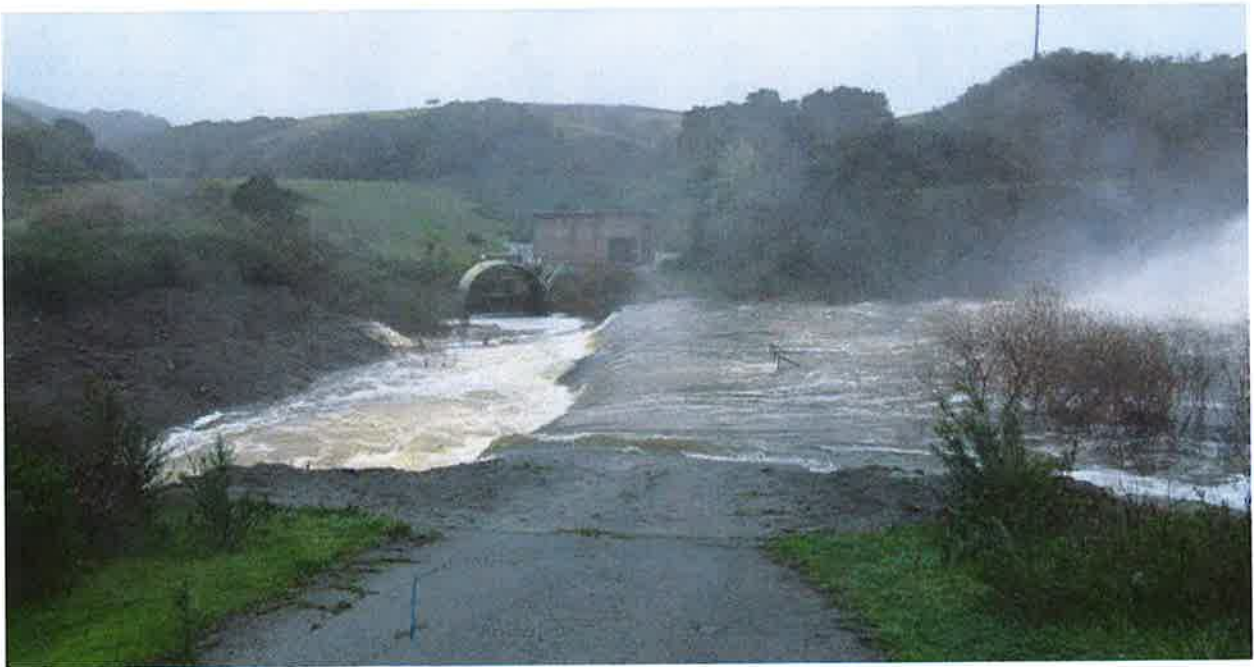
Spillway flow over the primary access road. All-weather access for any and all equipment required to safely operate the dam and reservoir is a dam safety requirement.
