STATE OF CALIFORNIA  
CALIFORNIA NATURAL RESOURCES AGENCY  
DEPARTMENT OF WATER RESOURCES  
DIVISION OF SAFETY OF DAMS

**INSPECTION OF DAM AND RESERVOIR IN CERTIFIED STATUS**

Name of Dam Alpine Dam No. 33 County Marin  
 Type of Dam GRAV Type of Spillway Eight siphons  
 Water is 5 feet below the spillway crest and 13 feet below the dam crest.  
 Weather Conditions Clear and mild  
 Contacts Made Lucy Croy and Conner Pollard during the inspection  
 Reason for Inspection Periodic evaluation

Inspected by J. Lowe  
 Date of Inspection 15 February 2018  
 Date of Report 16 February 2018

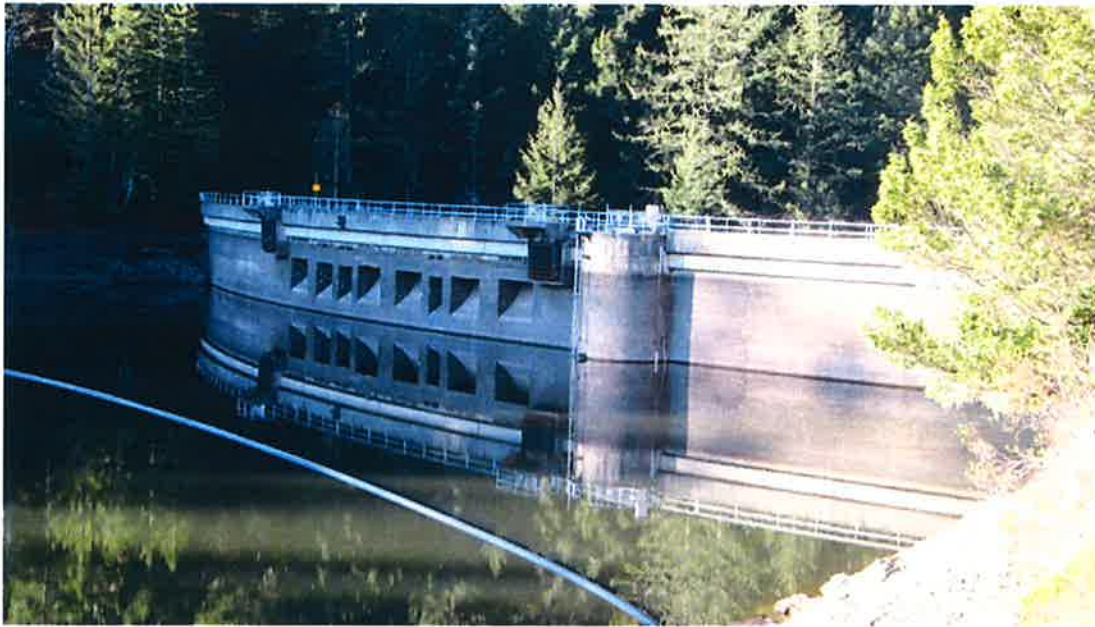
The upstream face as viewed from the upstream right abutment. Note the log boom upstream of the dam.

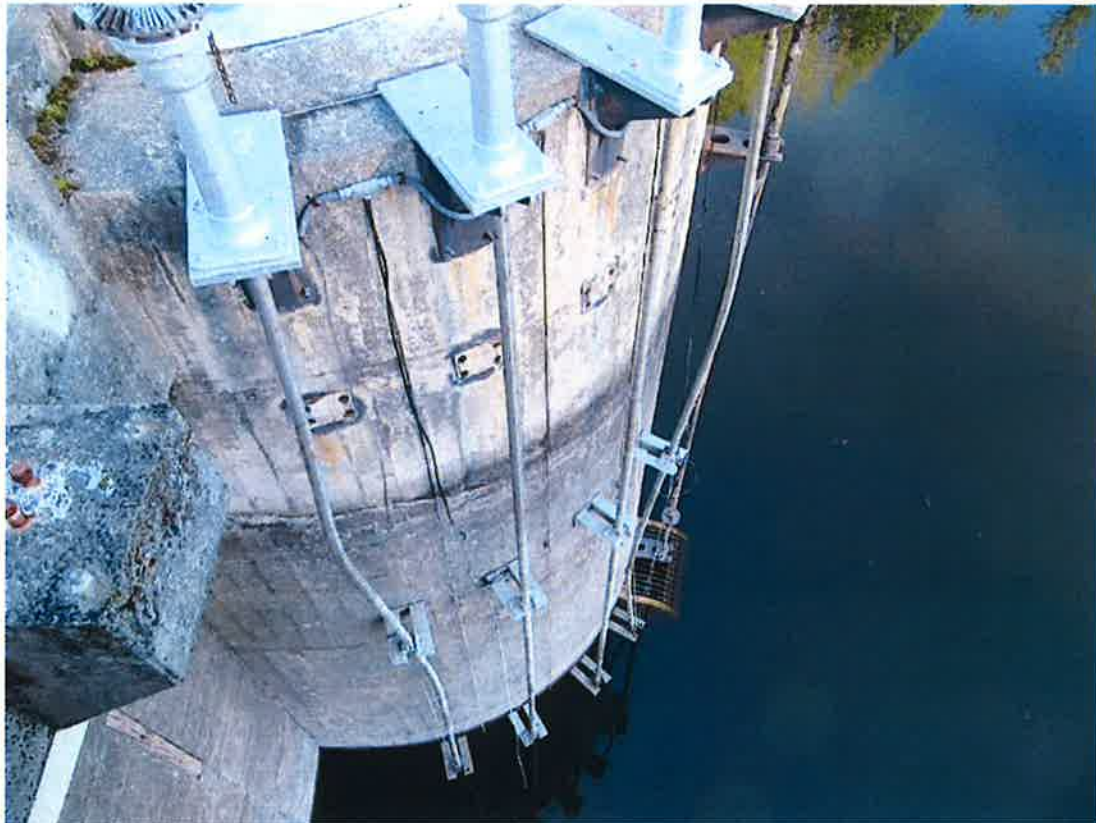
None of the upstream controls were cycled during this inspection because the control stems were damaged by improper operation prior to this inspection. The owner is planning on replacing the damaged control stems within the next month or so.

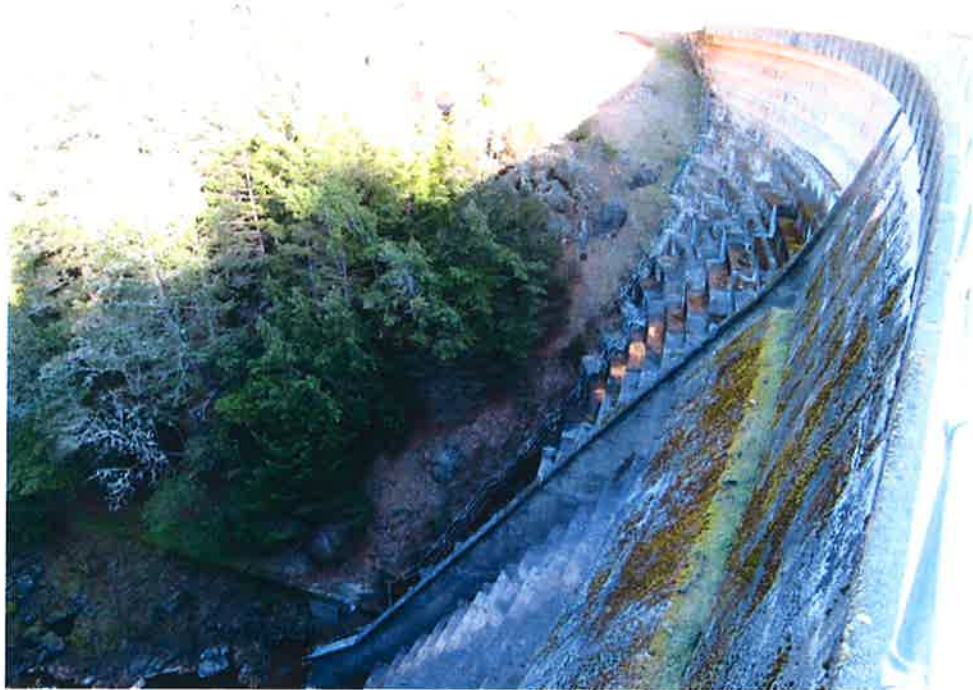
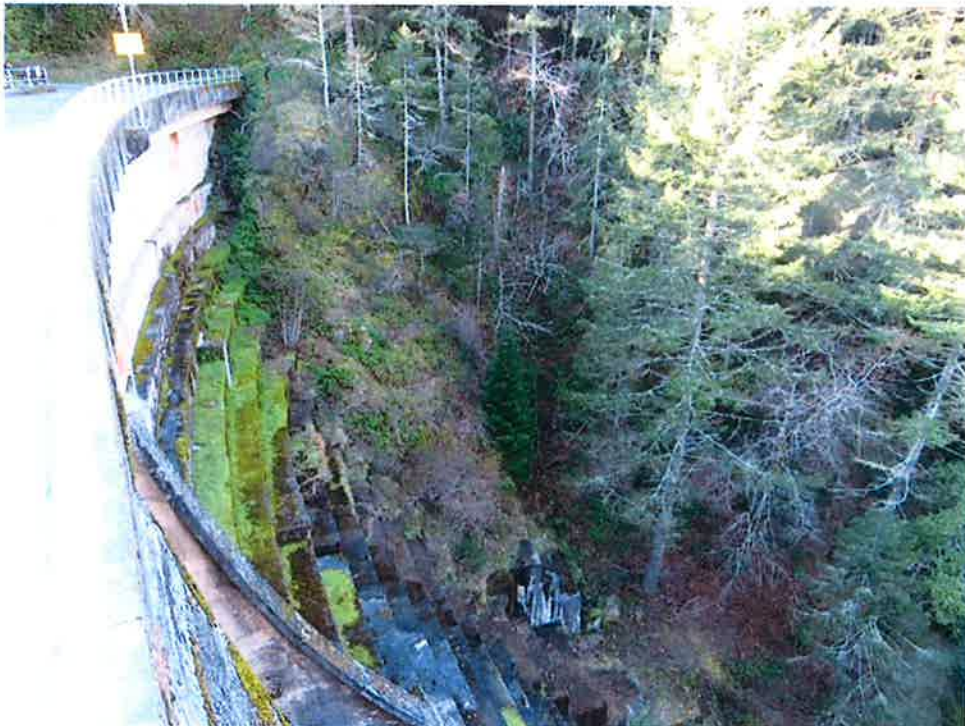
The right downstream face and groin, above, and the left downstream face and groin, below. Vegetation control is mostly satisfactory, but it's time once again to schedule clearing of emerging trees, bushes, and other tall and dense vegetation from alongside both downstream groins.
