**INSPECTION OF DAM AND RESERVOIR IN CERTIFIED STATUS**

Name of Dam Bon Tempe Dam No. 33-6 County Marin  
 Type of Dam ERTH Type of Spillway Concrete weir and chute  
 Water is 3 feet below the spillway crest and 5.6 feet below the dam crest.  
 Weather Conditions Clear and mild  
 Contacts Made Lucy Croy, Carl Sanders, and Conner Pollard during the inspection  
 Reason for Inspection Periodic Evaluation

Inspected by J. Lowe  
 Date of Inspection 14 February 2018  
 Date of Report 16 February 2018

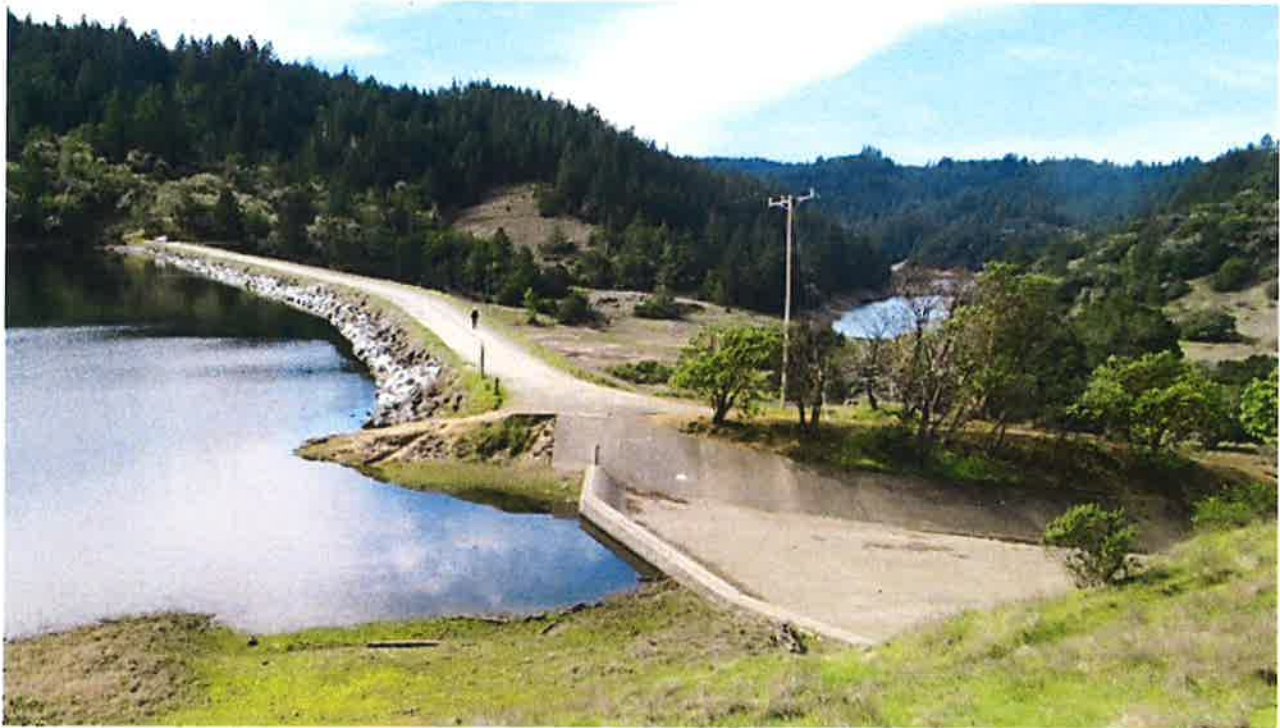
Following the placement of additional large boulder riprap, the upstream face riprap protection is satisfactory.

The upstream face and spillway entrance as viewed from the right abutment. The recently placed large boulder riprap along the upstream face waterline is lighter in color than the original rock.

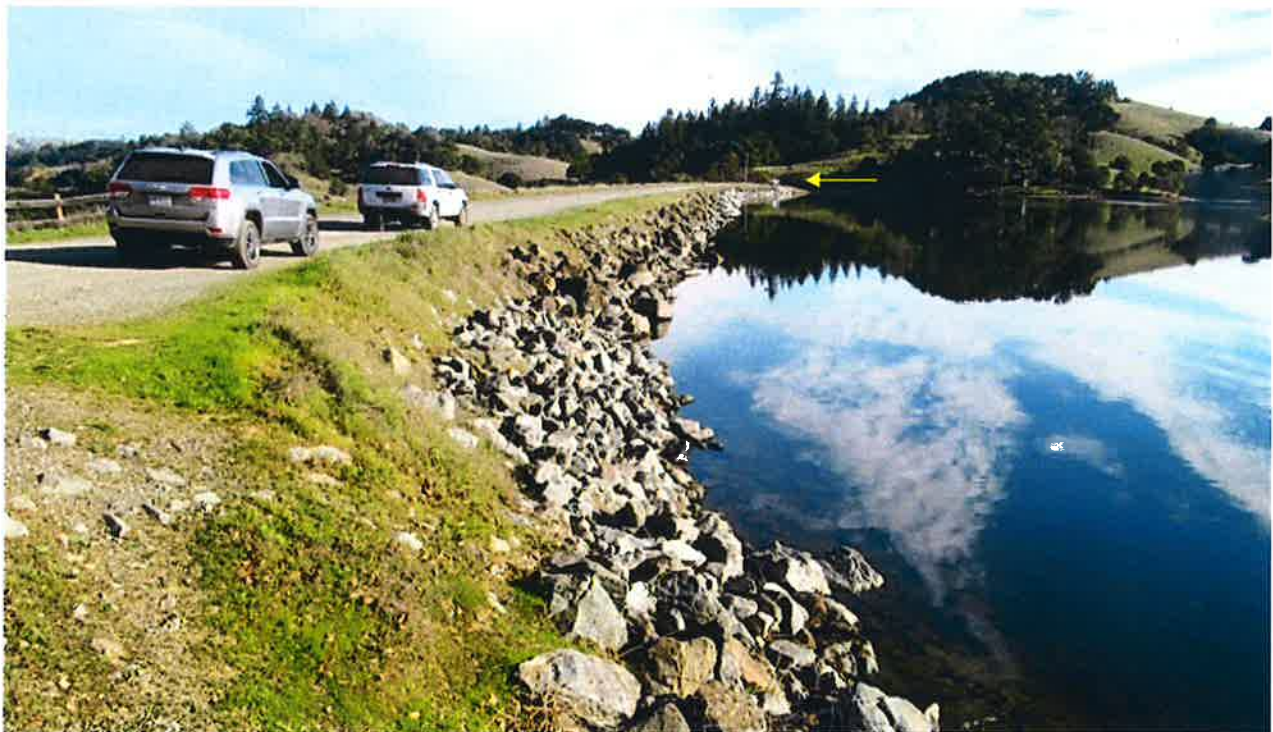
Another view of the upstream face, this time looking towards the spillway entrance.

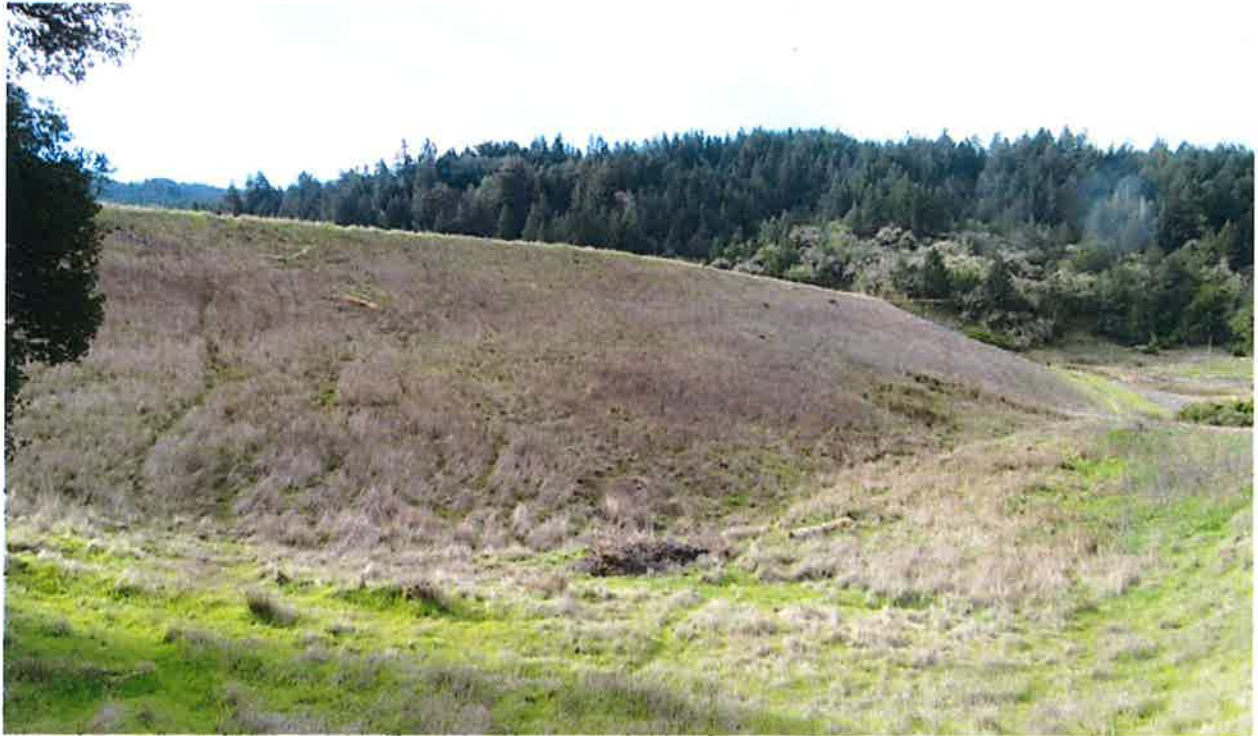
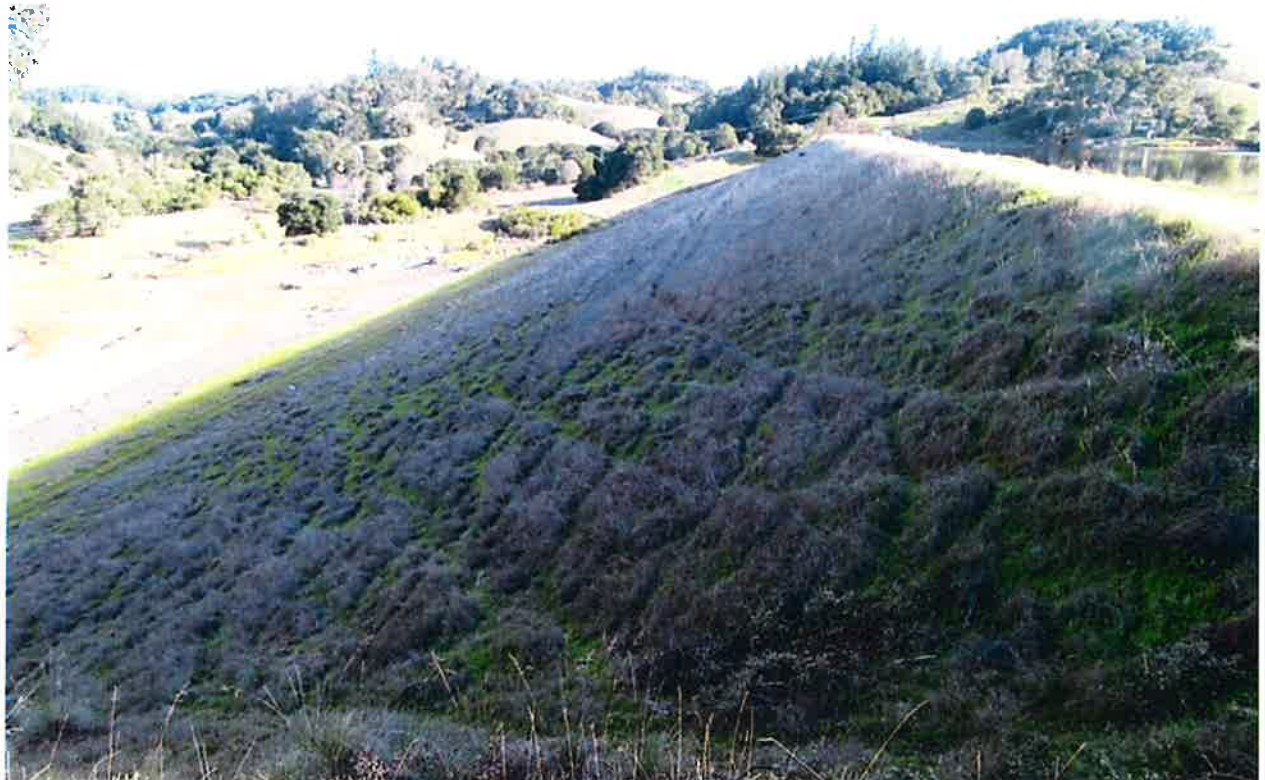
The downstream face looking towards the left abutment, above, and looking towards the right abutment, below. Vegetation control is very good.

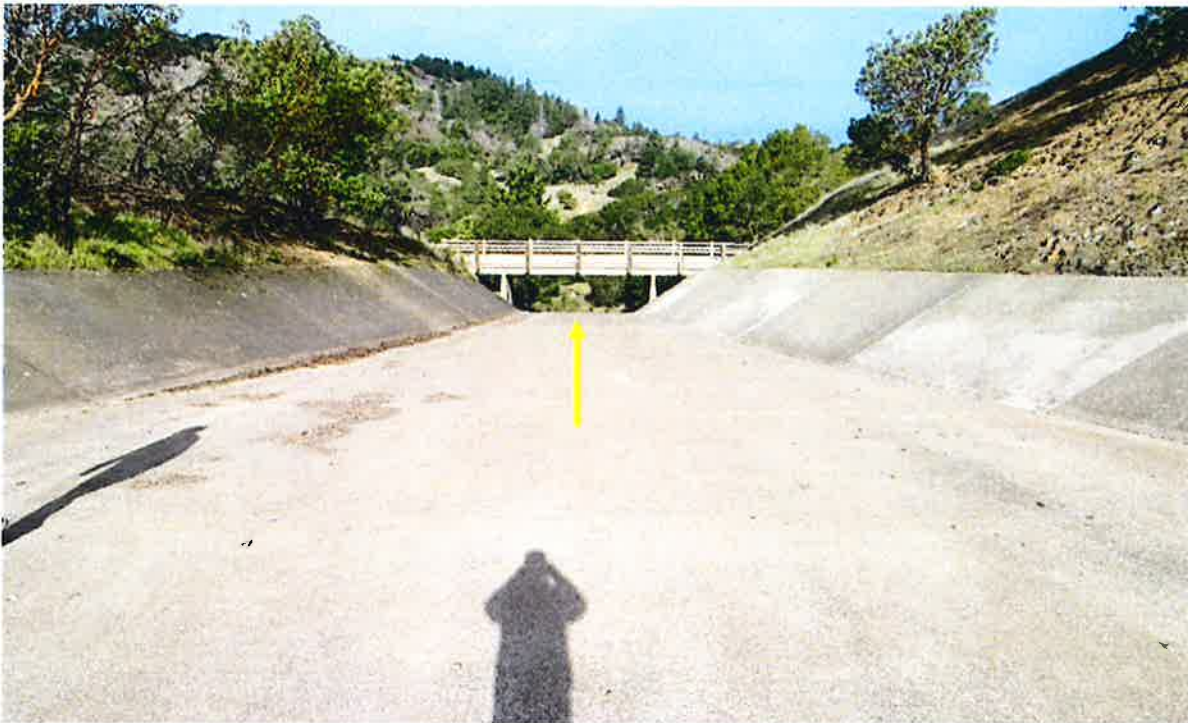
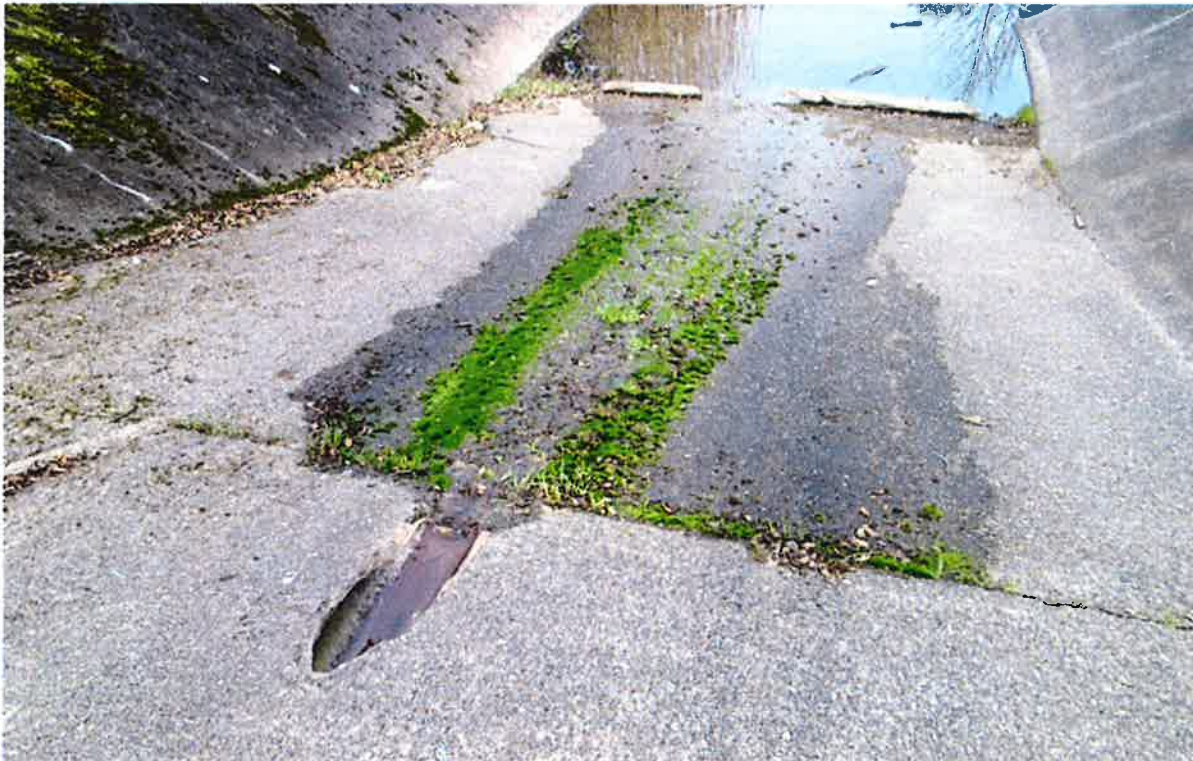
The concrete lined spillway channel remains in satisfactory condition (above); direction of flow is indicated by the arrow. I asked Ms. Croy to investigate whether the seepage into the spillway near the bottom of the concrete channel is consistent with design expectations (below).
