STATE OF CALIFORNIA
CALIFORNIA NATURAL RESOURCES AGENCY
DEPARTMENT OF WATER RESOURCES
DIVISION OF SAFETY OF DAMS

INSPECTION OF DAM AND RESERVOIR IN CERTIFIED STATUS

Name of Dam Peters Dam No. 33-7 County Marin
 Type of Dam ERTH Type of Spillway Concrete weir and chute
 Water is 24.5 feet below the spillway crest and 39.5 feet below the dam crest.
 Weather Conditions Clear and mild
 Contacts Made Lucy Croy, Conner Pollard, and Carl Sanders during the inspection
 Reason for Inspection Periodic Evaluation

Inspected by J. Lowe
 Date of Inspection 13 February 2018
 Date of Report 16 February 2018

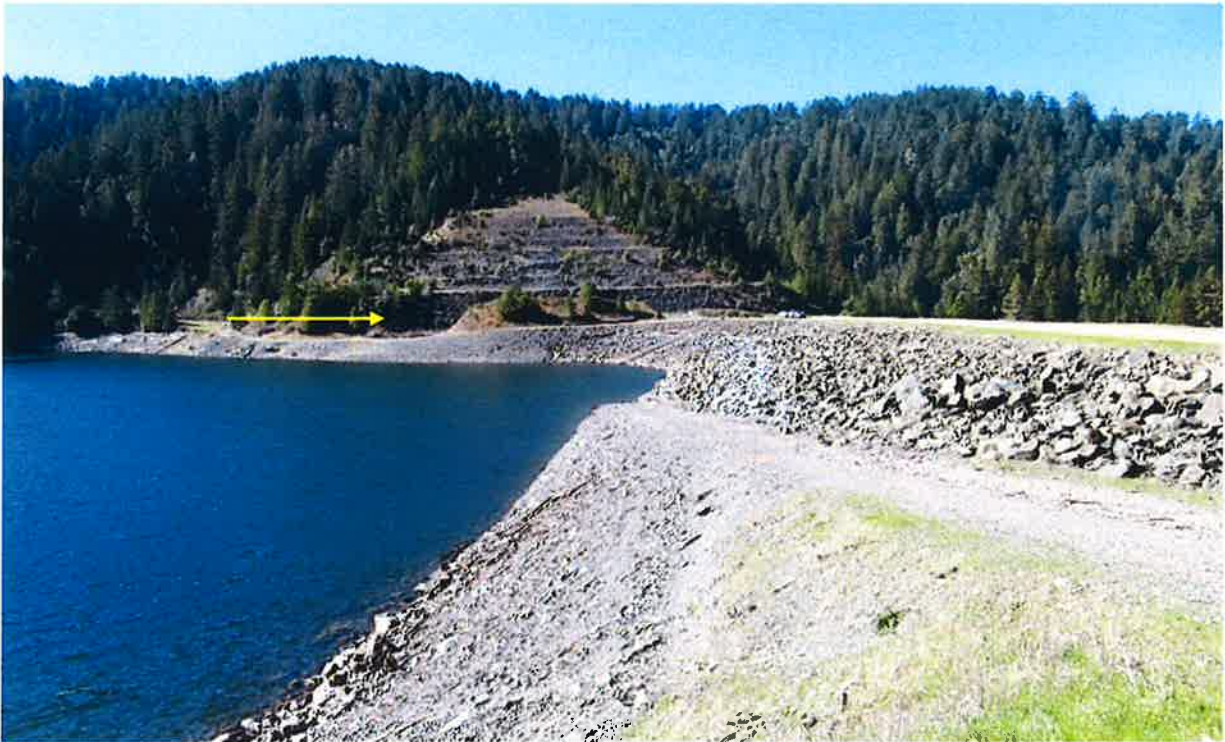
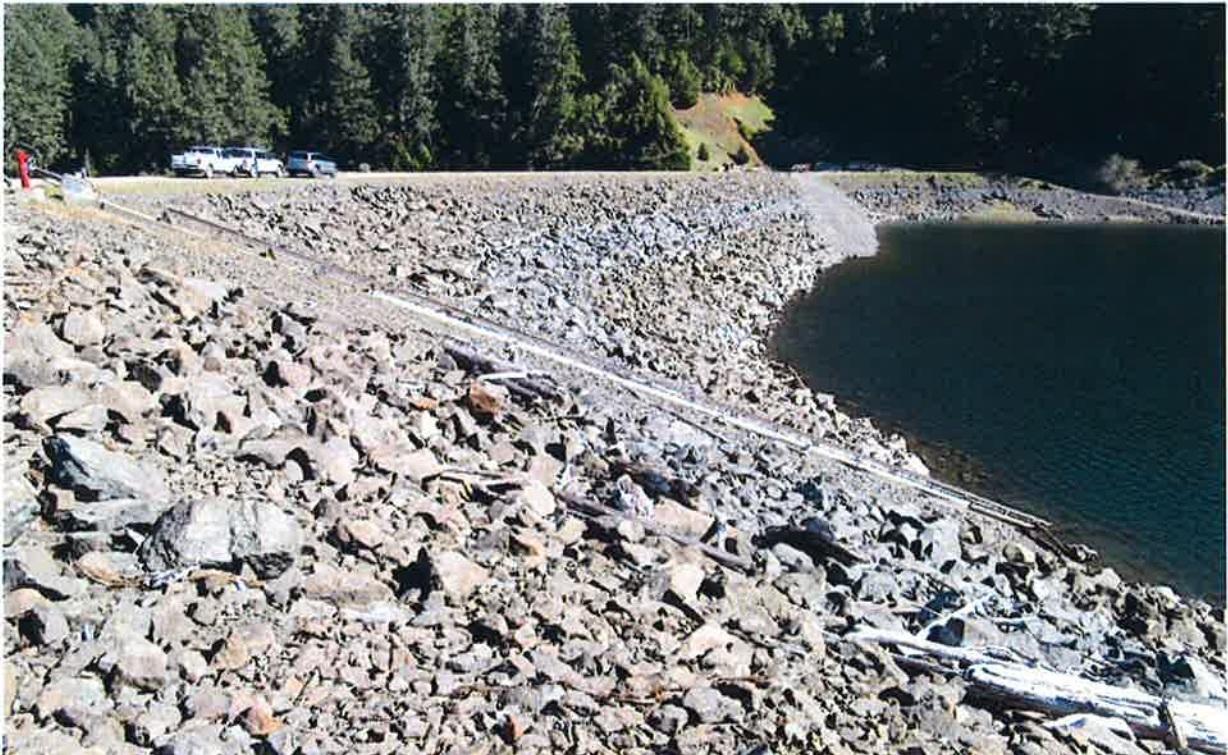
<u>Dam</u>	<p>The visible portion of the upstream face, crest, downstream face, and abutments are in satisfactory condition with no indication of surficial distress or instability. The large boulder rock riprap upstream face protection remains in good condition.</p> <p>Vegetation control remains excellent, and the crest, groins, and downstream face of the embankment are covered with ankle tall grass and other low ground cover that protect against erosion without hindering inspection and monitoring for seepage and other defects. Similar to recent past inspections, rodent control remains satisfactory and few to no indications of rodent activity were observed.</p> <p>The roadway cut and hillside above the outlet tower shows no obvious signs of renewed movement. Past sliding at this location during a winter storm has reportedly caused damage to the outlet valve controls.</p>
<u>Spillway</u>	<p>The spillway approach, control weir, and exit channel were open and clear. The large redwood log that had drifted into and was caught on the right side of the concrete spillway control weir was removed as requested. The upper half of the concrete spillway chute was inspected and found to be in generally very good condition. A small area of eroded concrete on the upper right invert should be repaired to prevent further damage. Due to safety concerns, the lower half of the spillway could not be entered for close examination, but no significant flaws were noted from our safe vantage points. The owner has contracted with AECOM to perform a detailed evaluation of the concrete spillway, and I asked Ms. Croy to forward a copy of AECOM's spillway report to DSOD.</p> <p>The original spillway, now used as a discharge chute for the 60" diameter upper level outlet, remains in satisfactory condition.</p> <p>The current design storm, prepared in 1981, is for a 170,000-year return period producing 19,900 cfs</p>

The upstream face looking towards the spillway entrance (indicated by arrow), above, and looking towards the right abutment, below.

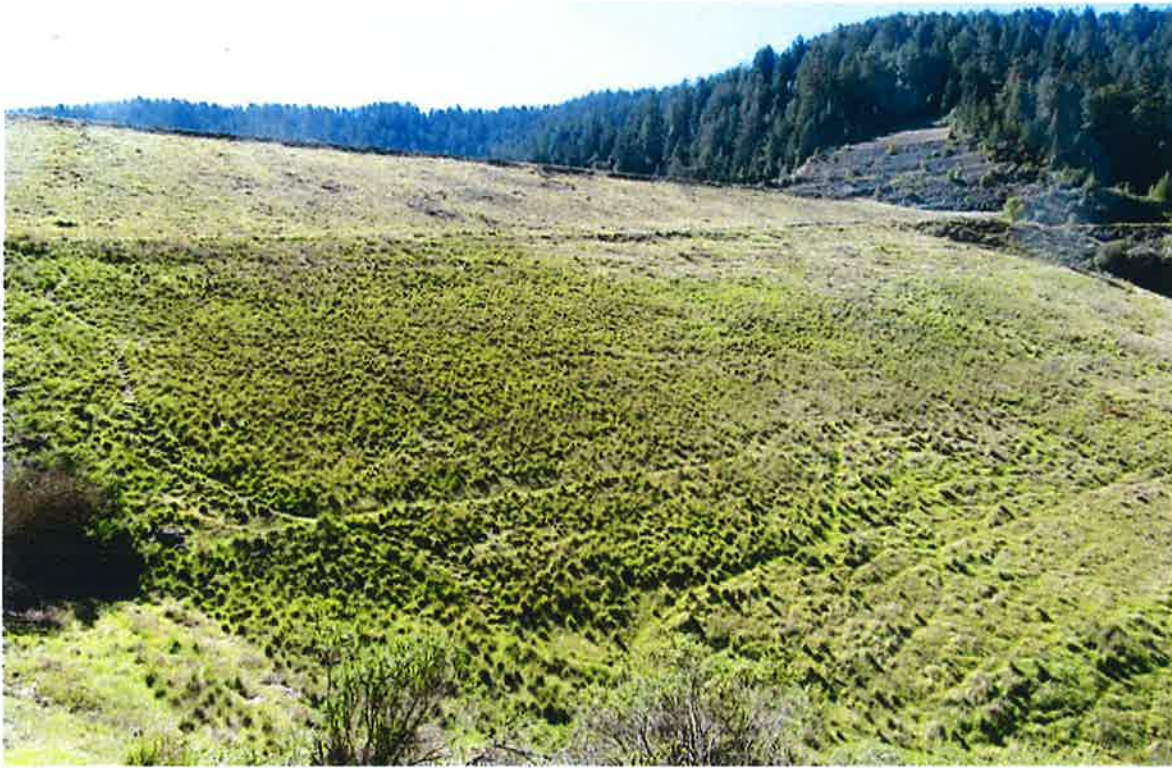
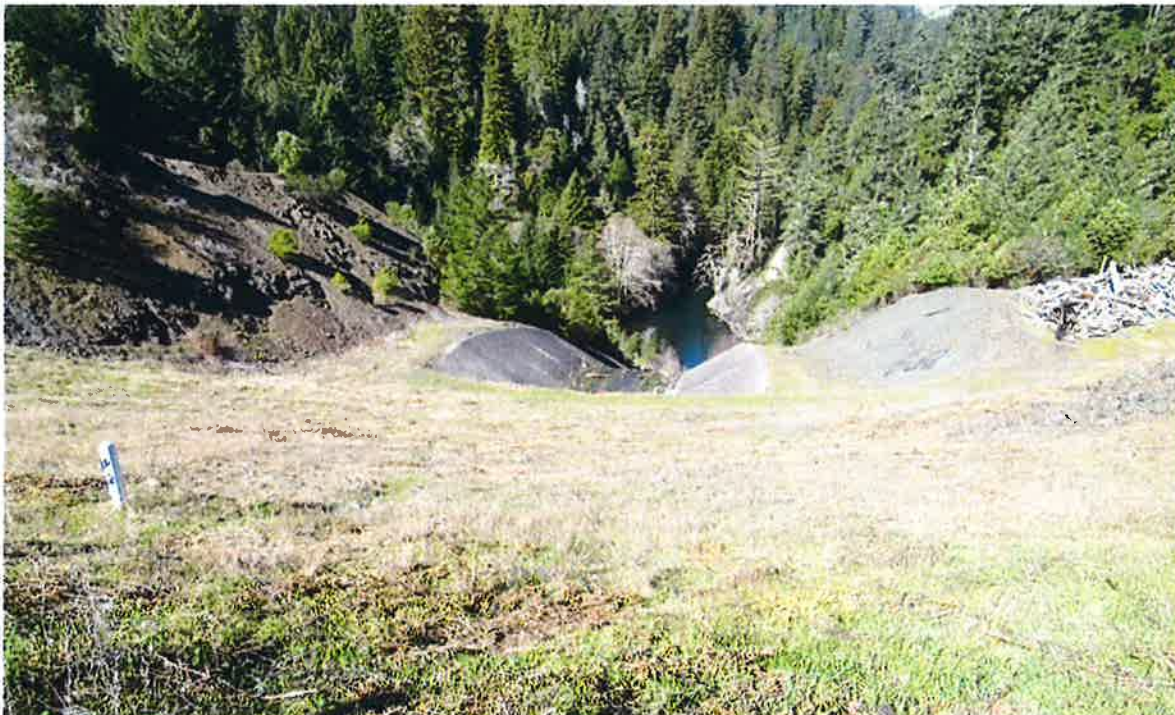
The downstream face of the main portion of the embankment, above, and the downstream face of the embankment above the original spillway, below. Vegetation control remains excellent.

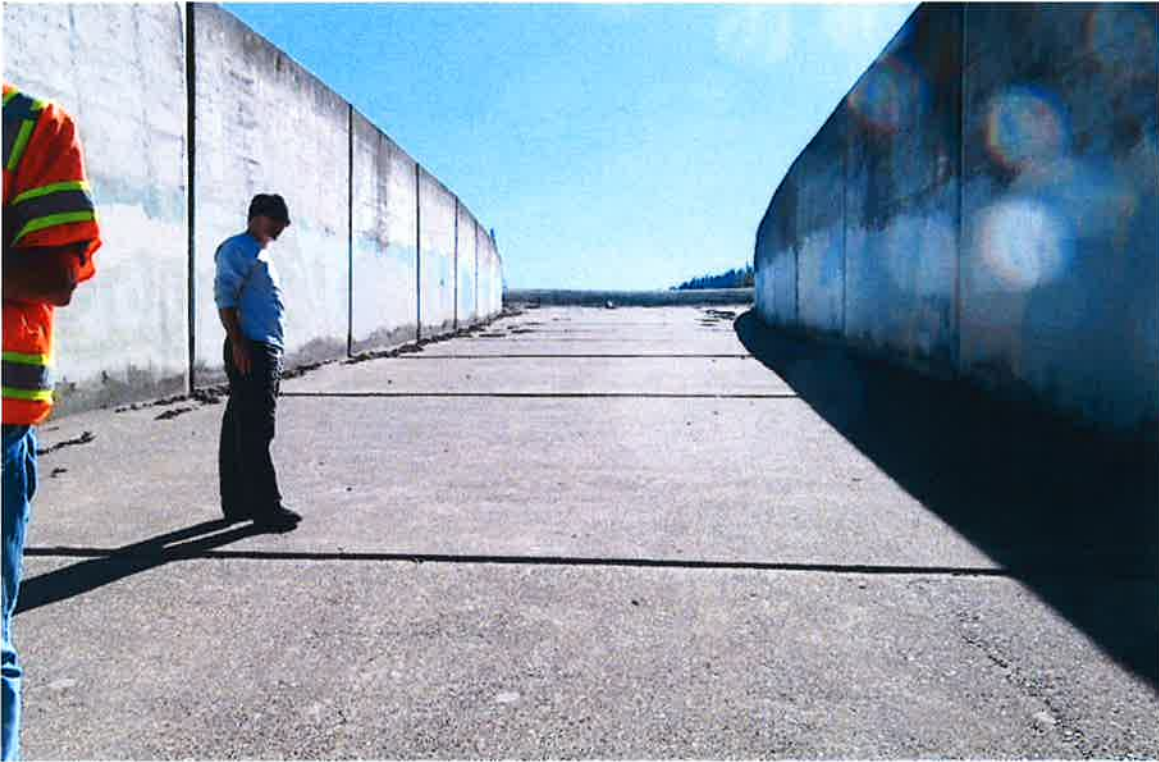
The upper half of the concrete spillway chute was inspected and found to be in generally very good condition (above). A small area of eroded concrete on the upper right invert, circled in the bottom photograph, should be repaired to prevent further damage.

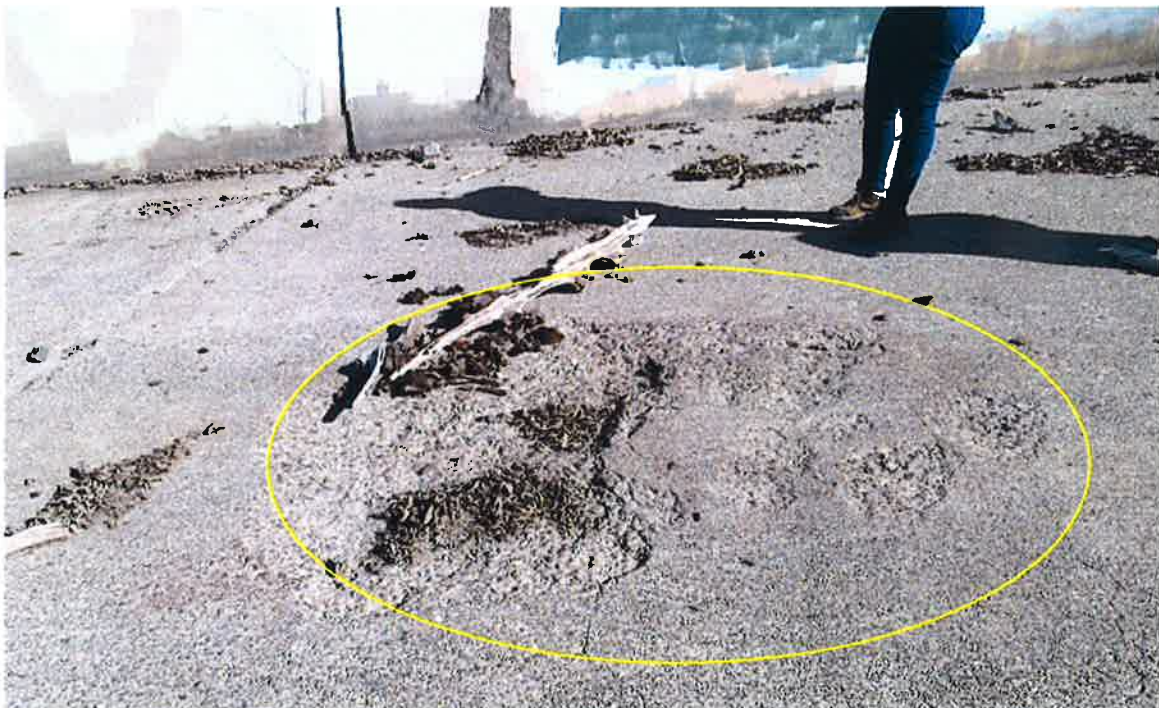
Overall care and maintenance of the dam and appurtenances is excellent.
 The large redwood log that had drifted into and was caught on the right side of the concrete spillway control weir was removed as requested.
 A small area of eroded concrete on the upper right invert should be repaired to prevent further damage.

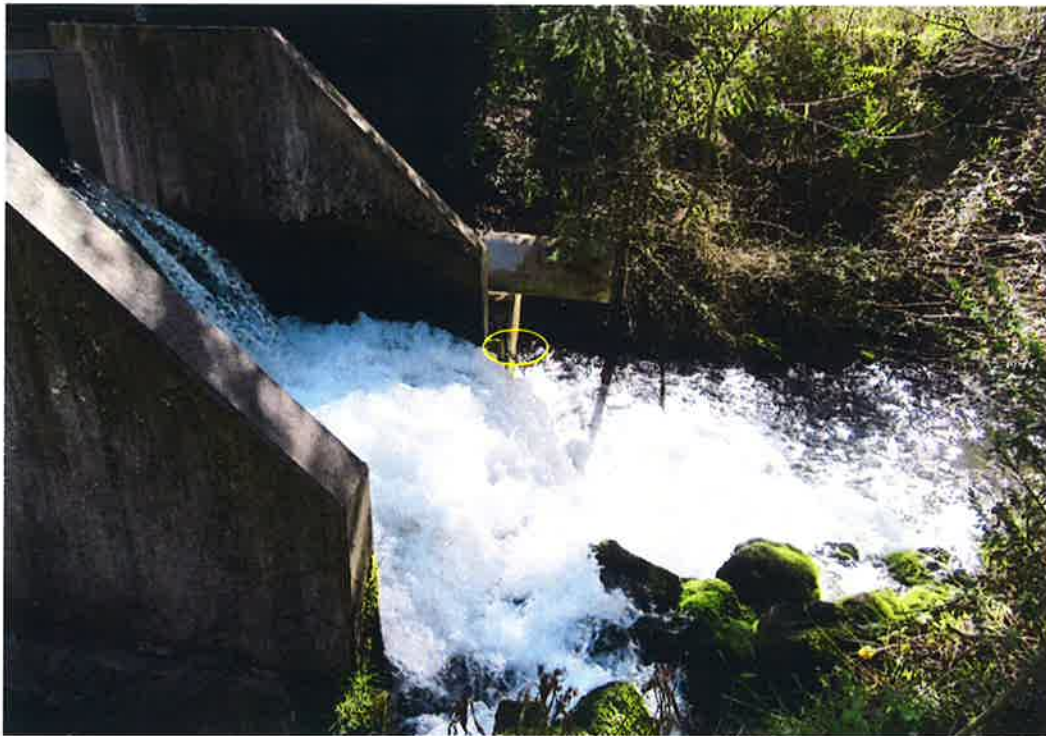
No evidence of seepage was observed along the downstream face, abutments, or groins. Seepage from the single toe drain was estimated to be approximately 25 gpm at the 90-degree V-notch weir.

Seepage at all locations was clear, and within historical values. Toe drain seepage measured at the 90-degree V-notch weir is greatly influenced by rainfall and storm water runoff, and has reached values as high as 420 gpm following large storm events.

Seepage from the toe drain was estimated to be approximately 25 gpm at the 90-degree V-notch weir (circled above). There was approximately 12 gpm seepage from the 60" diameter upper level outlet pipe, and seepage from both the left and right collar drains for the upper level outlet discharge were estimated to be about 1/2 gpm from each drain (circled below).

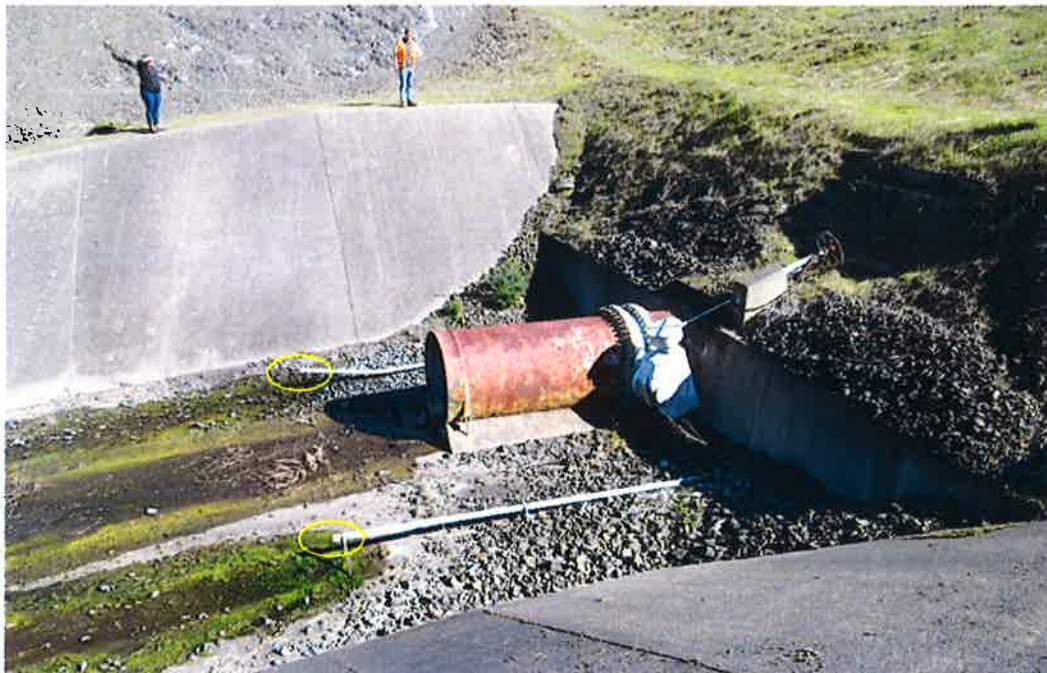
There was approximately 12 gpm seepage from the 60" diameter upper level outlet outfall pipe, and seepage from both the left and right collar drains for the upper level outlet discharge were estimated to be about 1/2 gpm from each drain.
