STATE OF CALIFORNIA
CALIFORNIA NATURAL RESOURCES AGENCY
DEPARTMENT OF WATER RESOURCES
DIVISION OF SAFETY OF DAMS

INSPECTION OF DAM AND RESERVOIR IN CERTIFIED STATUS

Name of Dam Lagunitas Dam No. 33-2 County Marin
 Type of Dam ERTH Type of Spillway Concrete weir with steel and timber flume
 Water is 0.1 feet above the spillway crest and 7.4 feet below the dam crest.
 Weather Conditions Clear and mild
 Contacts Made Lucy Croy and Conner Pollard during the inspection
 Reason for Inspection Periodic Evaluation

Inspected by J. Lowe
 Date of Inspection 14 February 2018
 Date of Report 16 February 2018

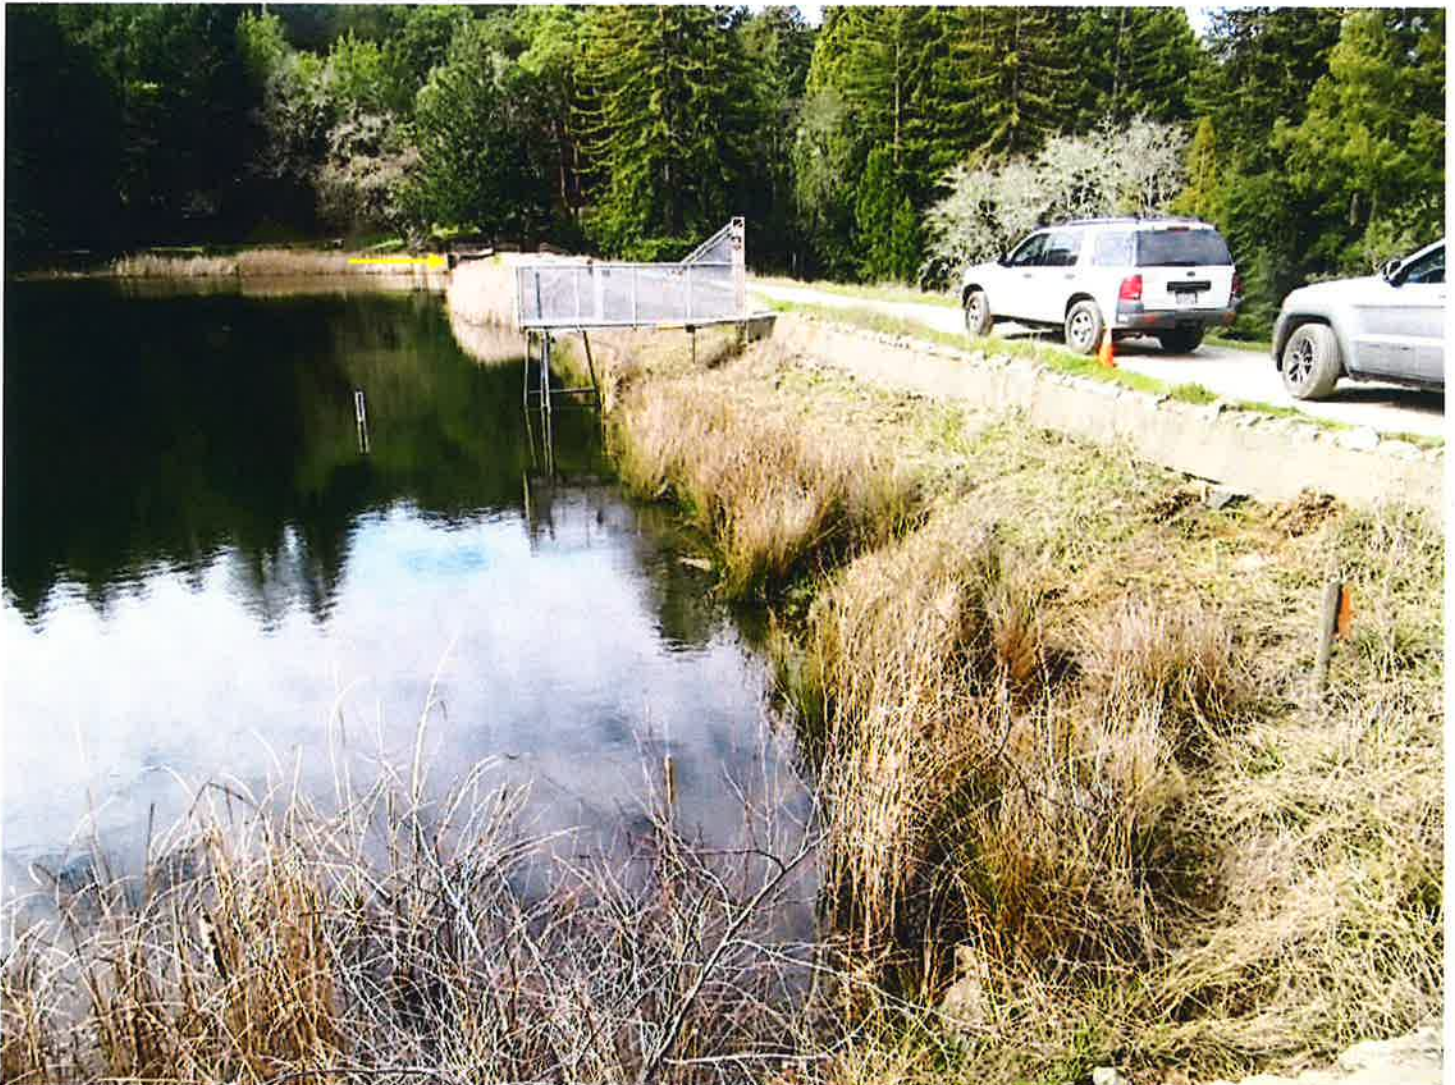
As discussed in the inspection reports dating back to April 2016, vegetation control along the upstream face needs improvement, and numerous small trees, bushes, and other woody vegetation that have accumulated along the waterline and upstream groins require removal.

The upstream face looking in the direction of the spillway entrance (indicated by arrow). As discussed in the inspection reports dating back to April 2016, vegetation control along the upstream face needs improvement, and numerous small trees, bushes, and other woody vegetation that have accumulated along the waterline and upstream groins require removal.

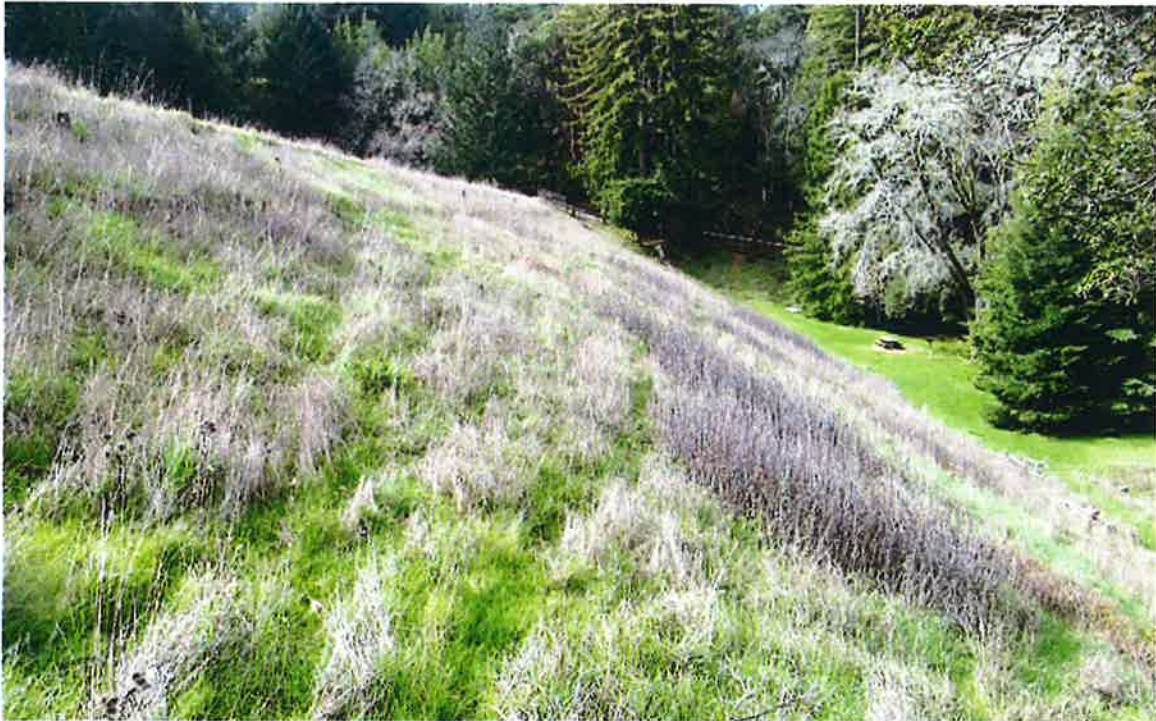
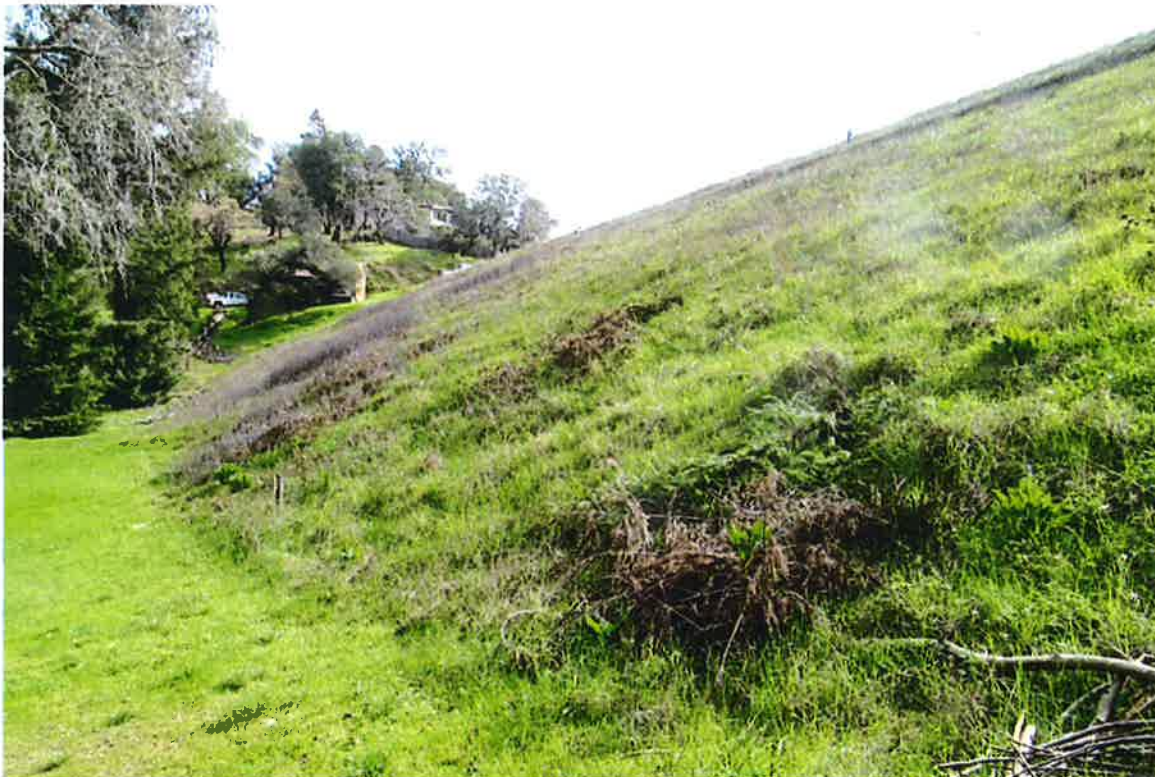
The downstream face looking towards the left abutment, above, and looking towards the right abutment, below. Vegetation control along the downstream face is quite good.

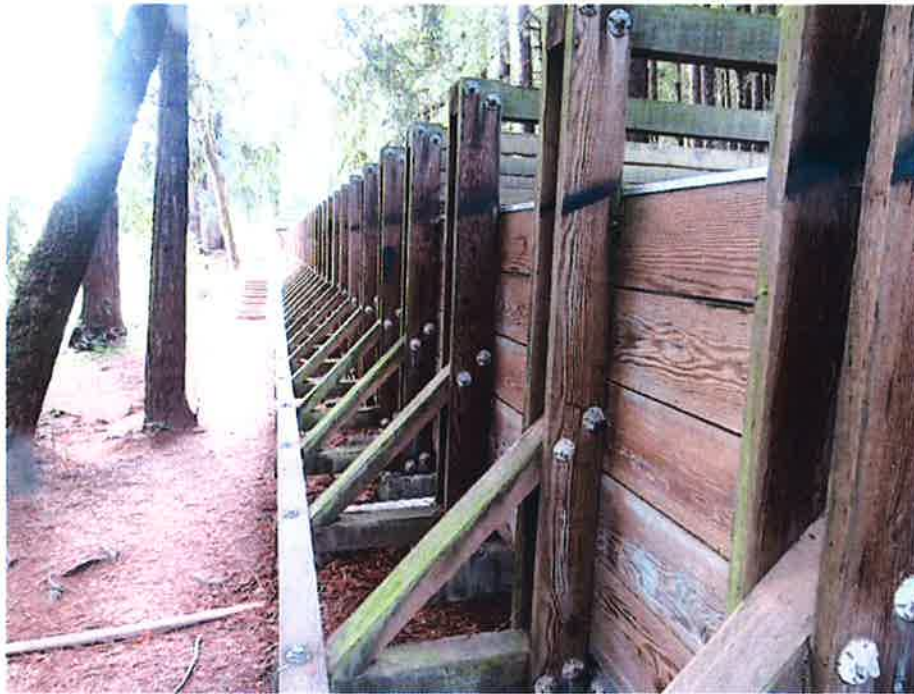
Pressure treated timbers supporting the flume appear to be in good condition, as does the stainless-steel flume sheathing, the under flume supports, and flume foundation connections.

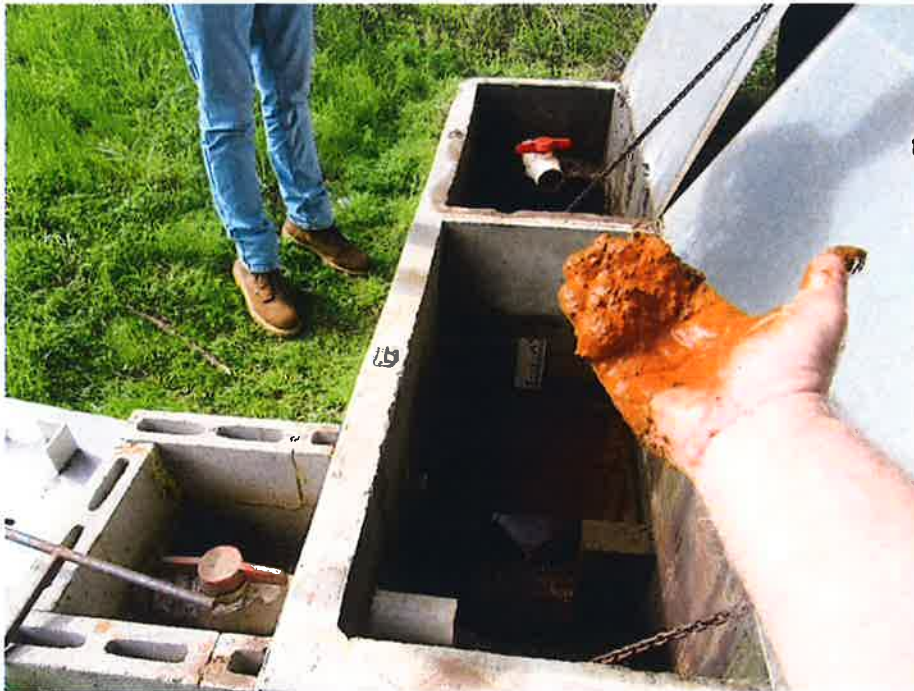
The seepage collection box has a significant accumulation of sediment. I asked Ms. Croy to ascertain the source of the sediment, and recommended running a sieve analysis to better identify the materials collected. The concern is that the sediment may be the result of internal erosion. I also asked that the box be well cleaned to facilitate monitoring for additional sediment accumulation.
