INSPECTION OF DAM AND RESERVOIR IN CERTIFIED STATUS

Name of Dam Seeger (Nicasio) Dam No. 33-8 County Marin
 Type of Dam ERTH Type of Spillway Concrete side channel ogee
 Water is 4.8 feet below the spillway crest and 19.8 feet below the dam crest.
 Weather Conditions Clear and mild
 Contacts Made Lucy Croy, Conner Pollard, and Carl Sanders during the inspection
 Reason for Inspection Periodic Evaluation

Inspected by J. Lowe
 Date of Inspection 13 February 2018
 Date of Report 16 February 2018

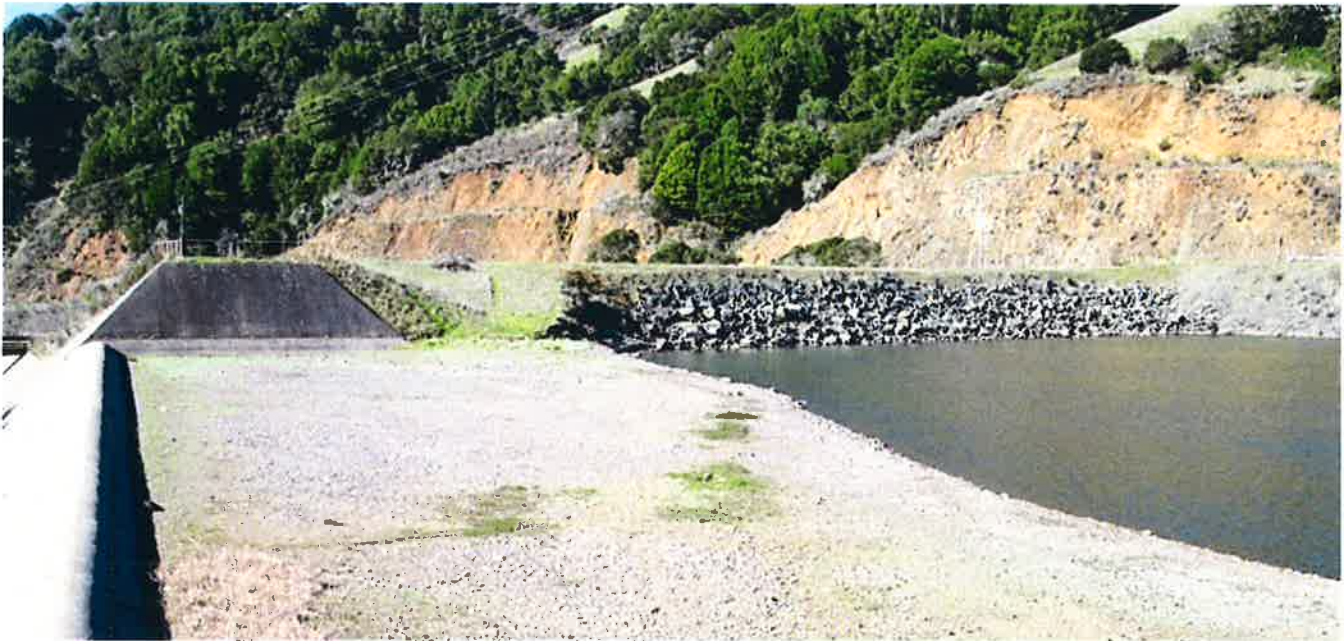
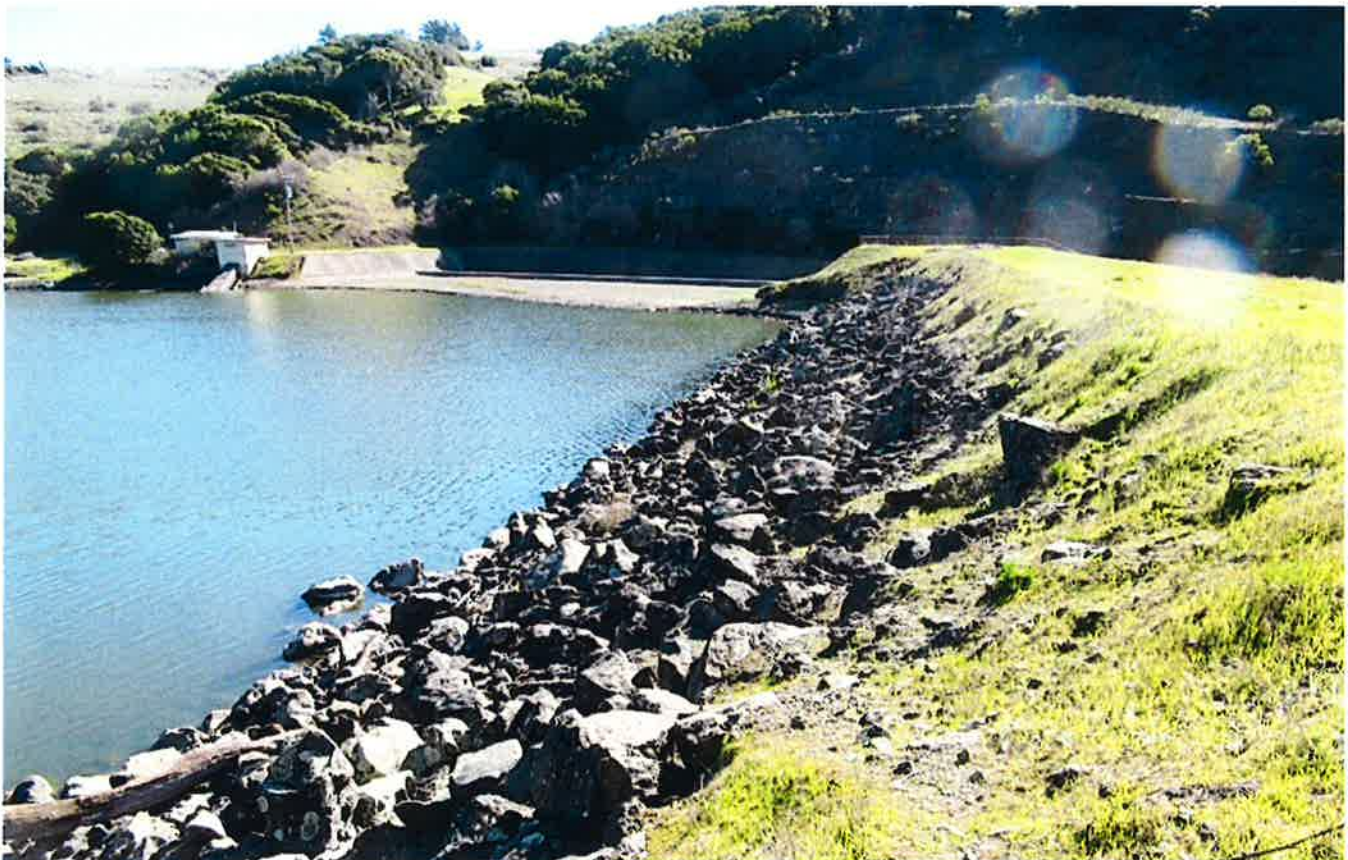
The upstream face is armored with large boulder riprap that remains in generally satisfactory condition, but that in limited areas may require additional material to compensate for normal wear and tear.

The upstream face as seen from the spillway entrance, above, and as seen looking towards the spillway entrance, below. The upstream face is armored with large boulder riprap that remains in generally satisfactory condition, but that in limited areas may require additional material to compensate for normal wear and tear.

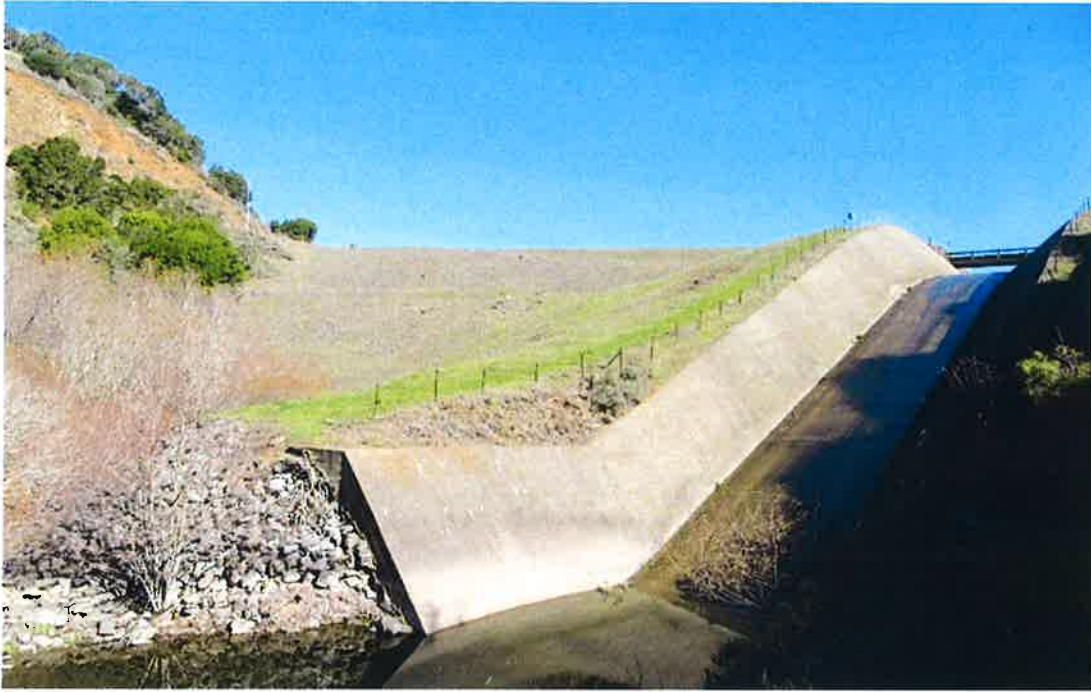
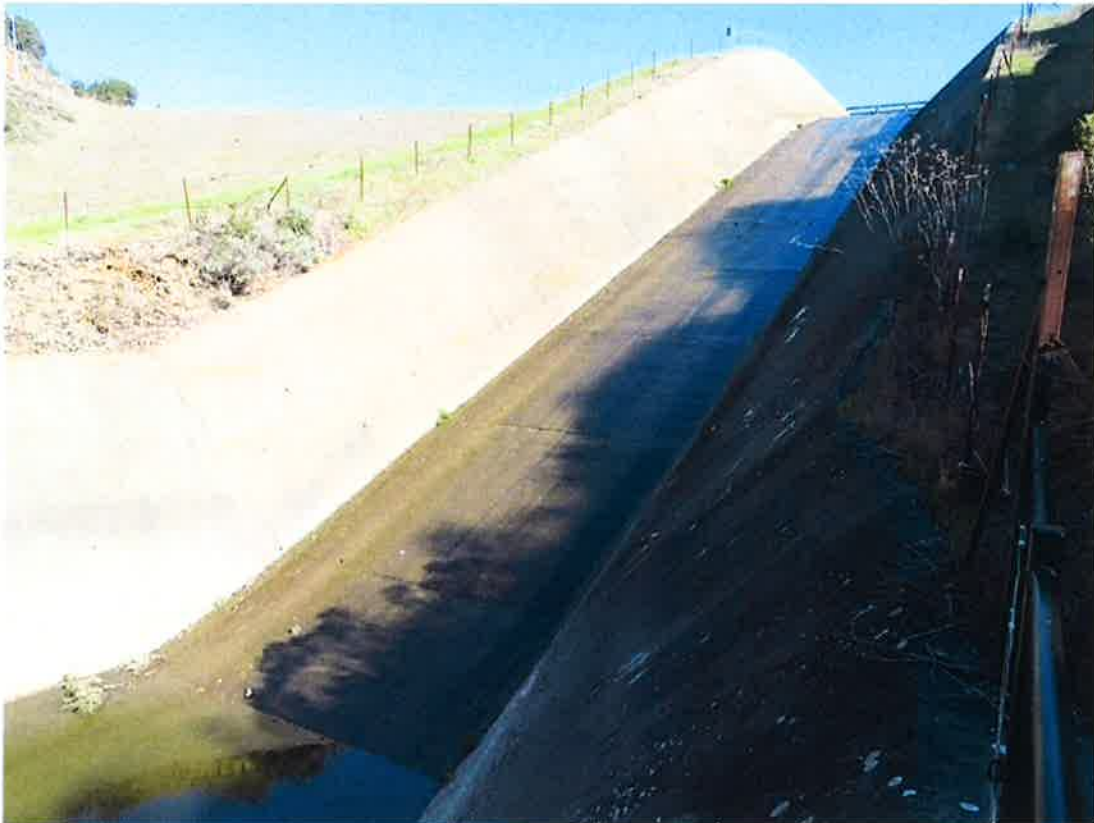
The downstream face and lower spillway, above, and a closer look at the lower spillway, below. The owner has contracted with AECOM to perform a detailed evaluation of the concrete spillway. I asked Ms. Croy to forward a copy of AECOM's spillway report to DSOD.

The owner has contracted with AECOM to perform a detailed evaluation of the spillway. I asked Ms. Croy to forward a copy of AECOM's spillway report to DSOD.

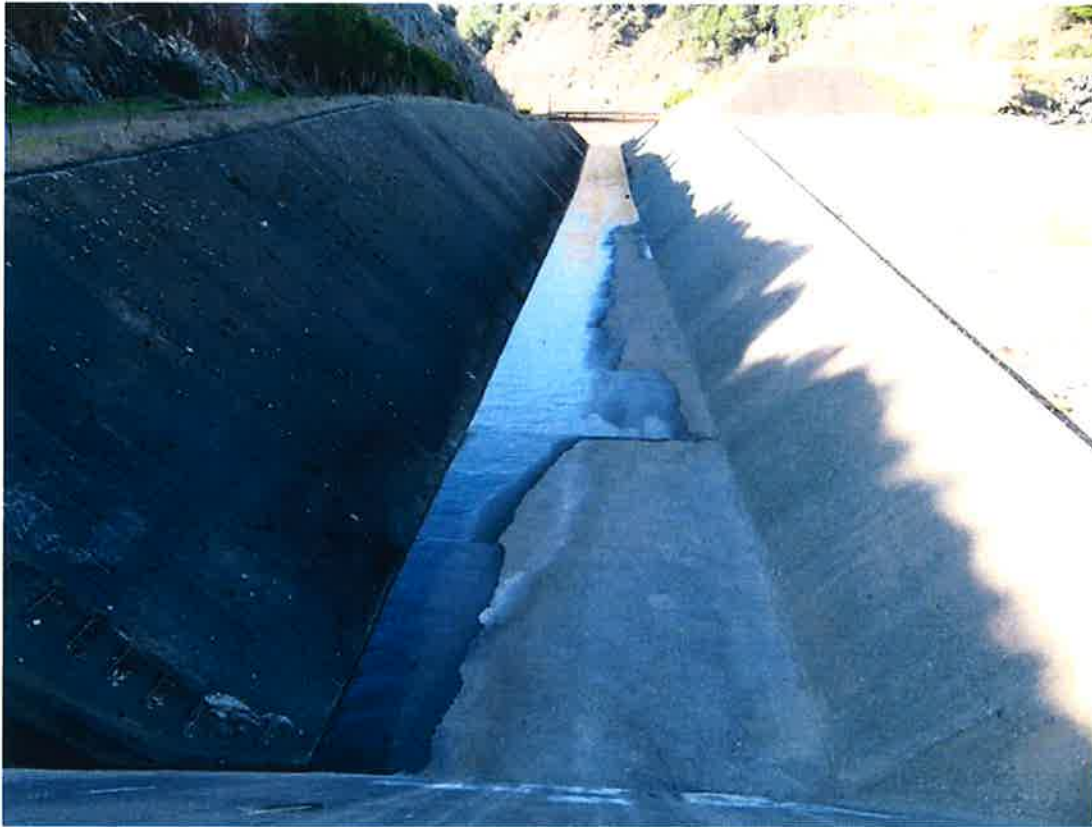
The upper spillway as viewed from the upstream outlet control access road.

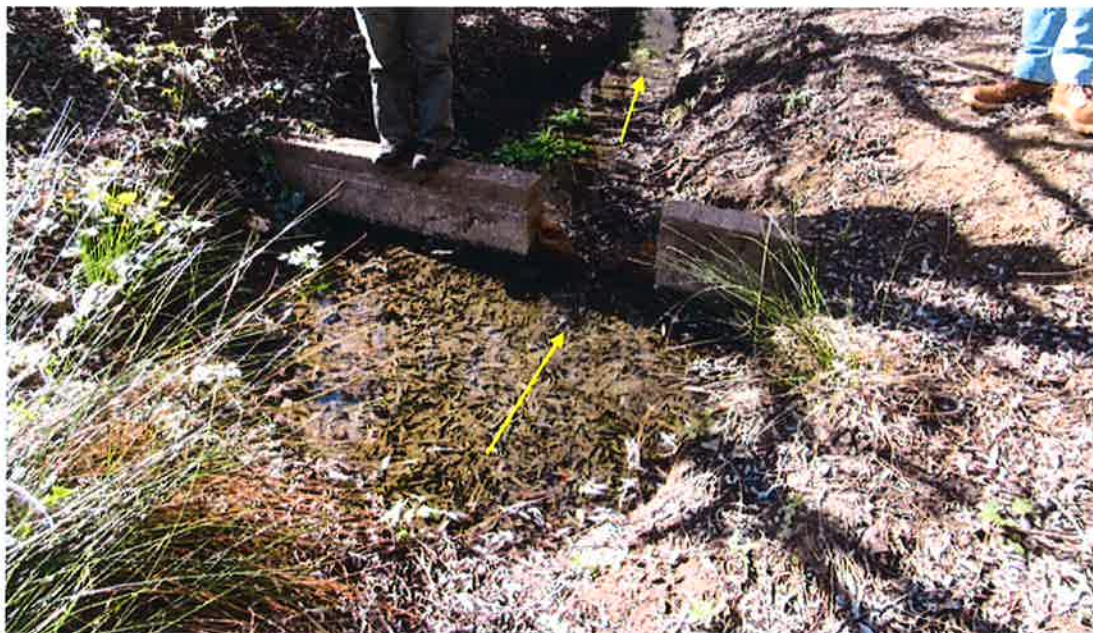
Clear seepage flow at the toe weir was roughly 7 gpm, and is within historical values. Normal peak seepage, in the range of 40 or more gpm, quickly falls to near zero following the secession of winter storms.
