INSPECTION OF DAM AND RESERVOIR IN CERTIFIED STATUS

Name of Dam Phoenix Lake Dam No. 33-3 County Marin
 Type of Dam ERTH Type of Spillway Concrete weir and chute
 Water is 0.1 feet above the spillway crest and 15.1 feet below the dam crest.
 Weather Conditions Clear and mild
 Contacts Made Lucy Croy and Conner Pollard during the inspection
 Reason for Inspection Periodic Evaluation

Inspected by J. Lowe
 Date of Inspection 14 February 2018
 Date of Report 16 February 2018

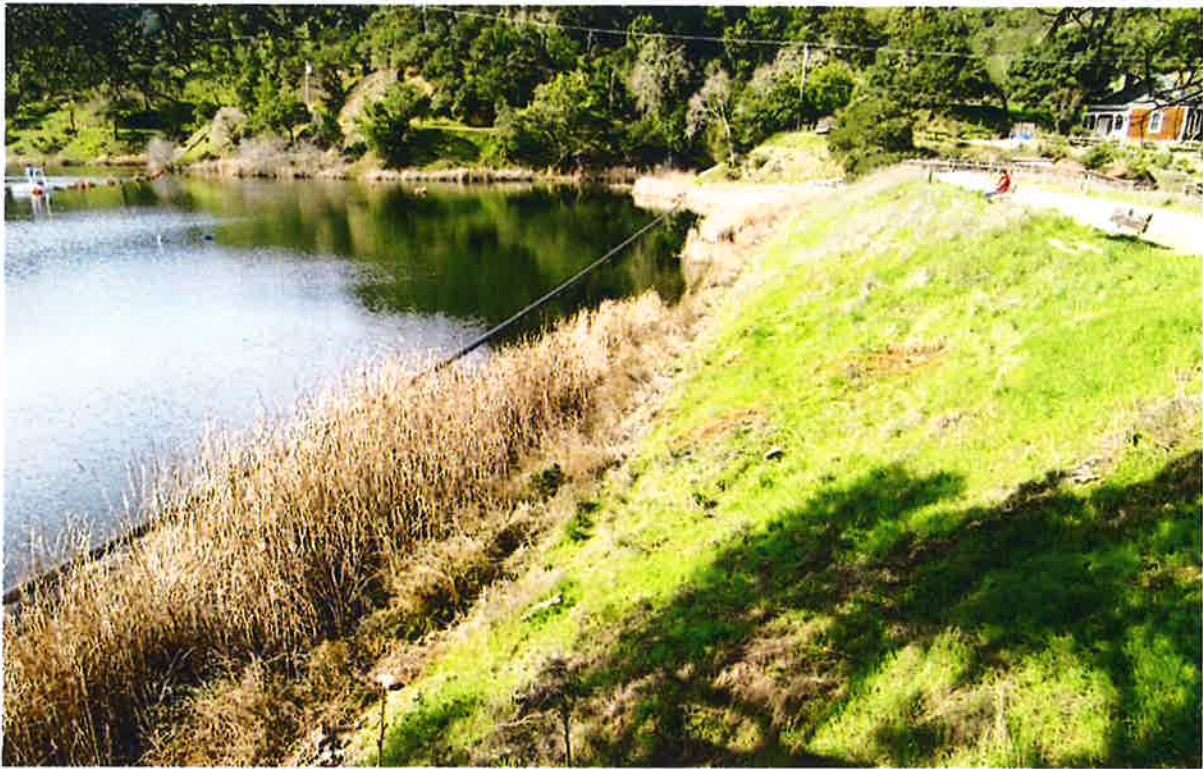
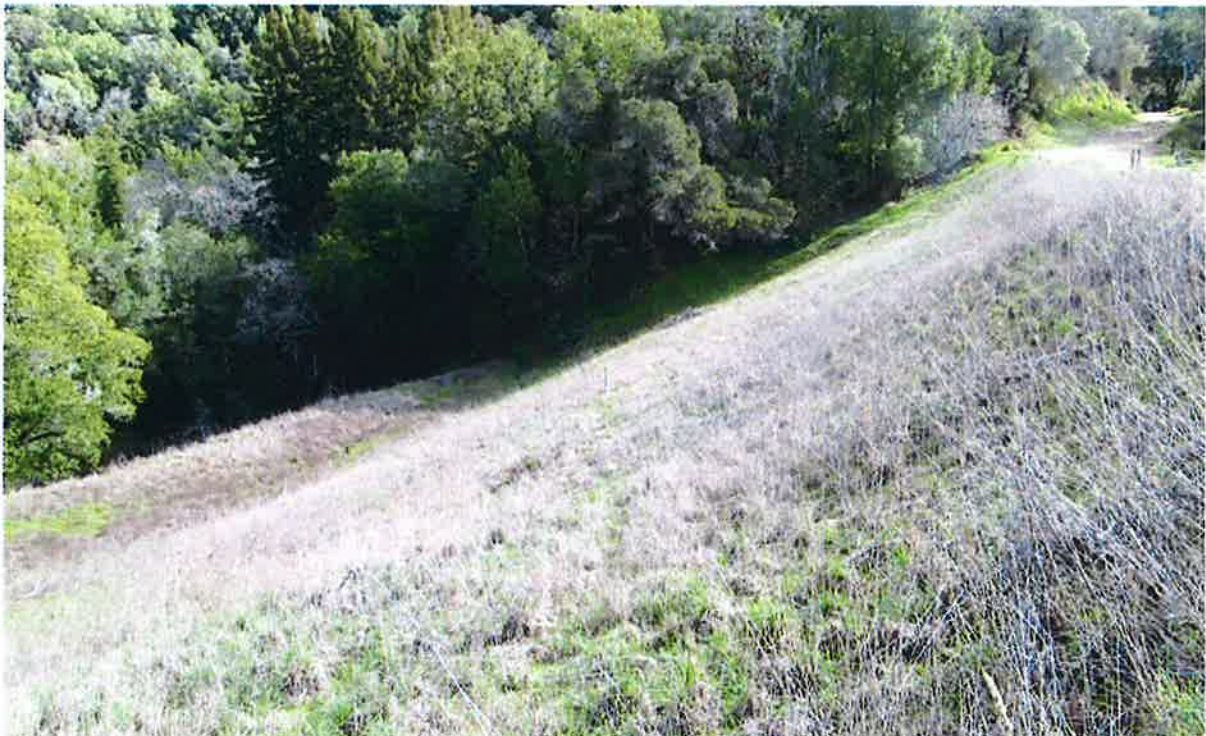
The upstream face looking towards the spillway entrance, above. Tule and cattails along the waterline must also be cleared. Vegetation control along the downstream face, below, is quite good.

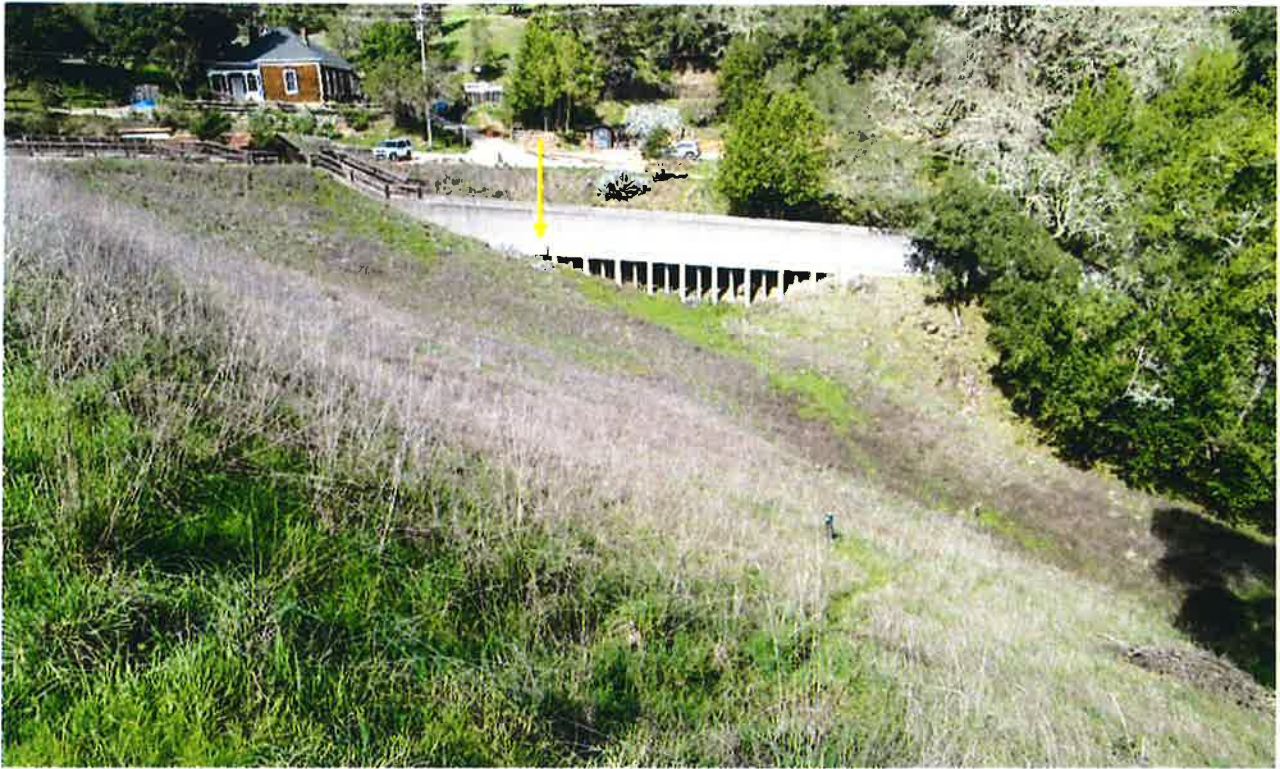
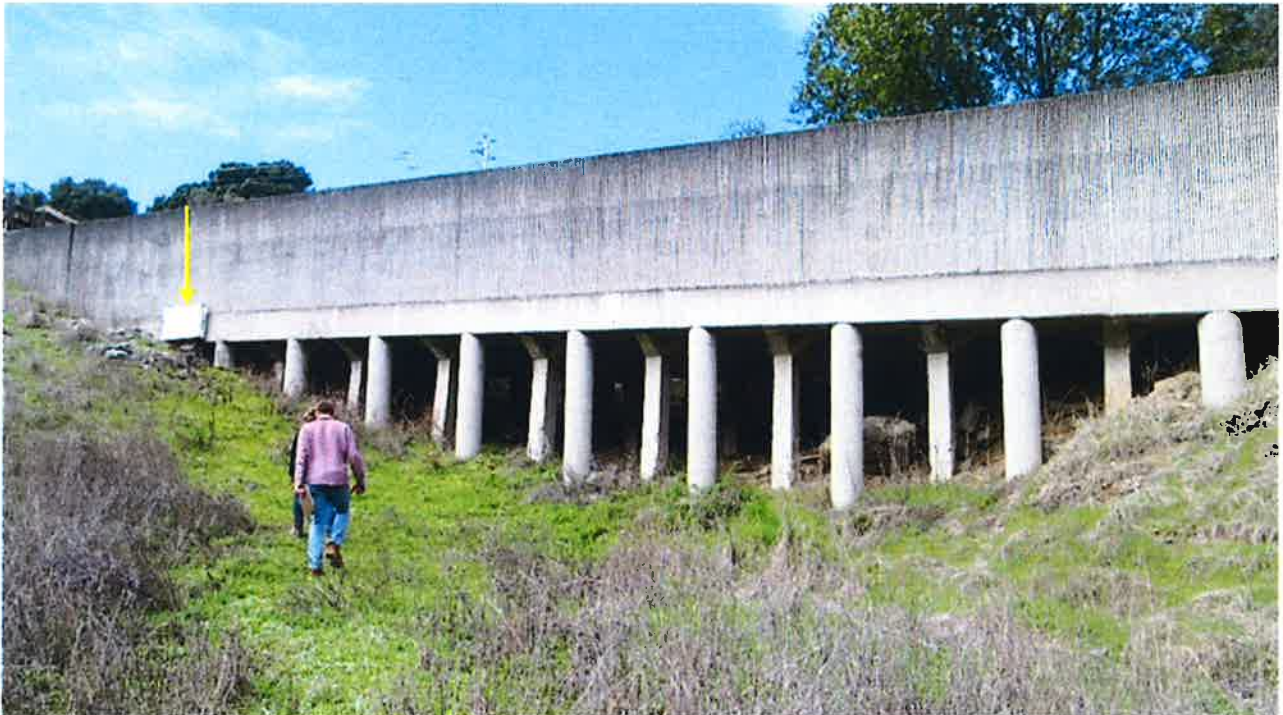
Spillway crack data covers the period between December 2005 and June 2017. Crack monitors indicate horizontal displacements are cyclic, though following recent recalibration of the extensometers and data logger in late 2015, reported displacements have increased many fold and are now in the 25 mm to 35 mm range. The reported displacements are inconsistent with observations in the field, and I asked Ms. Croy to continue to evaluate the performance of both the spillway and the spillway crack monitoring instrumentation.

Looking across the downstream face towards the raised spillway section, above, with a closer look at the raised spillway below. The location of the crack within the spillway is indicated in both photographs.

The dam appears to be performing satisfactorily, and no additional instrumentation is believed necessary at this time, but careful and consistent monitoring of the spillway crack is imperative, and any indication of potentially adverse displacements must be reported to DSOD immediately. I recommended that the owner thoroughly evaluate the spillway for static and seismic stability, and to make whatever repairs or improvements are necessary to maintain the spillway in a safe condition for operation.

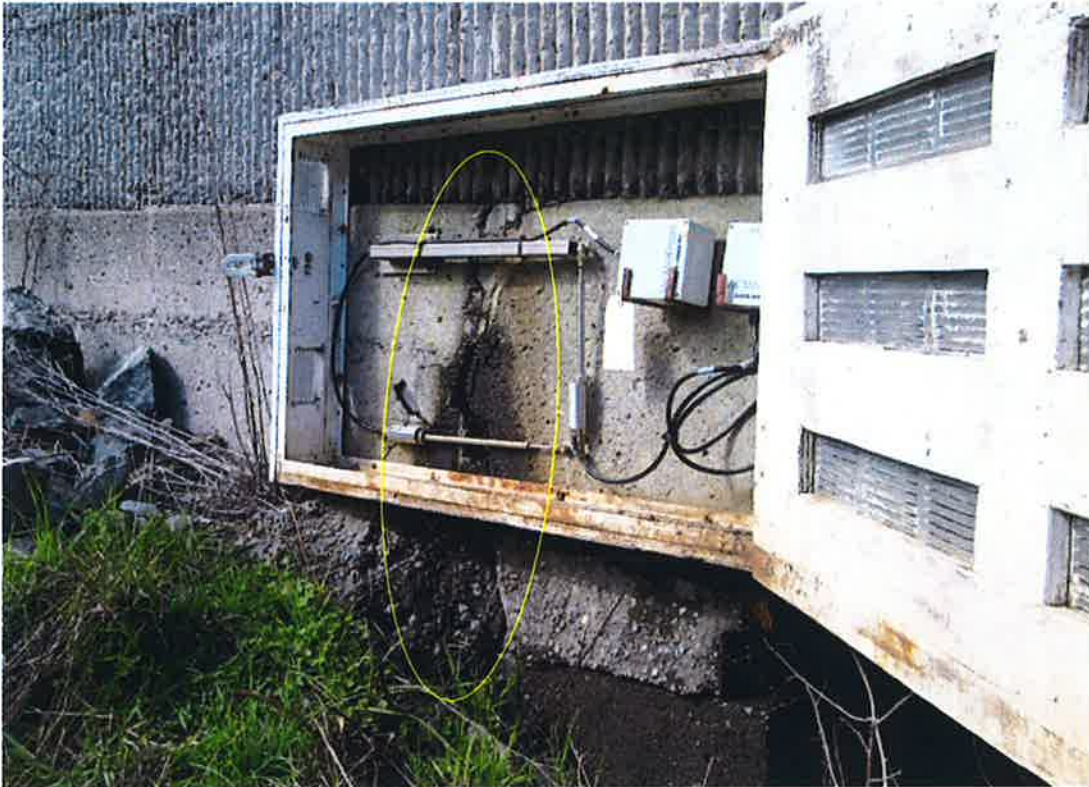
A crack within the spillway is presently being monitored using electronic extensometers, but the data generated appears to be unreliable. I recommended the owner place inexpensive crack movement indicators across the crack so that the crack can be monitored while they are working to sort out their instrumentation issues. See page below the spillway crack indicates a fair amount of leakage through the crack. I would estimate that several gpm or more is leaking through the spillway crack.

The spillway crack exposed behind the instrumentation box. I recommended the owner place inexpensive crack movement indicators across the crack so that the crack can be monitored while they are working to sort out their instrumentation issues.

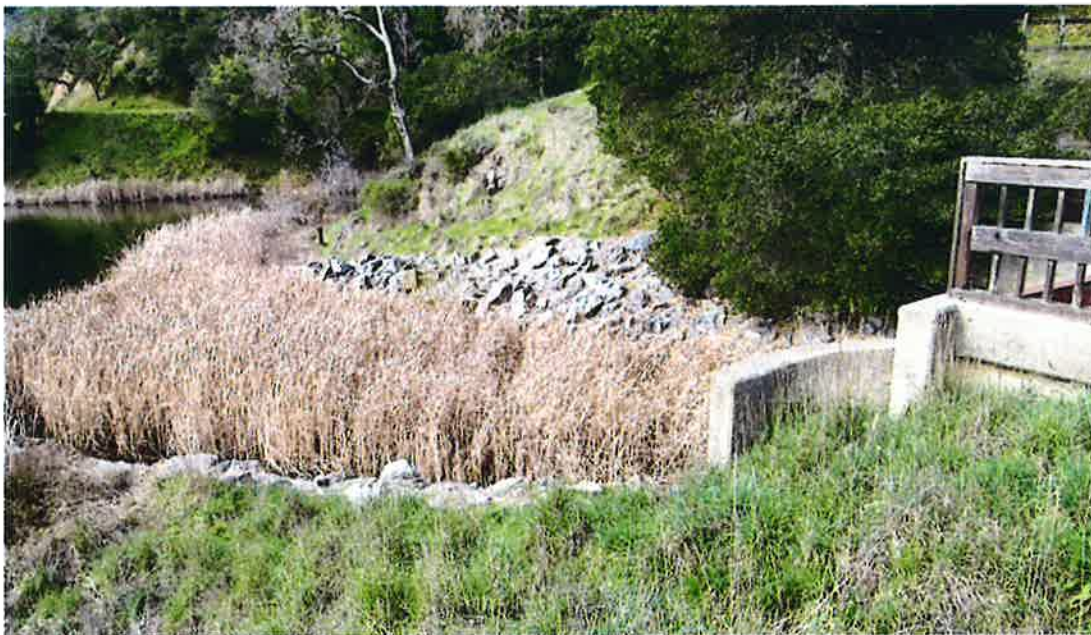
The spillway entrance is occupied with dormant tules and cattails which require removal. I directed Ms. Croy to have the tules and cattails removed as soon as possible.
