**INSPECTION OF DAM AND RESERVOIR IN CERTIFIED STATUS**

Name of Dam Soulajule Dam No. 33-9 County Marin  
 Type of Dam ERTH Type of Spillway Concrete weir and chute  
 Water is 6 feet below the spillway crest and 18 feet below the dam crest.  
 Weather Conditions Clear and mild  
 Contacts Made Lucy Croy, Conner Pollard, and Carl Sanders during the inspection  
 Reason for Inspection Periodic Evaluation

Inspected by J. Lowe  
 Date of Inspection 13 February 2018  
 Date of Report 16 February 2018

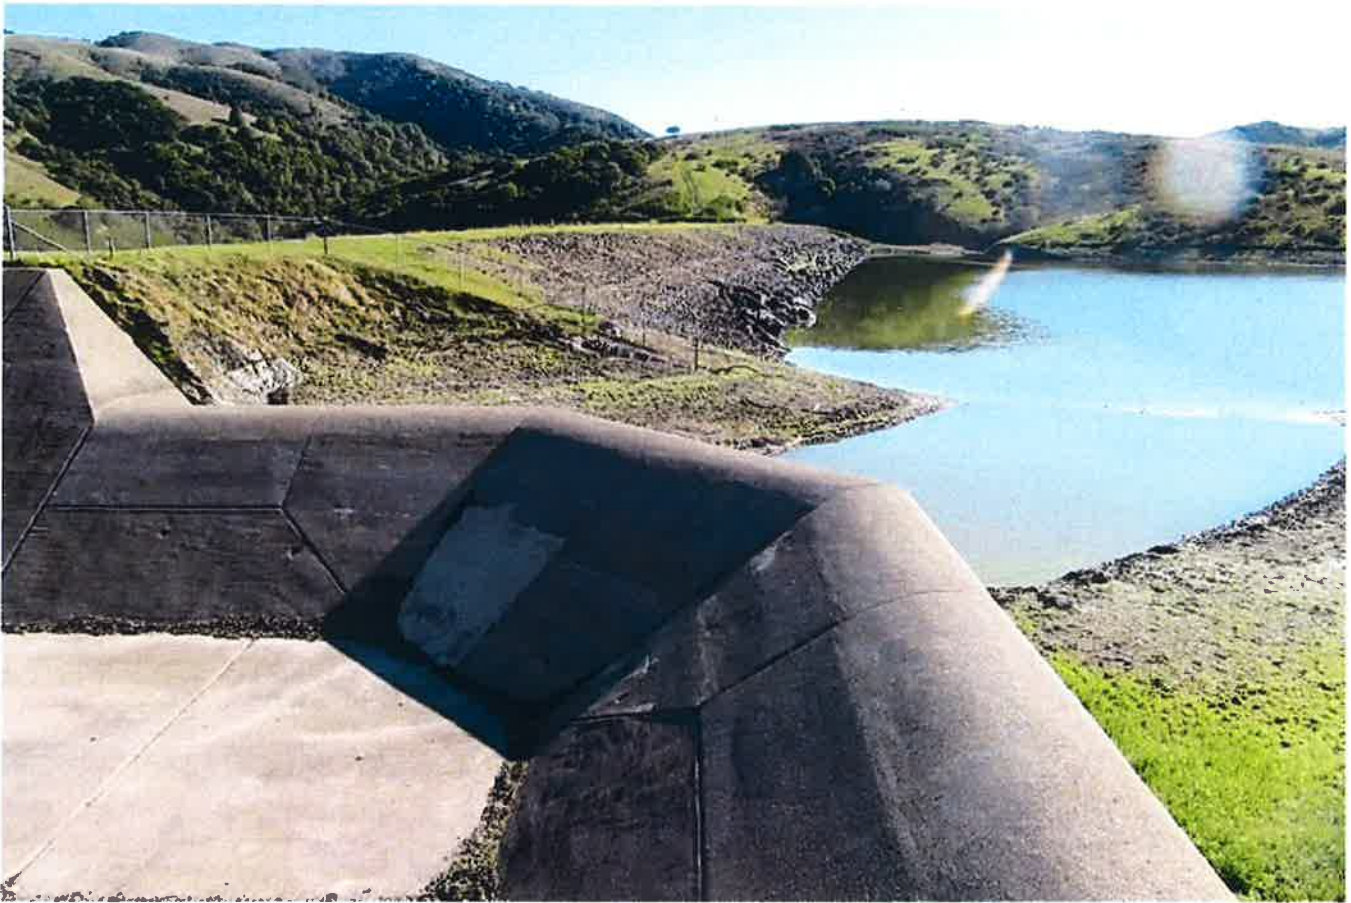
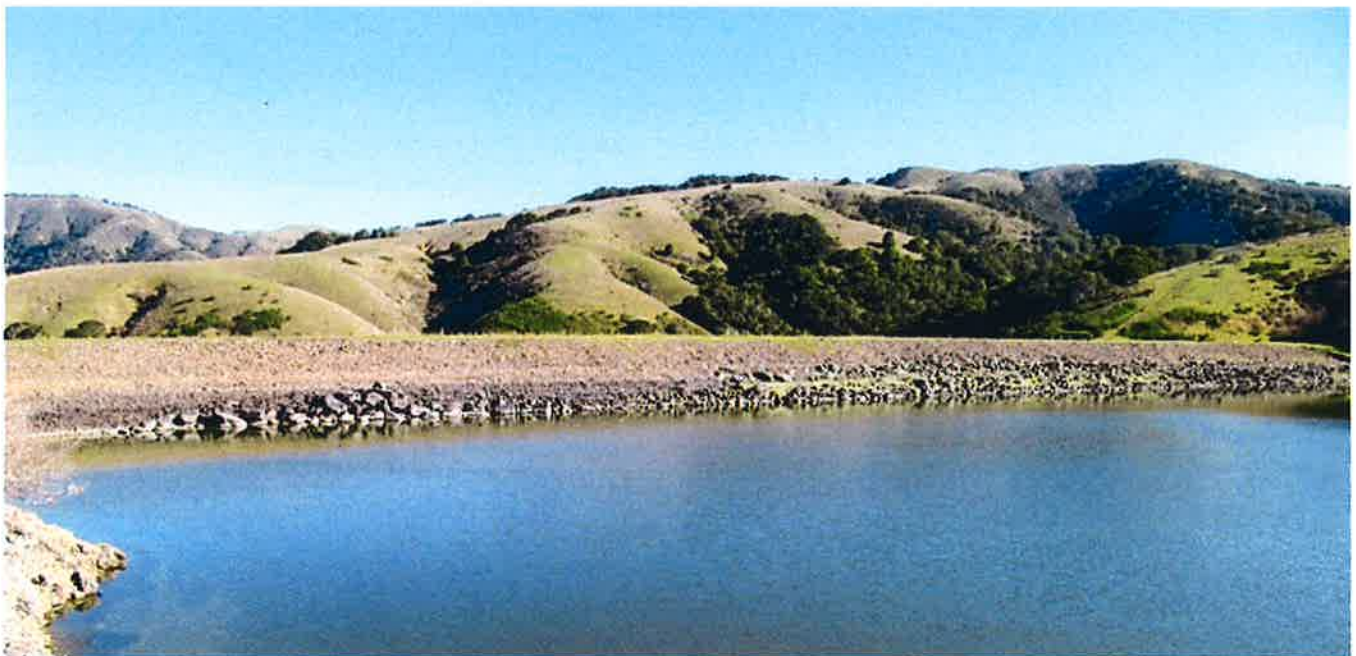
<u>Dam</u>	<p>The visible portions of the upstream face, crest, downstream face, and abutments are in satisfactory condition, with no indication of surficial distress or instability. The upstream riprap armor remains in satisfactory condition and continues to provide reasonably adequate protection against wave action.</p> <p>Overall care and maintenance of the dam and appurtenances continues to improve, and vegetation control is now excellent. The embankment is covered with ankle tall grass and other low ground cover that protect against erosion without hindering access for inspection and monitoring for seepage and other defects.</p> <p>Rodent control remains satisfactory and only minor indications of burrowing are evident along portions of the crest.</p>
<u>Spillway</u>	<p>The approach, control section, and exit channel were open and clear; a polyethylene log boom was in place several hundred feet upstream of the dam. Due to safety concerns, the spillway could not be entered for close examination, but no significant flaws were noted from our safe viewing locations. The owner has contracted with AECOM to perform a detailed evaluation of the concrete spillway. I asked Ms. Croy to forward a copy of AECOM's spillway report to DSOD.</p> <p>The current design storm, prepared in 1978, is for a 10,000-year return period producing 15,223 cfs (~814 cfs / sq mi) from the 18.7 square mile drainage area. The spillway capacity is ~17,300 cfs which is greater than the peak inflow. Total freeboard is 12 feet and the residual freeboard for the design storm is 3.3 feet. Freeboard is satisfactory.</p>

The upstream face as viewed from the spillway entrance, above, and as viewed from the upstream outlet control valves, below.

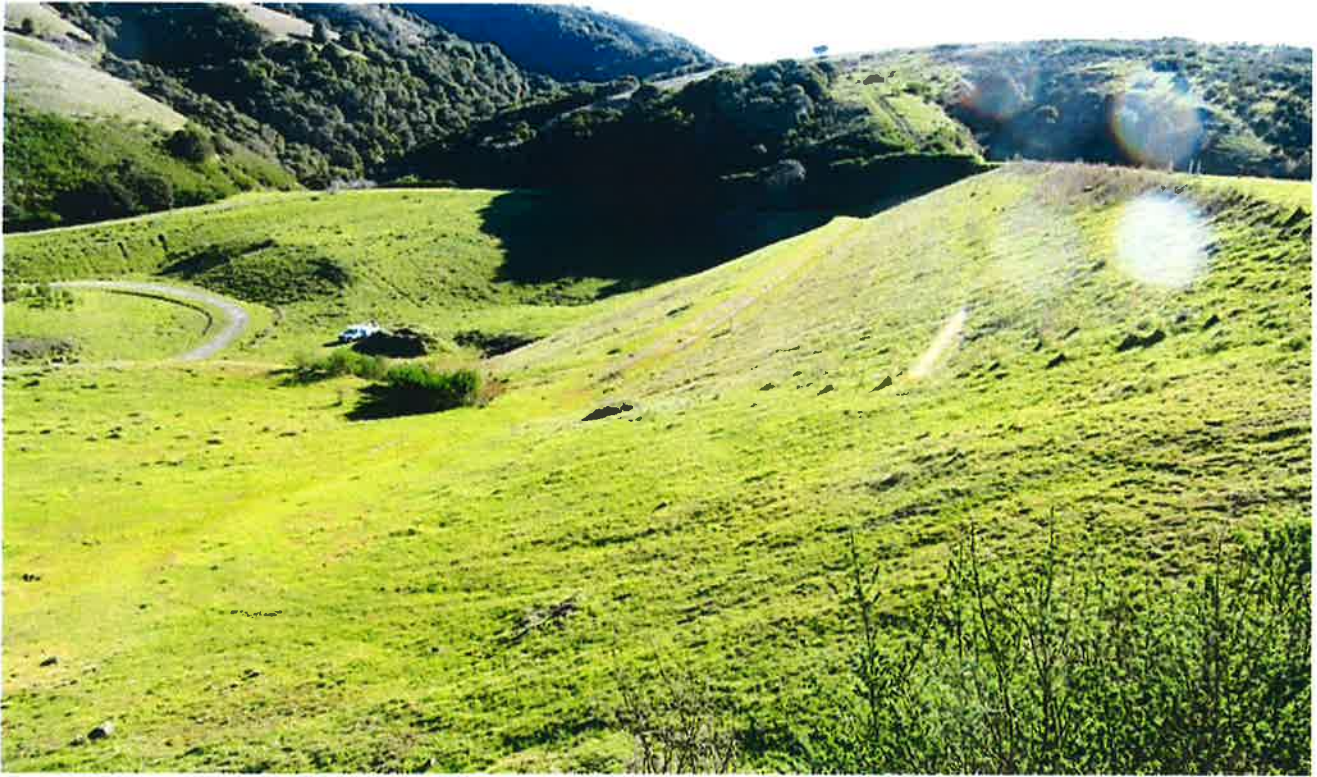
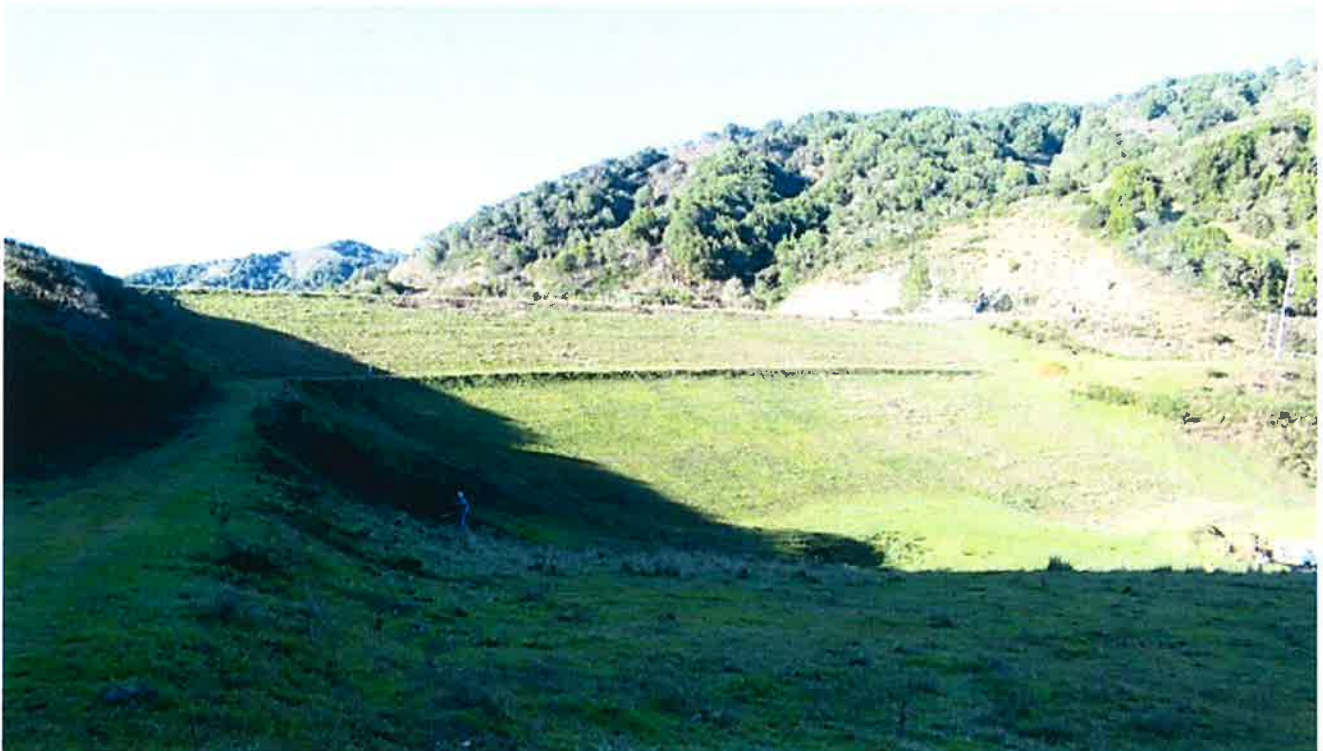
Overall care and maintenance of the dam and appurtenances continues to improve, and vegetation control is now excellent.

The downstream face as viewed from the right spillway abutment, above, and as viewed from the alternative access road along the right side of the dam, below. Vegetation control is excellent.

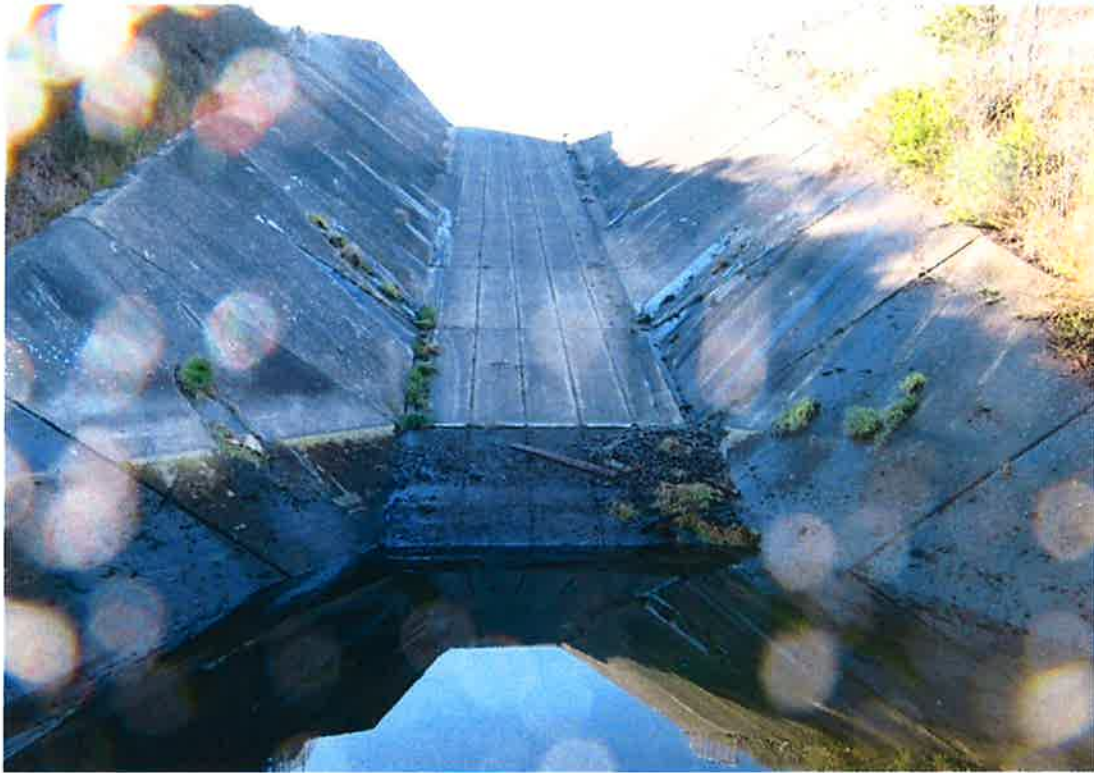
The owner was draining the spillway flip bucket in preparation for a detailed evaluation of the spillway by AECOM. I asked Ms. Croy to forward a copy of AECOM's spillway report to DSOD.

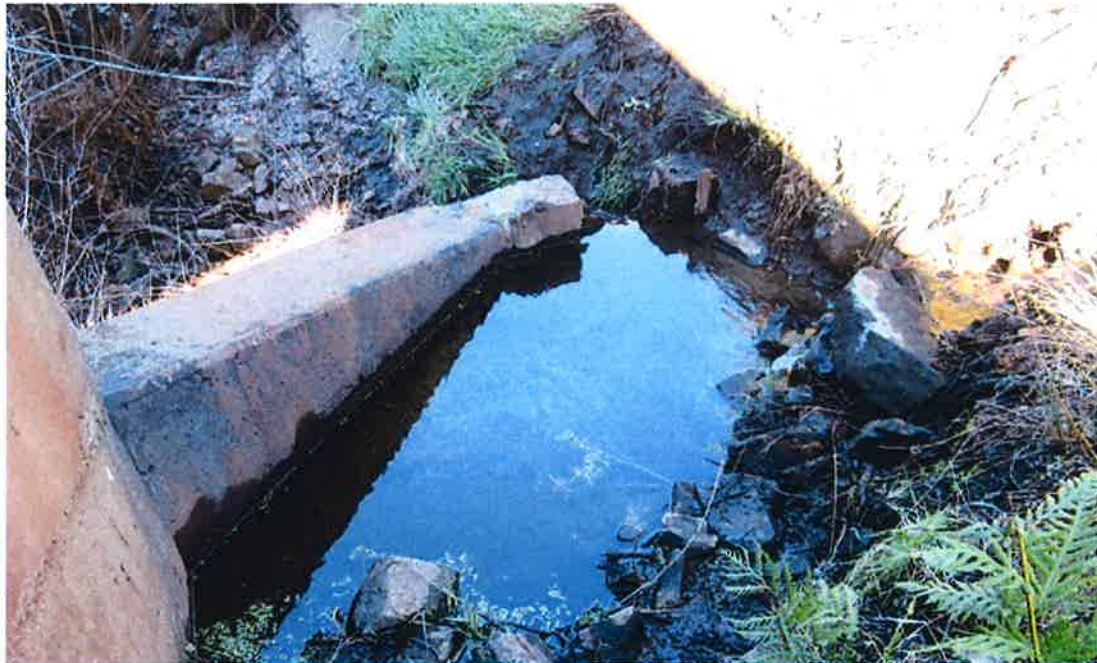
The seepage monitoring weir is located next to the right side of the outlet energy dissipating structure. Estimated flow was approximately 8 gpm, which remains within historical values. Clear seepage measured at the monitoring weir correlates closely to rainfall; in the absence of rainfall seepage drops to essentially zero.

Clear seepage measured at the monitoring weir correlates closely to rainfall; in the absence of rainfall seepage drops to essentially zero. Flow at the time of the inspection was approximately 8 gpm.
