STATE OF CALIFORNIA
CALIFORNIA NATURAL RESOURCES AGENCY
DEPARTMENT OF WATER RESOURCES
DIVISION OF SAFETY OF DAMS

INSPECTION OF DAM AND RESERVOIR IN CERTIFIED STATUS

Name of Dam Alpine Dam No. 33 County Marin
 Type of Dam Gravity Type of Spillway Eight siphons
 Water is 0.13 feet above the spillway crest and 7.87 feet below the dam crest.
 Weather Conditions Sunny and warm
 Contacts Made Lucy Croy, Kristin Arnold, and Jonathan Fouche (Marin Municipal Water District)
 Reason for Inspection Annual Inspection

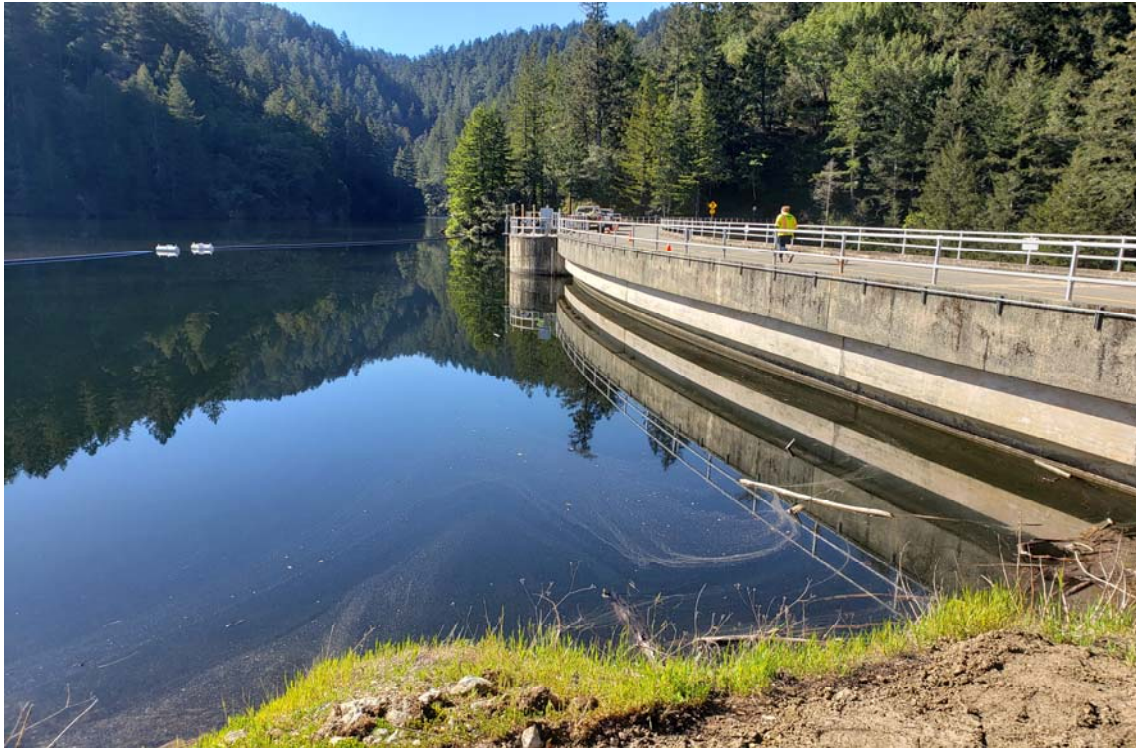
Photo 1: View of the upstream face as seen from the right abutment.

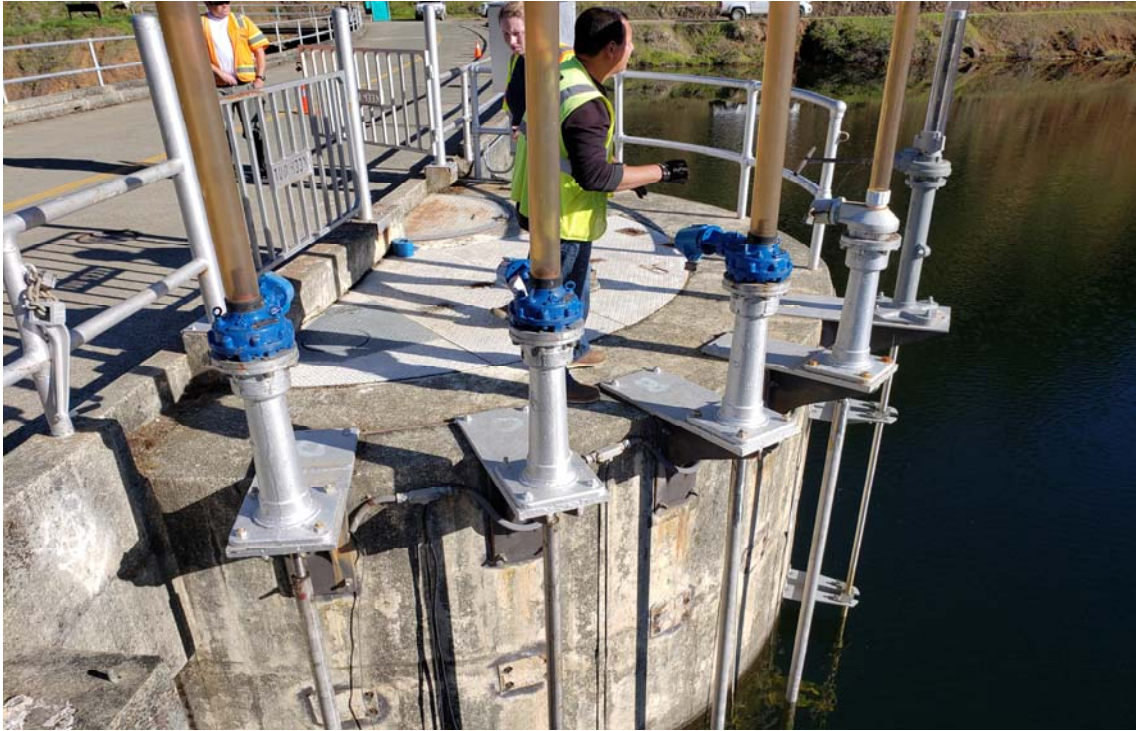
Photo 2: View of the recently replaced valve stems for the upstream slide gates.

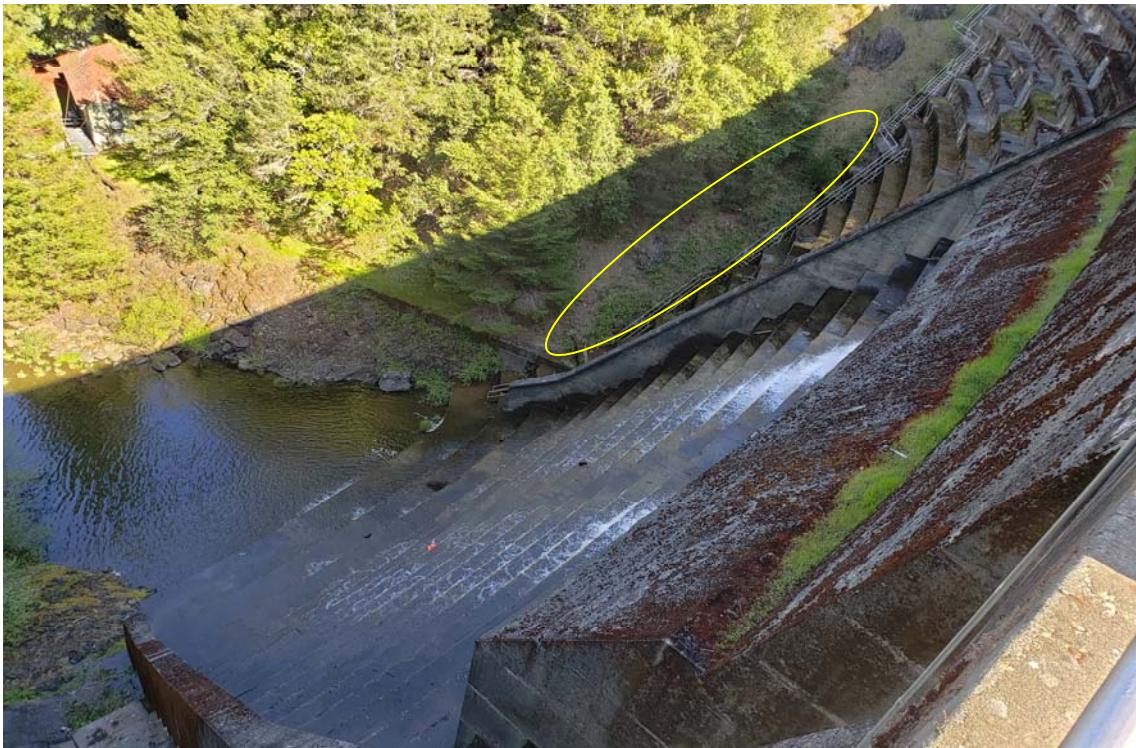
Photo 3: View of the downstream face as seen from the left abutment. Minor vegetation in the right groin (circled) requires removal.

Vegetation in both downstream groins needs to be removed to allow for access, visibility for inspection, and monitoring for seepage and other defects (photos 3 & 4).
 The owner must arrange for the galleries to be inspected during the next periodic inspection.
 The downstream outlet controls will need to be cycled in the presence of DSOD during the next inspection.
 In future instrumentation submittals, the owner must provide an evaluation of each component of the data with regards to dam safety.

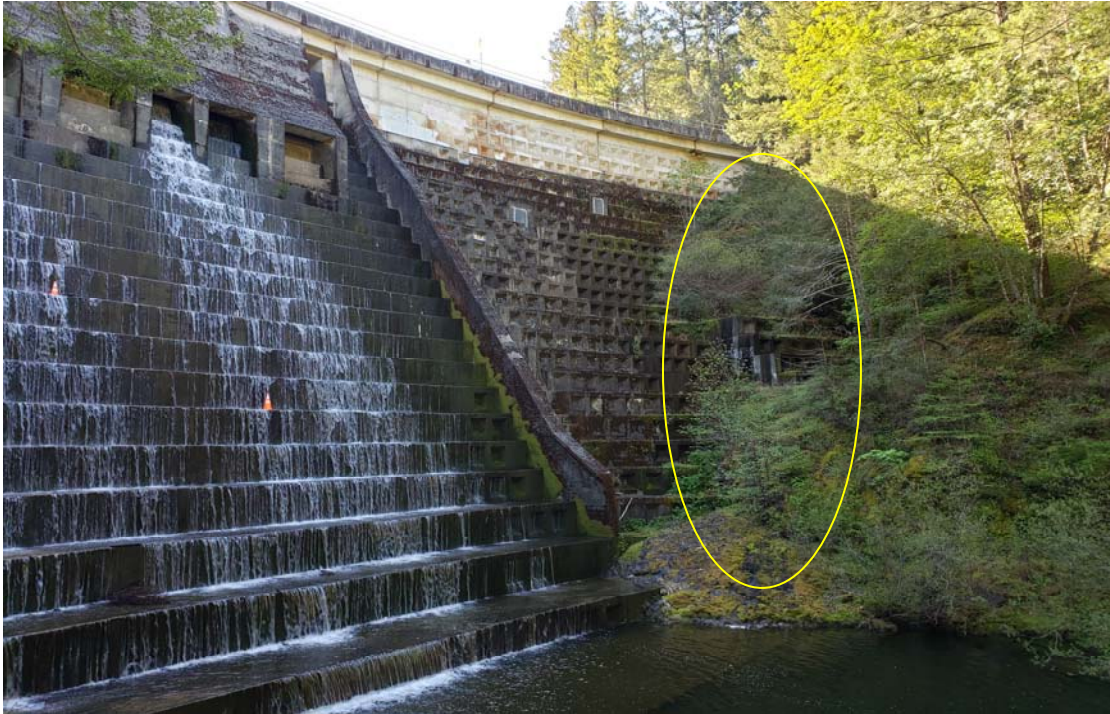
Photo 4: View of the downstream face looking towards the left abutment. Vegetation in the left groin (circled) requires removal.
