STATE OF CALIFORNIA
CALIFORNIA NATURAL RESOURCES AGENCY
DEPARTMENT OF WATER RESOURCES
DIVISION OF SAFETY OF DAMS

INSPECTION OF DAM AND RESERVOIR IN CERTIFIED STATUS

Name of Dam Bon Tempe Dam No. 33-6
 Date of Inspection April 15, 2020

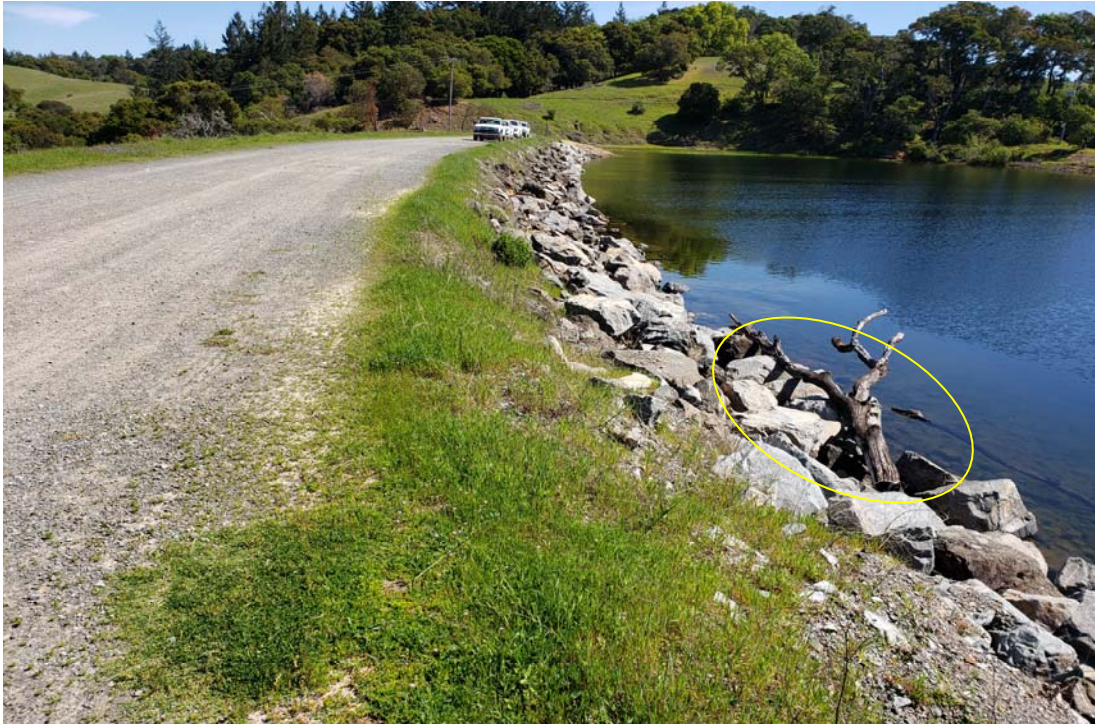
The wood log on the upstream face needs to be removed (photo 1).

Photo 1: View of the upstream face looking toward the right abutment and spillway. The circled debris needs to be removed.

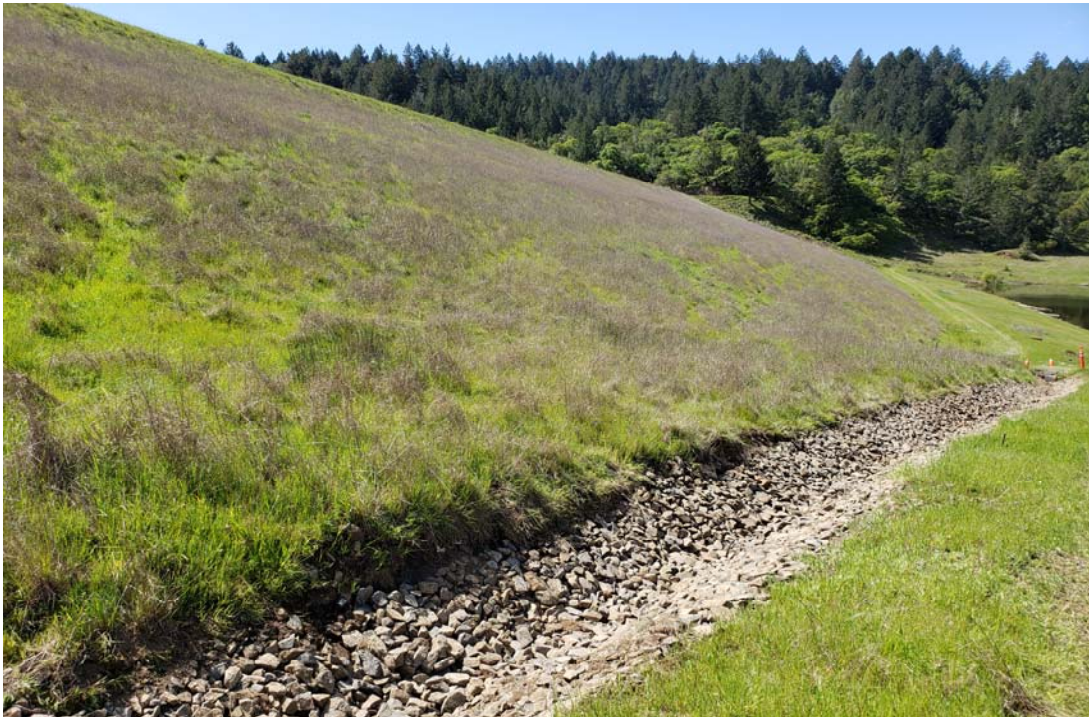
As requested in the previous inspection report, woody vegetation was removed from the downstream face and groins (photo 2).

The rock in the drainage ditch at the right abutment was replaced with larger rock and is now performing satisfactorily (photo 2).

Photo 2: View of the downstream face and seen from the right abutment, and the replaced rock in the drainage ditch.

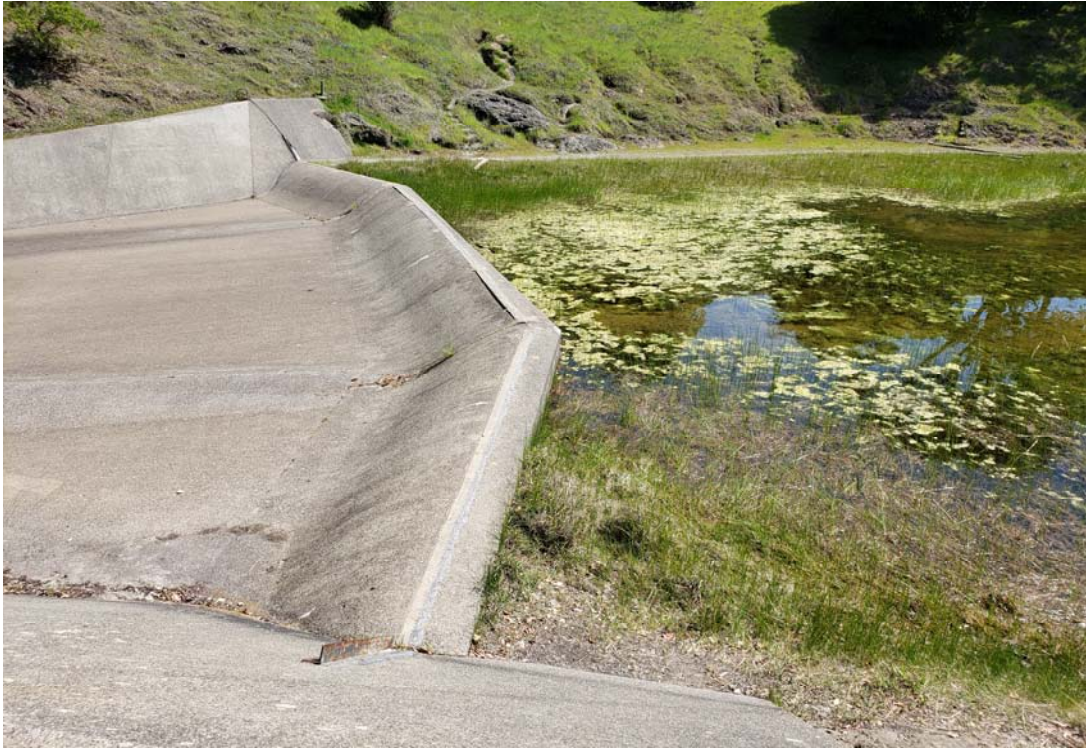
Photo 3: View of the spillway approach and concrete weir.

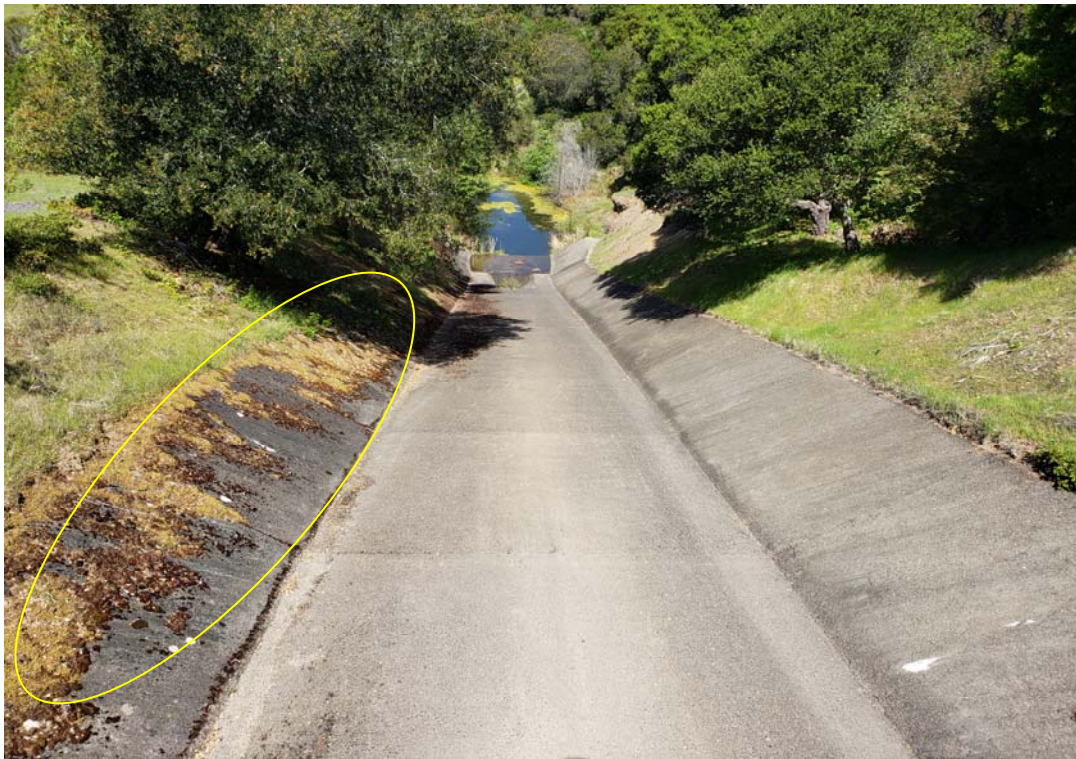
Vegetation growing in the concrete joints and behind the concrete walls of the spillway needs to be removed as part of annual maintenance (photo 4).

Photo 4: Vegetation growing in the spillway joints needs to be removed.
