STATE OF CALIFORNIA
CALIFORNIA NATURAL RESOURCES AGENCY
DEPARTMENT OF WATER RESOURCES
DIVISION OF SAFETY OF DAMS

INSPECTION OF DAM AND RESERVOIR IN CERTIFIED STATUS

Name of Dam Lagunitas Dam No. 33-2 County Marin
 Type of Dam Earth Type of Spillway Concrete weir with steel and timber flume
 Water is 0.2 feet above the spillway crest and 7.3 feet below the dam crest.
 Weather Conditions Sunny and warm
 Contacts Made Lucy Croy, Kristin Arnold, and Jonathan Fouche (Marin Municipal Water District)
 Reason for Inspection Annual Inspection

Inspected by Michelle Lockhart
 Date of Inspection April 15, 2020
 Date of Report April 29, 2020

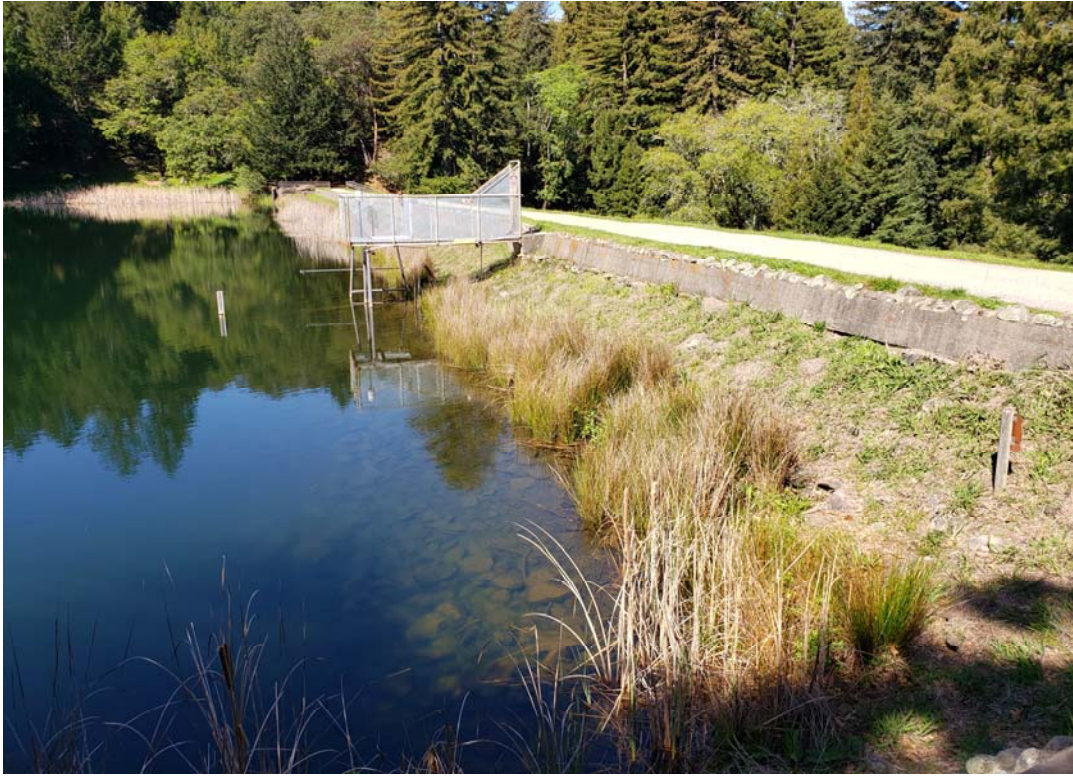
Tule and cattails along the upstream waterline and groins need to be removed (photo 1).

Photo 1: View of the upstream face as seen from the right abutment.

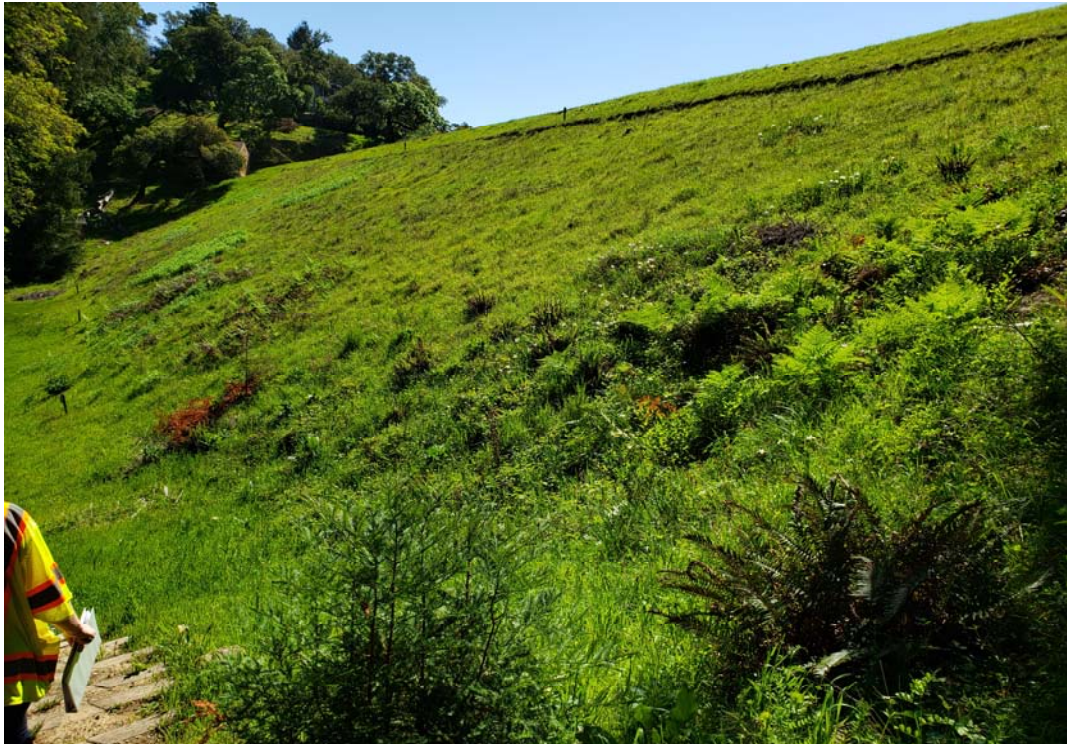
The occasional patches of dense vegetation on the downstream face need to be removed to allow for inspection and monitoring for seepage and other defects (photo 2).

Photo 2: View of the downstream face as seen from the toe. Patches of dense vegetation need to be removed.

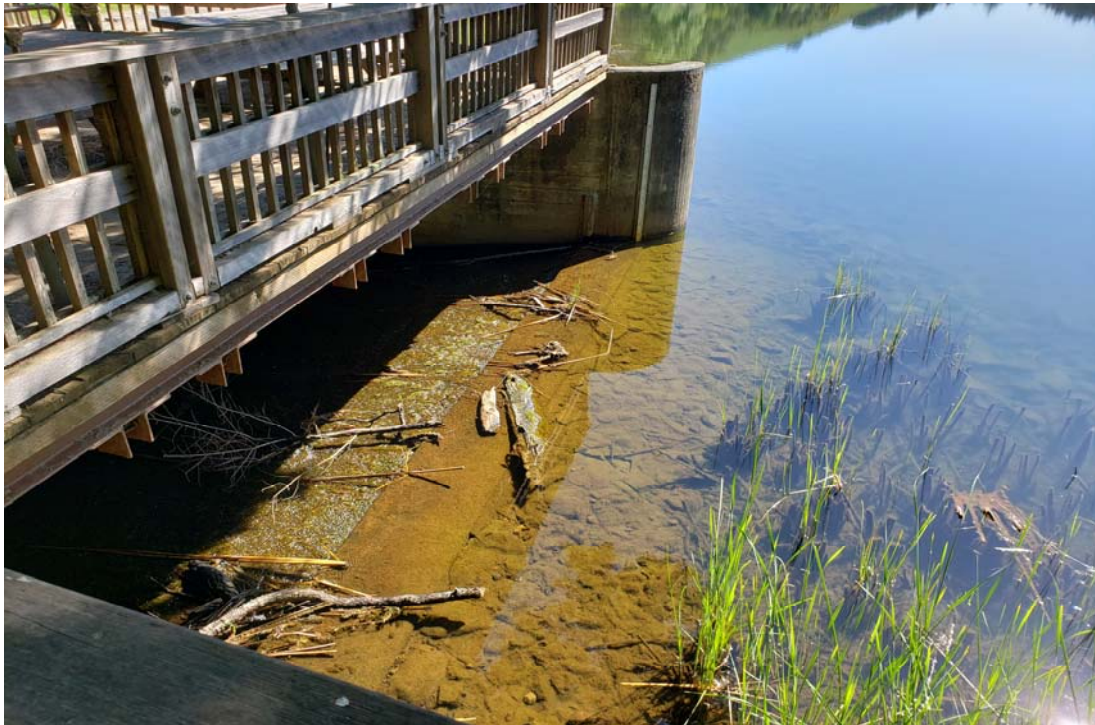
Photo 4: The spillway approach was clear and unobstructed and slightly spilling.
