## INSPECTION OF DAM AND RESERVOIR IN CERTIFIED STATUS

Name of Dam Phoenix Lake Dam No. 33-3 County Marin  
 Type of Dam Earth Type of Spillway Concrete weir and chute  
 Water is 0.16 feet above the spillway crest and 15.2 15.04 feet below the dam crest.  
 Weather Conditions Sunny and warm  
 Contacts Made Lucy Croy, Kristin Arnold, and Jonathan Fouche (Marin Municipal Water District)  
 Reason for Inspection Annual Inspection

Name of Dam Phoenix Lake Dam No. 33.3  
 Date of Inspection April 15, 2020

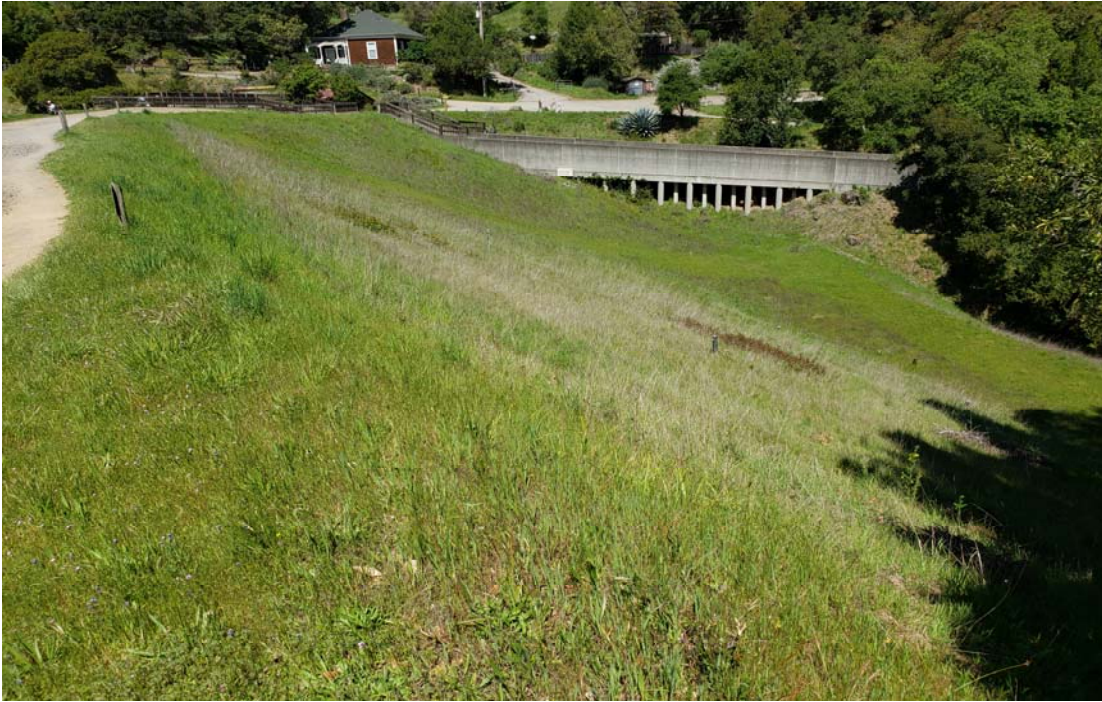
Photo 1: View of the downstream face as seen from the right abutment.

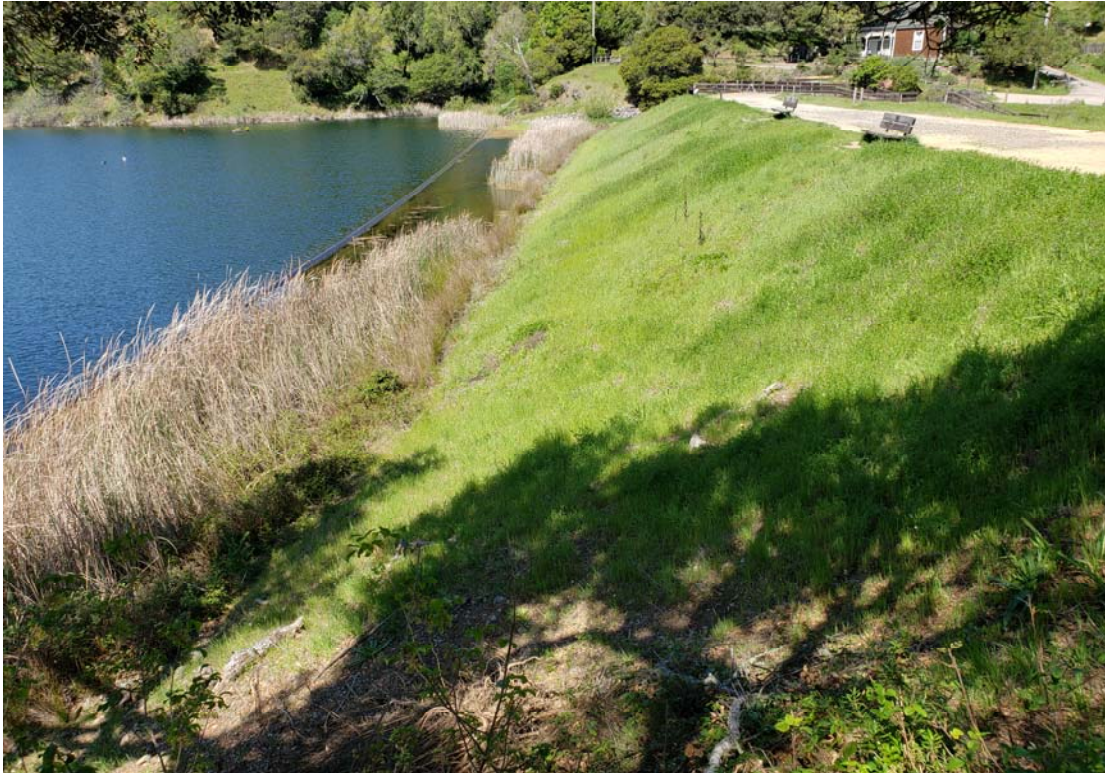
Tules growing along the upstream waterline and in the spillway approach need to be removed (photos 2 & 3).

Photo 2: View of the upstream face as seen from the right abutment. Tules along the waterline (circled) need to be removed.

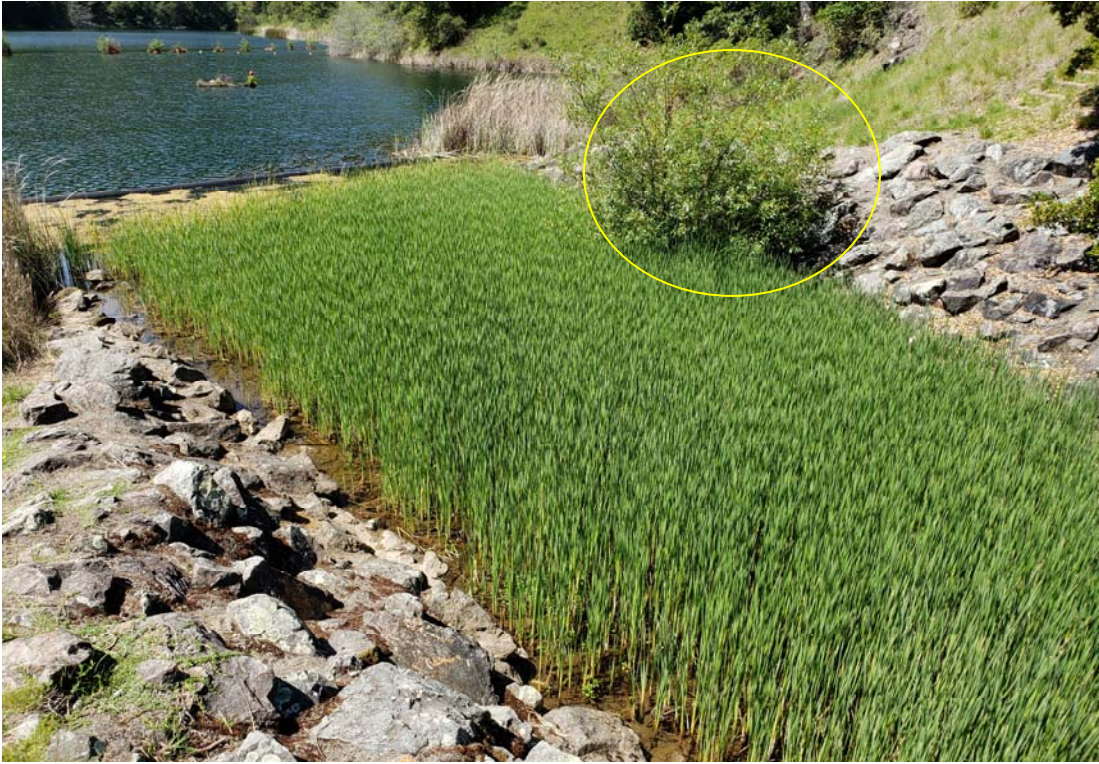
Photo 3: Tules and the circled tree in the spillway approach need to be removed.

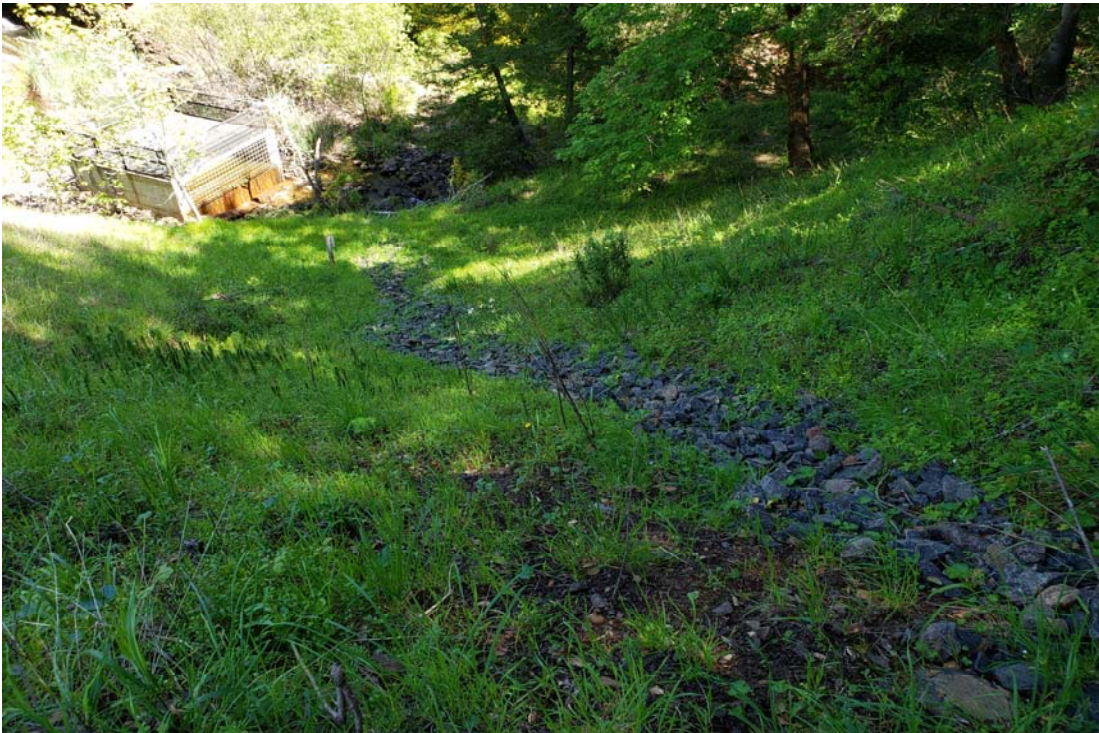
Photo 4: Additional rock was placed in the groins of the lower portion of the downstream face.

As requested in the previous inspection report, emerging vegetation was removed from the downstream right groin and rock was added to both lower downstream groins, preventing additional erosion (photo 4).
